**SUMMARY OF  
BUILDING EXCELLENT SCHOOLS TODAY (BEST)  
FY2012-13 GRANT APPLICATIONS  
RECEIVED ON MARCH 2, 2012**

DIVISION OF PUBLIC SCHOOL  
CAPITAL CONSTRUCTION ASSISTANCE

MAY 2012

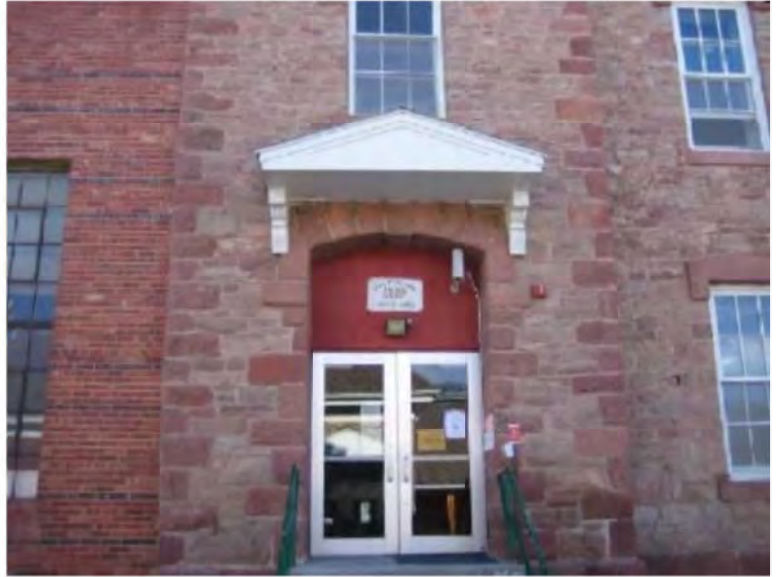
**Q#: 110.4 - What is the condition of the roof covering? The roof is beyond its expected life. Score: 2**

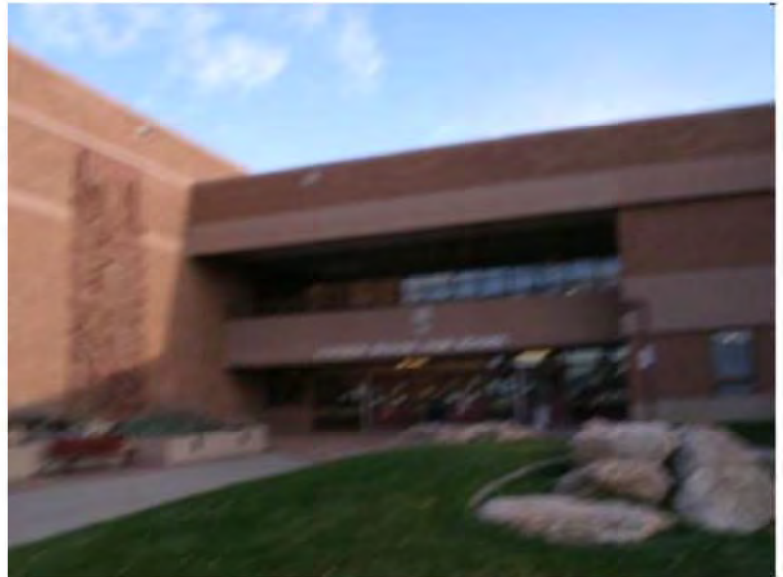
**Q#: 120-** Are there any noticeable odors in the school that suggest sewer lines are in poor condition? There are reoccurring odors in the school and chronic sewer line problems. Score: 2

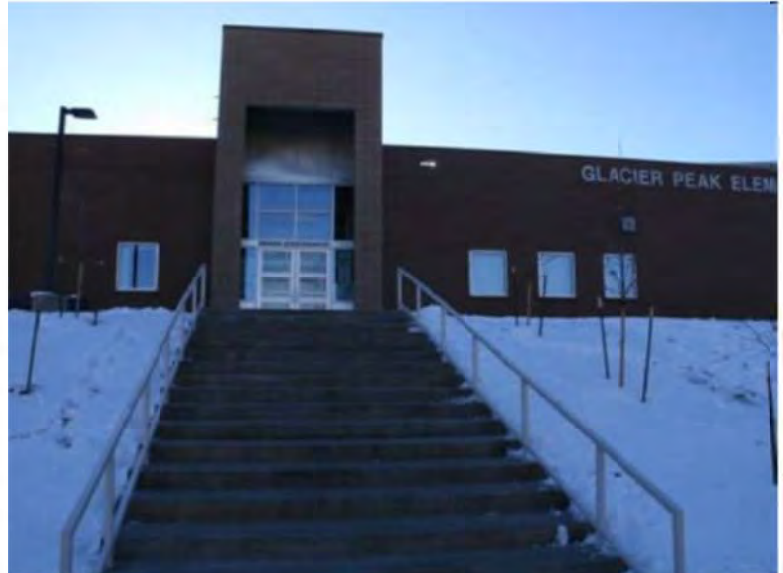
**Q#: 34 - Does water drain positively away from the school? No, the water drains towards the building. Score: 1**

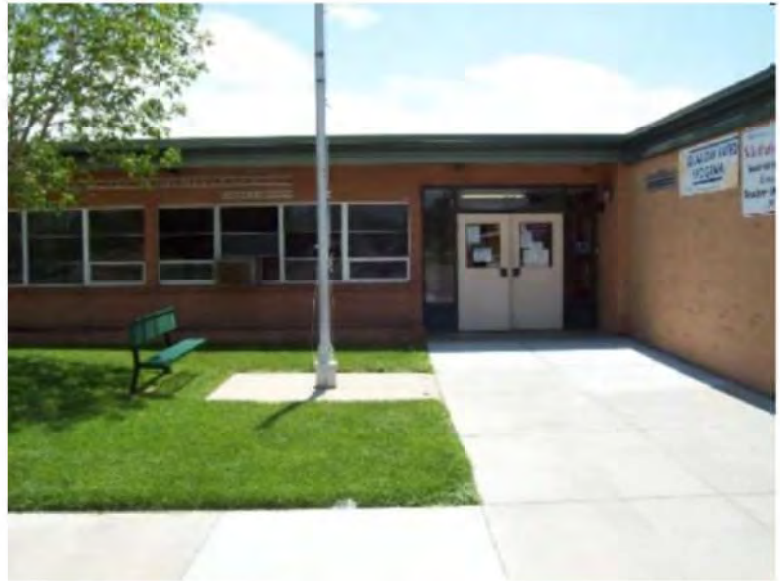
**Q#: 110.4 - What is the condition of the roof covering? The roof is in fair condition but beyond expected life. Score: 3**

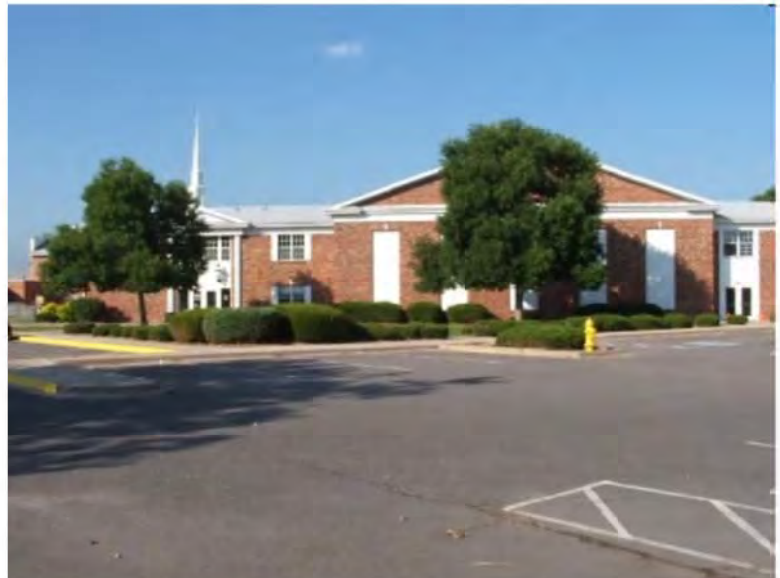
**Q#: 110.4 - What is the condition of the roof covering? The roof is in fair condition with leaks being patched in several areas. Score: 2**

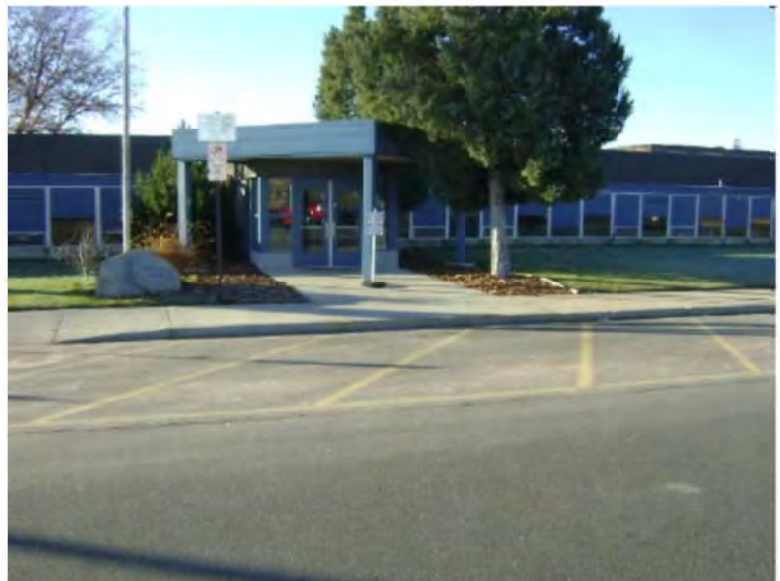
Q#: 110.4 - What is the condition of the roof covering? The roof is in very poor condition. Score: 1

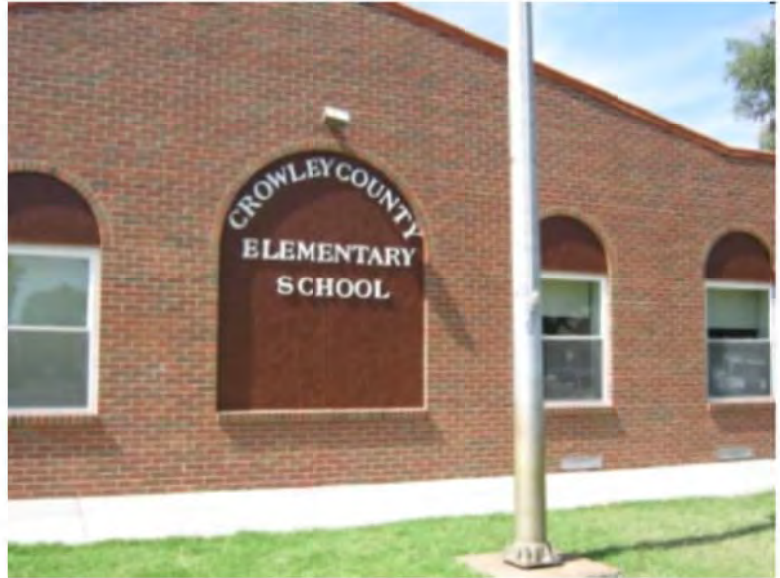
**Q#: 110.4 - What is the condition of the roof covering? The roof is in very poor condition. Score: 1**

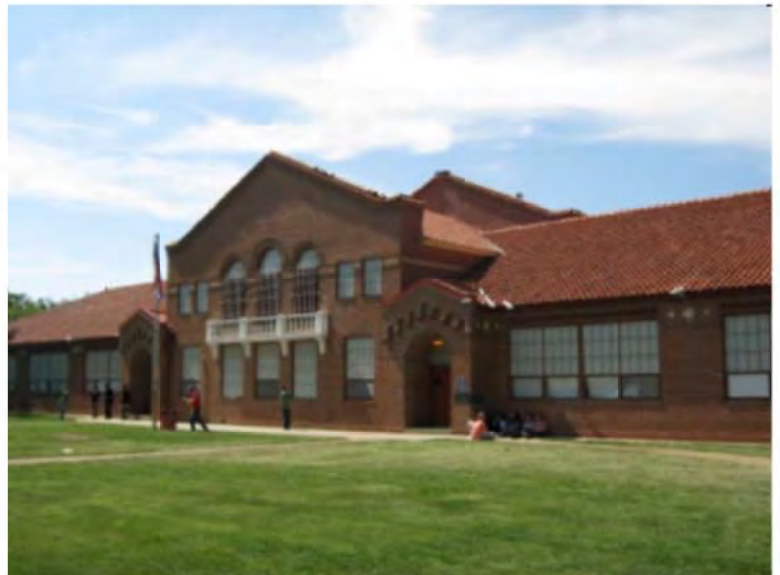
**Q#: 110.4 - What is the condition of the roof covering? All the roofs appear to be in good condition. There are no reports of leaks. Score: 3**

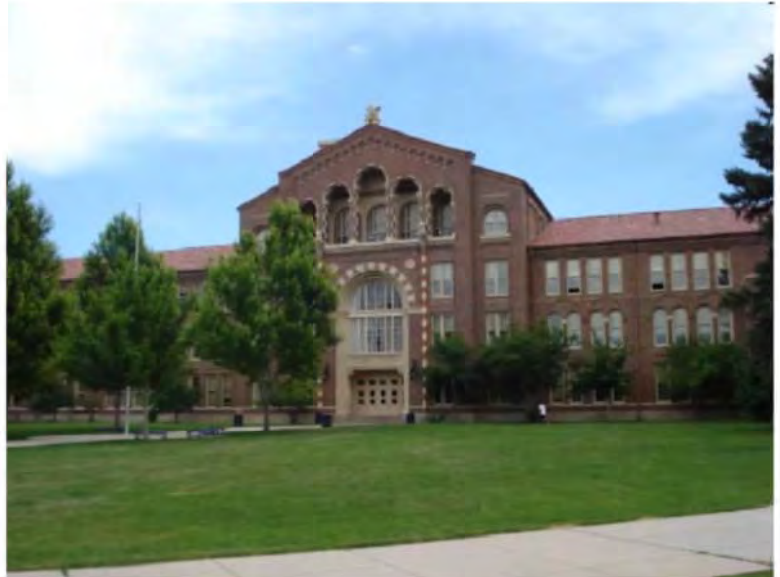
Q#: 110.4 - What is the condition of the roof covering? The roof is in fair condition with minor leaks. Score: 3

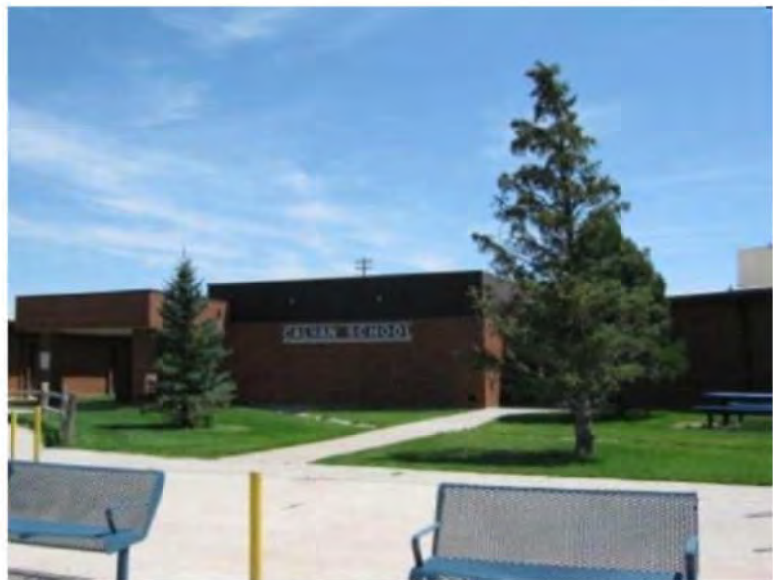
**Q#: 125.1 - Is there restricted access at secondary entrances and controlled access at the building main entrance as recommended in the CDE Construction Guidelines C 3.9? AGREE: There is restricted access at secondary entrances and controlled access at the building main entrance as recommended in the guidelines Score: 5**

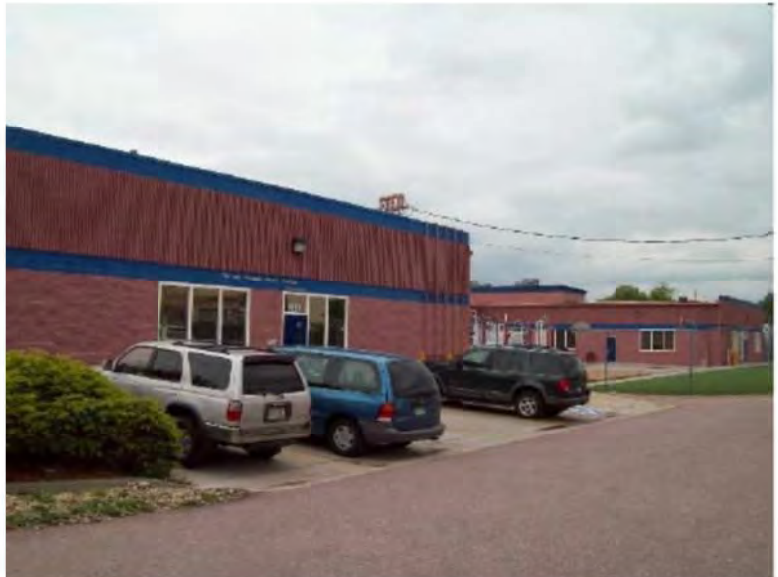
**Q#: 125.1 - Is there restricted access at secondary entrances and controlled access at the building main entrance as recommended in the CDE Construction Guidelines C 3.9? DISAGREE:** There is restricted access at secondary entrances and controlled access at the building main entrance as recommended in the guidelines. Secondary entrances are locked. The main entry is not controlled. Score: 1

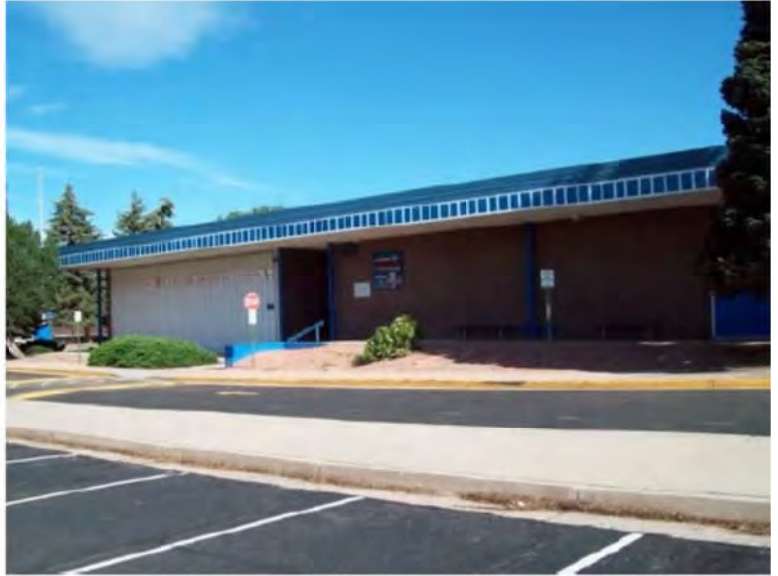
**Q#: 87 - Is there a school fire alarm system that meets current fire codes? IFC Required? Yes, there is a building fire alarm system that meets current fire codes. Score: 5**

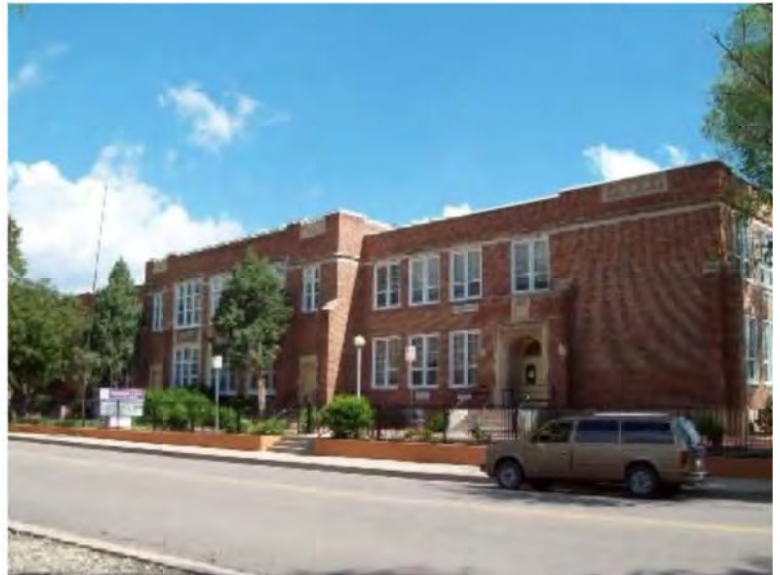
**Q#: 110.4 - What is the condition of the roof covering? The roofs are generally in good condition. The roof at the intergenerational center addition is in poor condition. Score: 3**

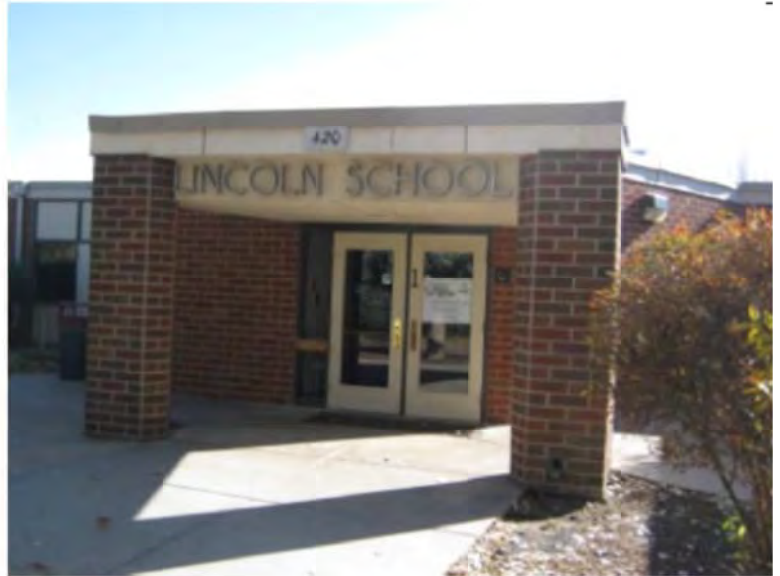
**Q#: 87 - Is there a school fire alarm system that meets current fire codes? IFC Required? The alarm system does not meet code and needs to be replaced. Score: 1**

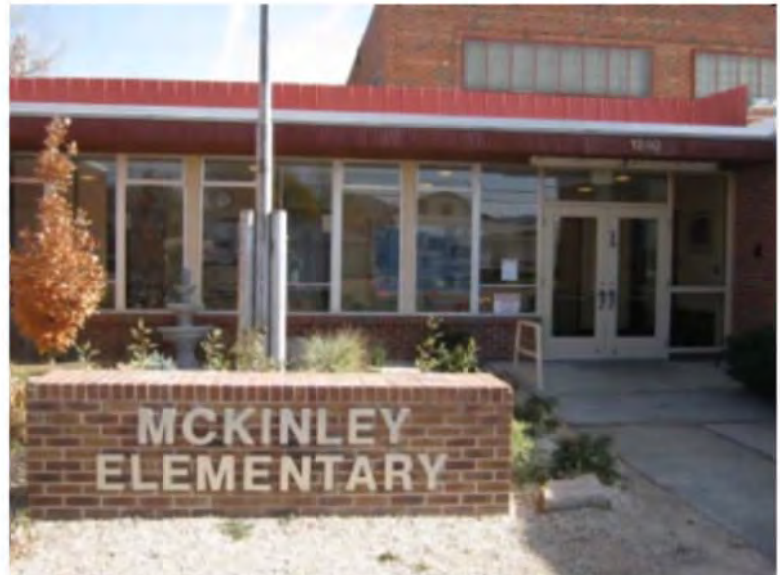
**Q#: 87 - Is there a school fire alarm system that meets current fire codes? IFC Required? The alarm system does not meet code and needs to be replaced. Score: 1**

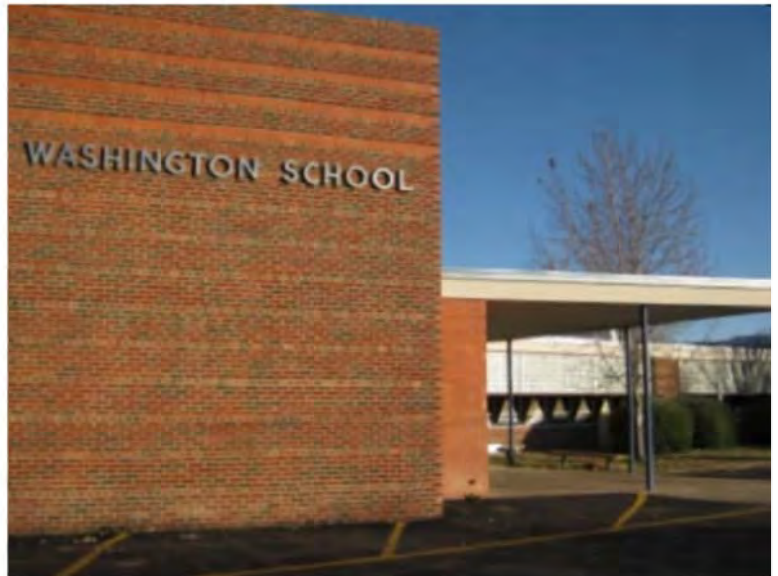
**Q#: 87 - Is there a school fire alarm system that meets current fire codes? IFC Required? The alarm system does not meet code and needs to be replaced. Score: 1**

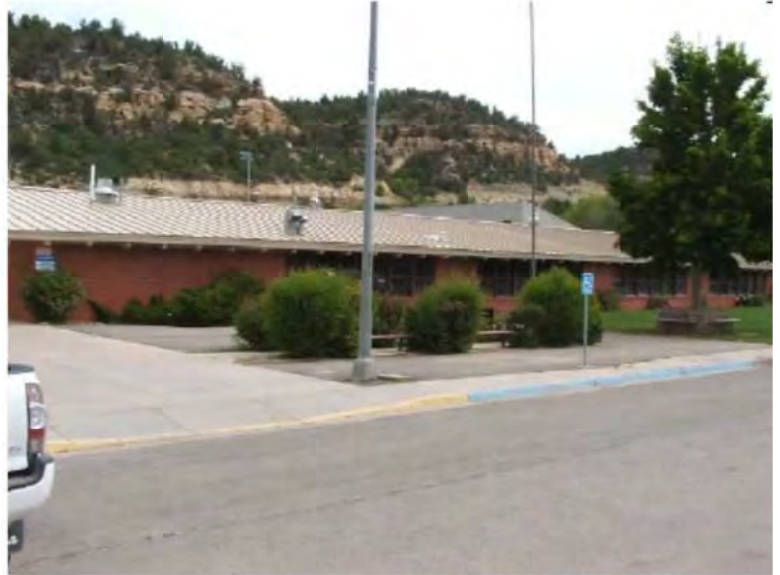
Q#: 16.2 - Is the bus loading and unloading zone and parent drop-off - pickup area separated from other vehicle and pedestrian traffic? Buses off load on street. Score: 4

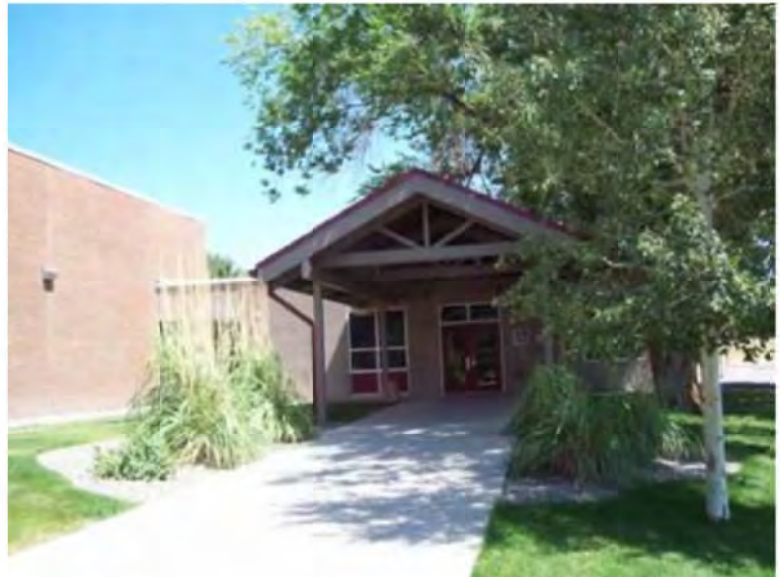
**Q#: 86 - Is the school provided with a sprinkler system? The school is only partially sprinkled and/or the school is sprinkled with a system in poor condition or with areas no longer in service. Score: 2**

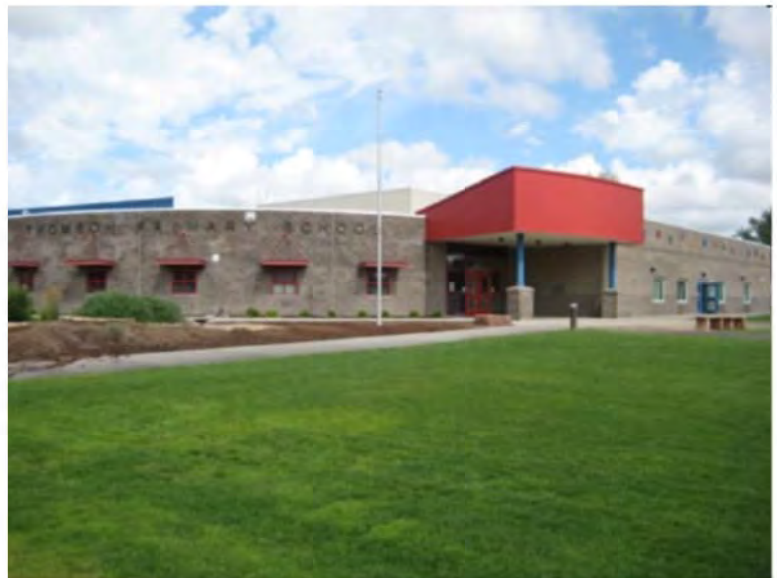
Q#: 125.1 - Is there restricted access at secondary entrances and controlled access at the building main entrance as recommended in the CDE Construction Guidelines C 3.9? AGREE: There is restricted access at secondary entrances and controlled access at the building main entrance as recommended in the guidelines. Score: 5 (For both schools above)

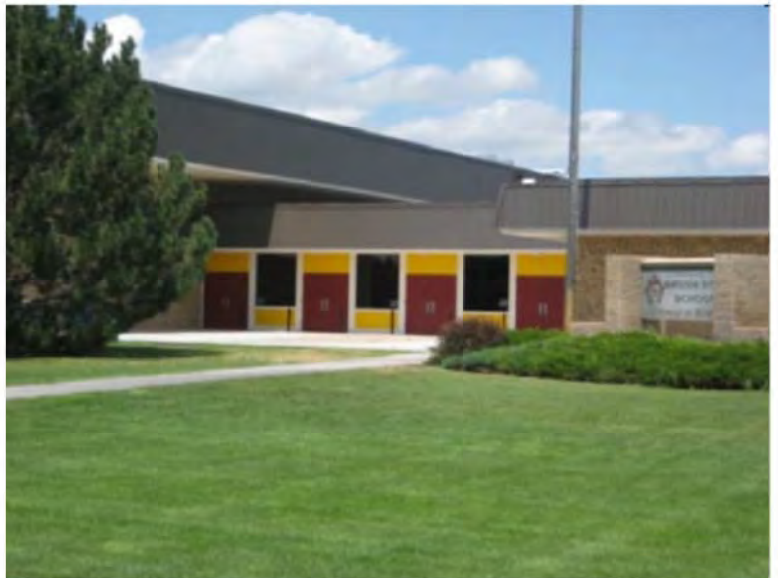
**Q#: 125.1 - Is there restricted access at secondary entrances and controlled access at the building main entrance as recommended in the CDE Construction Guidelines C 3.9? AGREE: There is restricted access at secondary entrances and controlled access at the building main entrance as recommended in the guidelines. Score: 5 (For both schools above)**

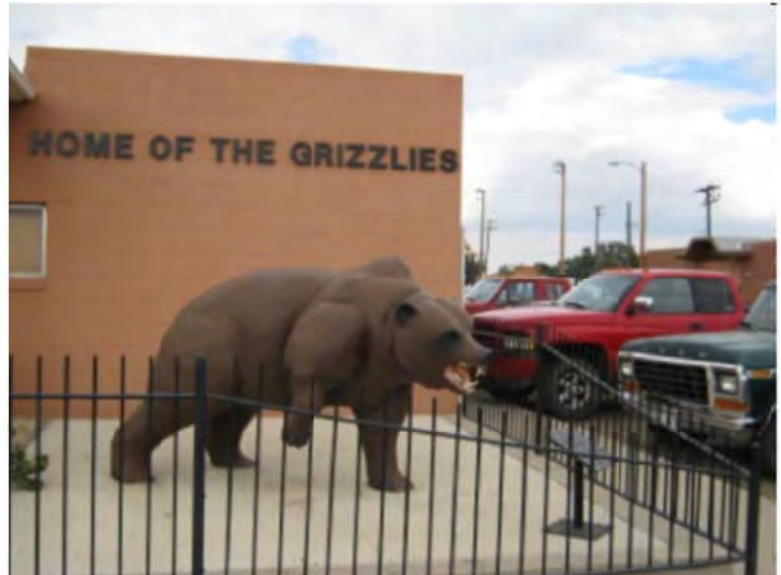
**Q#: 87 - Is there a school fire alarm system that meets current fire codes? IFC Required? The alarm system does not meet code and needs to be replaced. Score: 1**

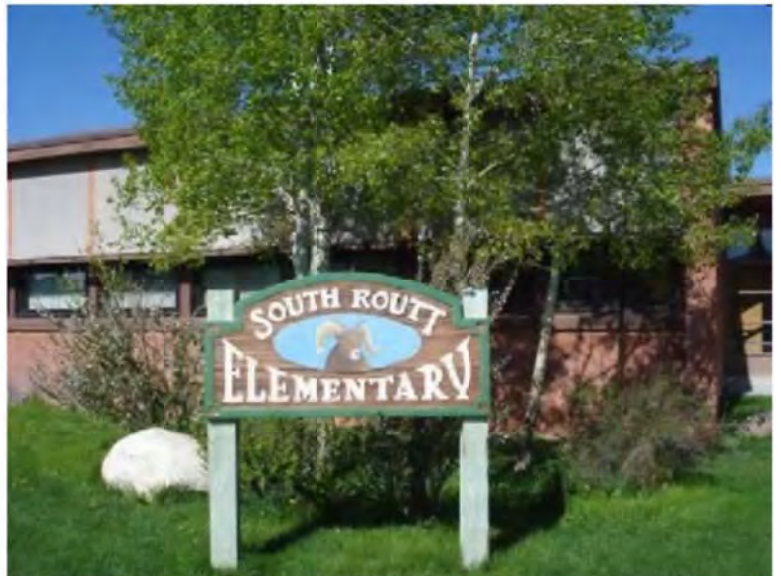
Q#: 125.1 - Is there restricted access at secondary entrances and controlled access at the building main entrance as recommended in the CDE Construction Guidelines C 3.9? AGREE: There is restricted access at secondary entrances and controlled access at the building main entrance as recommended in the guidelines Score: 5

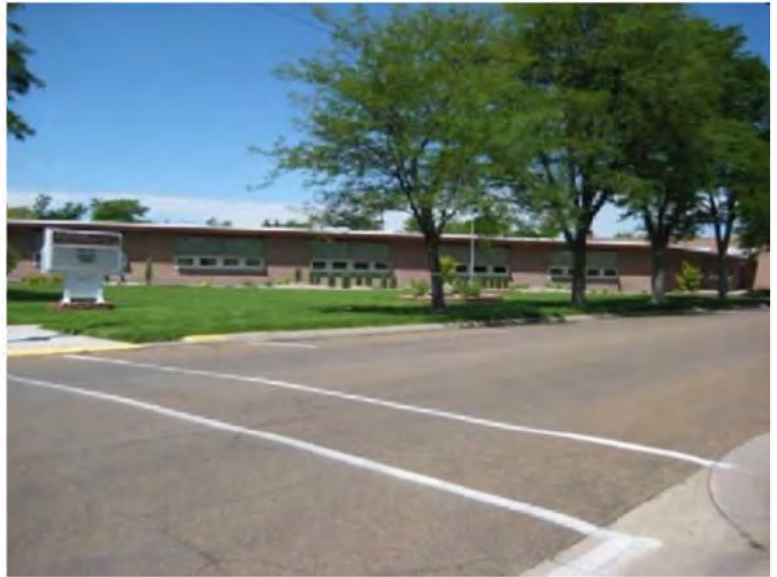
**Q#: 87 - Is there a school fire alarm system that meets current fire codes? IFC Required? The fire alarm system is in poor condition and some of its components are not functioning properly. Score: 2**

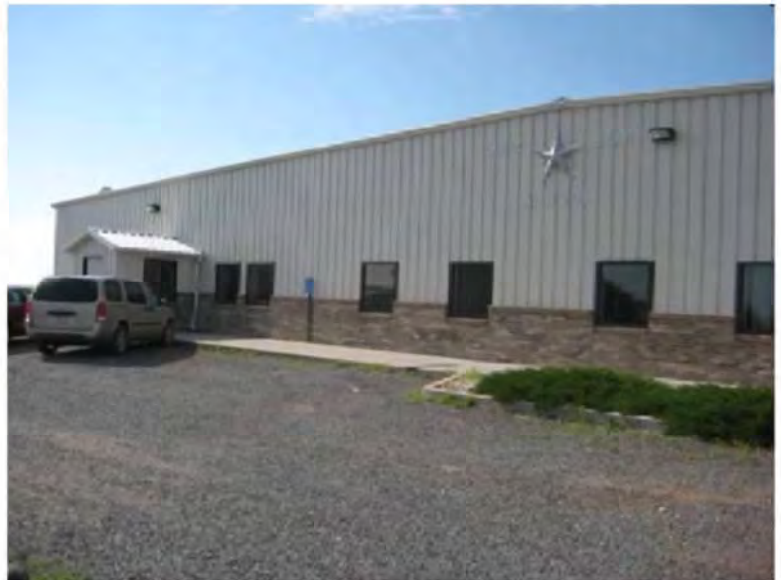
**Q#: 110.4 - What is the condition of the roof covering? The roof is in fair condition. Score: 3**

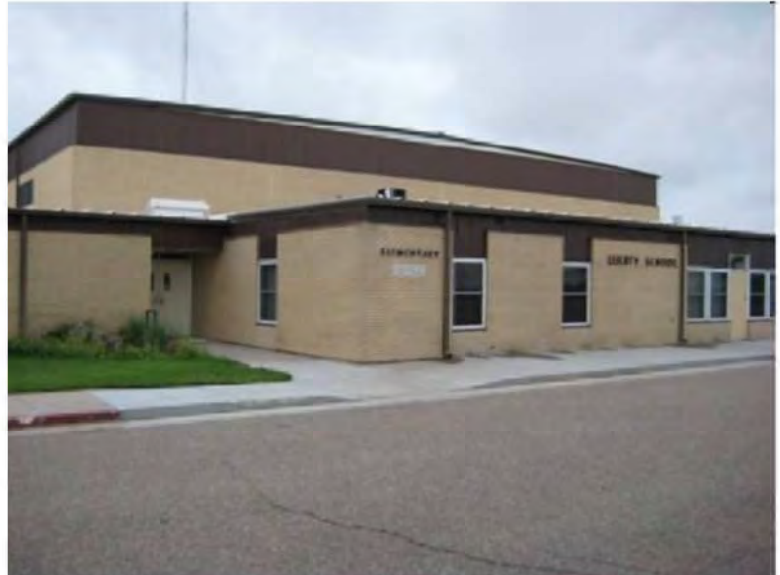
**Q#: 110.4 - What is the condition of the roof covering? The roof is in very poor condition. Score: 1**
