**State Engineer's
24th Annual Report on Dam Safety
to the
Colorado General Assembly
Water Year 2007-08**

**State Engineer's
24th Annual Report on Dam Safety
to the
Colorado General Assembly

For
Water Year 2007-08**

February 2009

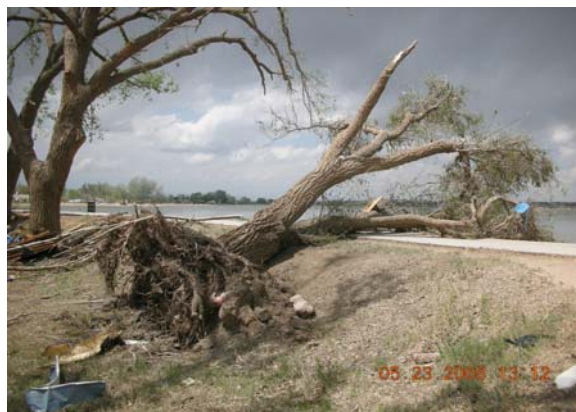
Windsor Lake Dam is a High Hazard dam located in Weld County. On May 22, 2008, a large tornado passed through the northeast corner of the Town of Windsor and directly over Windsor Lake Dam. Jeremy Franz observed an uprooted tree located at the downstream toe of the dam and a resulting hole approximately 10 feet in diameter and two to three feet in depth. Jeremy observed no evidence of active seepage due to the fact that there was no water being impounded on this portion of the dam at the time. Plans and specifications for repair of the hole left by the fallen tree as well as removal of other trees that are on the dam are being prepared by the owner's engineer.

**Windsor Lake Dam, Weld County
Division 1, High Hazard**

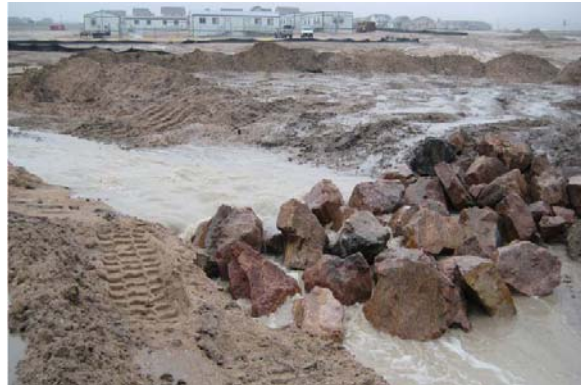
Sand Creek Detention Basin #6 is a component of the Sand Creek flood control scheme in Colorado Springs extending from Dam #1 at Constitution Avenue and Sand Creek to Dam #6 at Woodman Road and Sand Creek. On January 29, 2007, this office wrote a letter to the design engineer and to the dam owner instructing them to suspend construction until plans and specifications are reviewed and approved by the State Engineer. The Dam Safety Branch received no correspondence from the owner or the engineer as requested. On August 15, 2008, Bill McCormick received a phone call that informed him that the reservoir behind Sand Creek Detention Dam #6 was full and spilling. Bill visited the site and observed a large sinkhole about 20 feet wide and 4 feet deep along the upstream side of the embankment and one foot below the grade along the downstream side of the embankment. From Bill's observations it was estimated the hazard of the structure to be in the low to significant category. To prevent further rise in the reservoir and possible failure, a temporary spillway was excavated in the right abutment of the dam and the reservoir was lowered. As a result of Bill's actions and in the interest of public safety, the City of Colorado Springs closed Woodmoor Road to traffic during the incident.

**Sand Creek Detention Dam, El Paso County
Division 2, Non Roster**

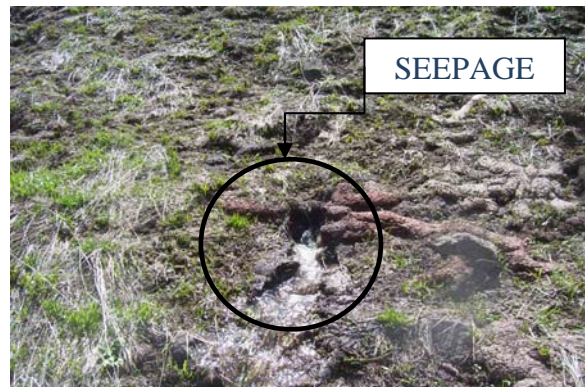
Hopkins Dam is a Significant Hazard dam located in Garfield County. John G. Blair observed an intermittent flow that was producing impulses of turbid water exiting the toe drain as a result of the reservoir filling above the restricted level with the heavy spring snowmelt runoff. The outlet was opened and the water level was lowered to below the current restricted level. An order to lower the spillway or breach the dam was issued as a result of this action.

**Hopkins Dam, Garfield County
Division 6, Significant Hazard**

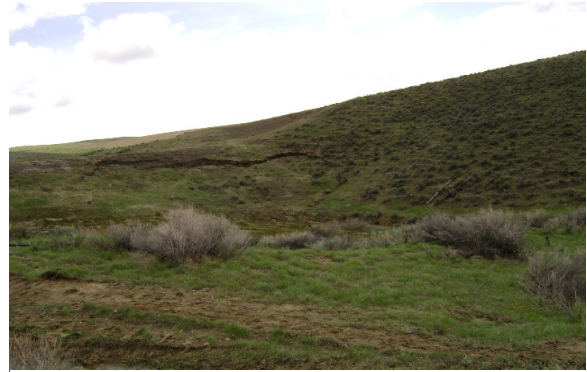
Biskup Dam is a Low Hazard dam located in Moffat County. Biskup Dam experienced a downstream slope failure. The slope failure occurred in an area where recent construction activities occurred without prior review and approval of the design by the Dam Safety Branch and State Engineer.

**Biskup Dam, Moffat County
Division 6, Low Hazard**

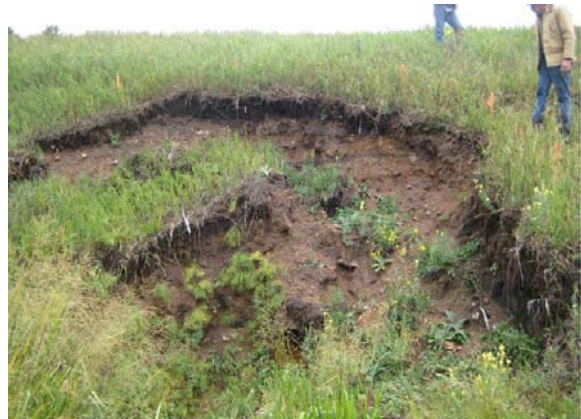
conduit resulted in additional sloughing and damage to the downstream slope of the dam. The owner is now under orders to breach the dam to remove this public safety hazard.

**Green Valley Retention Dam, Jefferson County
Division 1, Low Hazard**

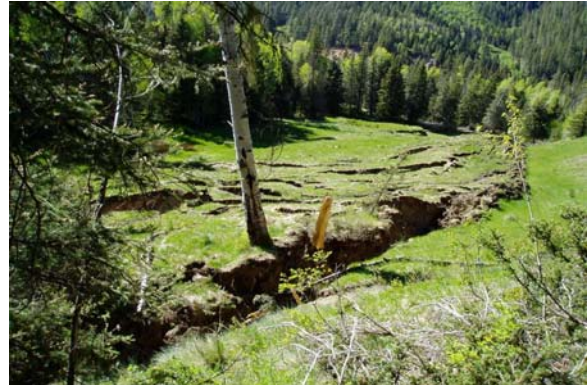
A landslide progressing into the river at a rate of approximately four feet per day on the East Fork of the San Juan River above Pagosa Springs generated concern over the potential flooding hazard that would result should the landslide form a natural dam across the river. The slide was located about 14 river miles upstream of Pagosa Springs. Paul Perri, Matt Gavin, and Bill McCormick performed an analysis to determine the peak discharge as a result of a failure of the natural dam. Due to the unpredictable nature of landslides, various dam heights and subsequent reservoir volumes were generated for dam heights up to 210 feet. Using empirical formulas and storage volumes generated at each dam height, peak breach flows were estimated. The peak flows for the various dam heights were routed downstream to estimate the potential impacts of the flood waters on downstream facilities and structures. After the spring snowmelt runoff season, the slide stabilized and did not continue to advance forward.

Landslide area above East Fork of the San Juan River, Archuleta County
