**State Engineer's
25th Annual Report on Dam Safety
to the
Colorado General Assembly
Water Year 2008-09**

**Colorado Division of Water Resources
Office of the State Engineer**

**For
Water Year 2008-09**

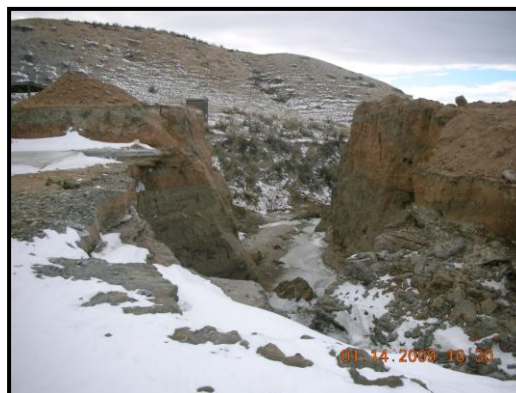
**Park Creek # 2 Dam, Larimer County
Low Hazard**

Park Creek Dam #2 is classified as Minor size, Low Hazard Dam and is located in Division 1. On Monday, January 12, Jeremy Franz, Division 1 Dam Safety Engineer, received a call from the owner’s engineer explaining that the contractor cut a small trench through the crest of the dam to start lowering the water surface of the reservoir so that they could start work on removing the outlet conduit. The contractor reportedly cut a 2 to 4 foot-wide trench through the crest near the left abutment. Eventually, the depth of the trench reached about 7’ allowing about 2’ depth of flow through the breach (the dam provides 5’ of freeboard). Shortly after this small breach was cut, the flow of water began eroding the breach rapidly. The breach grew to a size of approximately 25’ wide by 20’ deep with near-vertical side-walls (see photo). This resulted in loss of nearly all the water in the reservoir. The owner is in the process of submitting design documents for the repair of the dam.

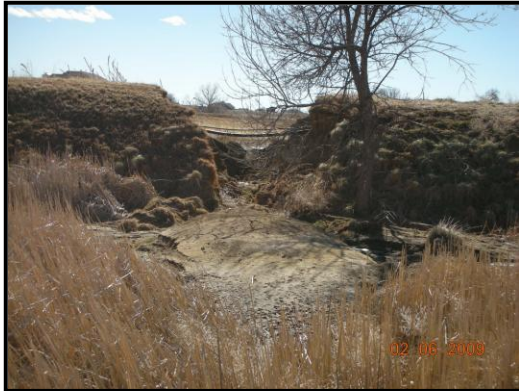
Non-Roster Dam, Weld County

On February 6, 2009 John Batka, Division 1 Dam Safety Engineer, identified a small dam that had recently breached. The breach occurred late in 2008 as a result of vandalism of the upstream reservoir's outlet gate resulting in the draining of a portion of the reservoir into the dam below. The owner plans to repair the damage and restore the dam back to original condition.

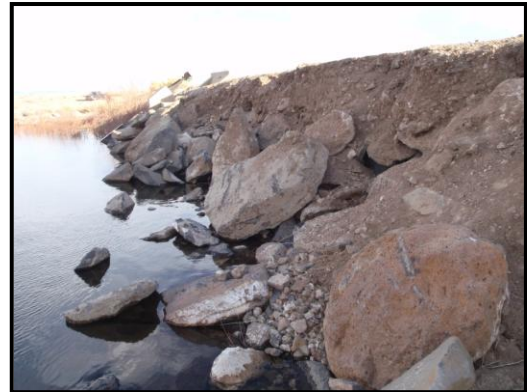
**Smith Dam, Costilla County
High Hazard**

Smith Dam is classified as a Large size, Significant Hazard Dam in Division 3. On April 21 2009, Matt Gavin, Division 3/7 Dam Safety Engineer, was notified by a DWR Water Commissioner that Smith Dam had sustained considerable wave damage during a recent wind storm. On April 22, Mr. Gavin performed a site visit to assess the damage and found that the dam had sustained erosion that penetrated into the seepage control portion of the embankment. As a result, a storage restriction of two feet below the spillway crest was recommended to prevent further damage, which could threaten the safety of the structure. Plans for rehabilitation of the upstream slope are currently being prepared by the Owners' consultant. In addition to the upstream slope rehabilitation, the Owners' consultant is also preparing plans for the rehabilitation of the upstream outlet gate, which should alleviate the pressurized conditions in the outlet, a long-standing dam safety concern for this facility. It is the Owners' intent to address these deficiencies in the fall of 2009.

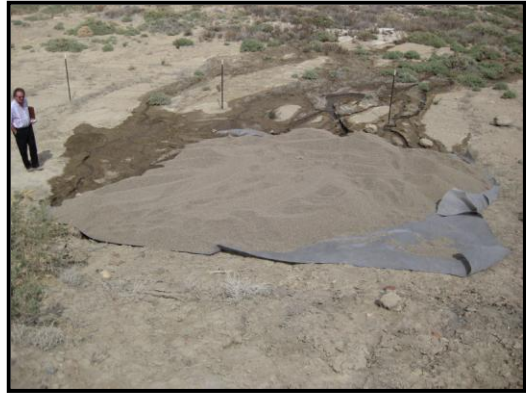
**Park Center L&W # 5 Dam, Fremont County
Low Hazard**

Park Center L & W #5 Dam is classified as a Minor size, Low Hazard Dam in Division 2. The dam about 18 feet in height has a normal storage volume of 57 acre-feet. On April 22, 2009, the Colorado Springs Field office of the Dam Safety Branch received a call from the manager of the Park Center Water District, the owner of the dam. The owner indicated that they had a problem at their dam, the dam was leaking and the seepage was cloud. The owner was in the process of lowering the reservoir with pumps with a capacity of 1,500 gpm. Bill McCormick, Division 1/ 2 Dam Safety Engineer, requested that they get some pea gravel material and filter fabric delivered to the site for use in stabilizing the loss of fines from the seep. After Mr. McCormick investigated the seepage area it was decided to use the available materials and construct a drainage blanket on top of the seep area to stabilize the downstream slope of the dam and control the seepage and minimize the loss of embankment materials. Placement of the material in combination with lowering of the reservoir water level the seepage had been reduced by approximately half of the original observation in a short period of time. The owner is in the process of submitting design documents for the repair of the dam.

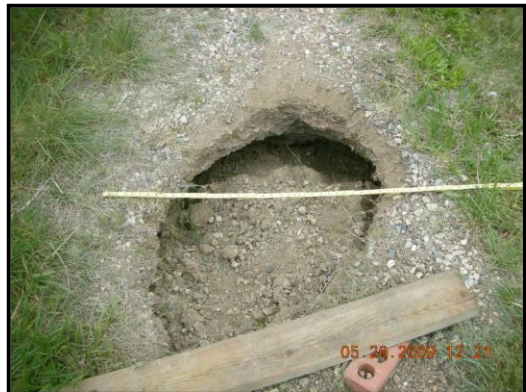
**Dixon Dam, Larimer County
Low Hazard**

Dixon Dam is classified as a Small size, Low Hazard Dam in Division 1. The dam is about 8.6 feet in high and impounds approximately 207 acre-feet. on May 20th, 2009 the Greeley field office received a call from the President of the Eagle Lake Association indicated that a sinkhole was found over the outlet of dam the night before and that he sinkhole had apparently increased in size overnight. Jeremy Franz, Dam Safety Engineer in Division 1 investigated the situation and determined that the sink hole was above the spillway conduit near the left abutment. Mr. Franz recommended that the owner take proper steps to lower the reservoir to a safe operating level. The owner informed Mr. Franz that to his knowledge the reservoir did not have a low-level outlet. The owner is in the process of turning off the inlet to the reservoir and submitting design documents for the repair of the dam.

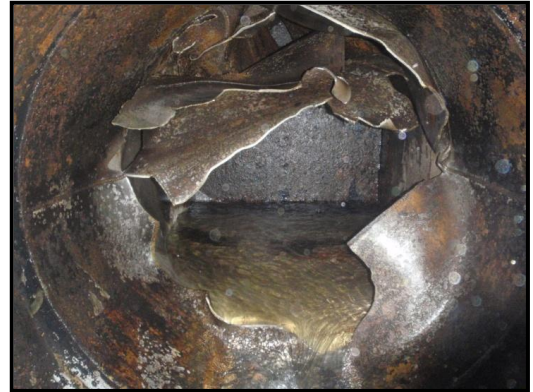
**Beaver Park Dam, Rio Grande County
High Hazard**

Beaver Park Dam is classified as a Large size, High Hazard Dam in Division 7. The dam has a jurisdictional height of 85 feet and a normal storage pool of 4,758 acre feet and is owned by the Colorado Division of Wildlife (DOW). On June 10, 2009, Matt Gavin, Dam Safety Engineer for Division 7, discovered during an annual inspection that the outlet gate chamber had suffered significant damage as a result of routine operation during spring runoff. Thanks to the timely discovery of the problem, additional damage to the gate chamber was avoided, and the design of repairs to correct the problem were initiated on an emergency basis. Repairs were completed in November 2009.

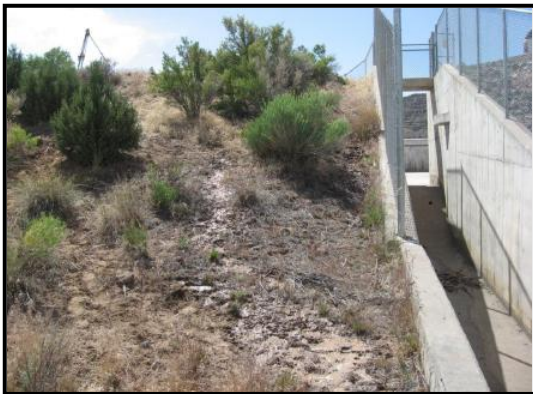
**Jerry Creek # 2 Dam, Mesa County
High Hazard**

Jerry Creek #2 is classified as a Large Size, High Hazard Dam. The dam has a jurisdictional height of 150 feet and a normal storage pool of 7,634 acre-feet. On June 17, 2009, Garrett Jackson, Division 4/5 Dam Safety Engineer received a phone call from the owner explaining that he observed water seeping into the service spillway through some of the construction joints and other cracks in the spillway concrete wall and upon further observation seepage was observed coming out of the ground on the right side of the spillway along the Dike 1 embankment. Mr. Jackson recommended that the reservoir be lowered a minimum of 1 to 2 feet. Upon lowering the reservoir 0.3 feet, the seepage stopped. The owner's engineer is in the process of developing a design to control the seepage.

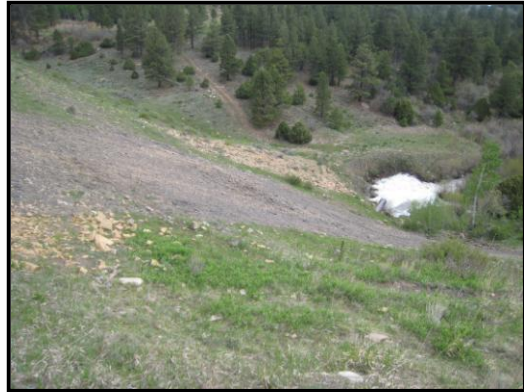
**Gurley Dam, San Miguel County
High Hazard**

Gurley Dam is a Large size, High Hazard Dam located in Division 4. The dam has a jurisdictional height of about 87 feet and a normal storage pool of 10,039 acre-feet. On April 27, 2009 Jason Ward, Division 4 Dam Safety Engineer received a phone call from the president of the Farmers Water Development Company. He indicated a small embankment slide had occurred at the bottom of the 2008 slope failure repair. He further explained that the slide appears to be top soil only. Observations by Mr. Ward indicated that the slide was minor in nature and did not appear to be a result of seepage related. Mr. Ward asked the owner to continue to monitor the embankment for additional signs of sliding.

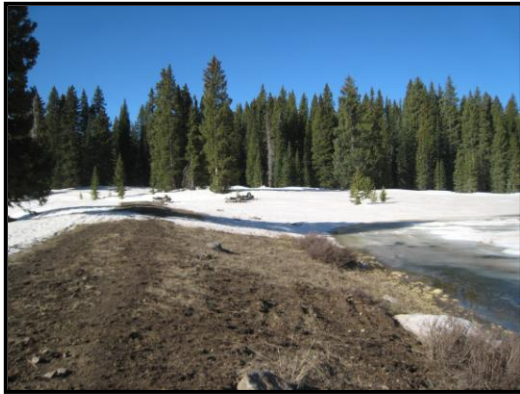
**Womack #2/3 Dam, Delta County
Low Hazard**

Womack #2/3 Dam is a small size, Low Hazard Dam located in Delta County. The dam has a jurisdictional height of 15 feet and a normal storage pool of 109 acre-feet. On May 14, 2009 Jason Ward Division 4 dam safety engineer received a phone call from Water Commissioner Jim Boyd explaining that the snow blockage in the emergency spillway that was previously identified by Mr. Ward in a site visit on May 8, 2009 had breached causing a wave of water to be released causing erosion damage in the downstream feeder ditches and in the discharge channel below the Womack #5 spillway. Mr. Ward informed the owner that timely clearing of the snowpack in the spillway to facilitate spring runoff flows is critical.

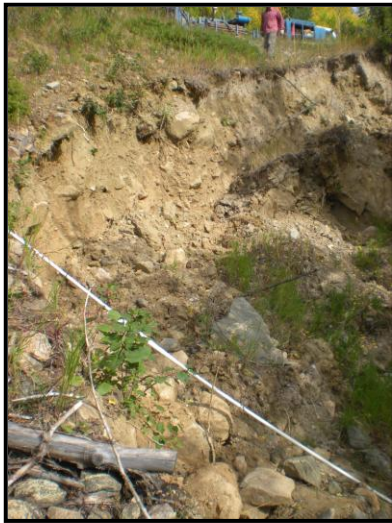
**Lower Cabin Creek Dam,
Clear Creek County
High Hazard**

Lower Cabin Creek is classified as a Small size, High Hazard Dam located in Division 1. The dam has a jurisdictional height of 80 feet and a normal storage pool of 1,988 acre-feet. On August 20, 2009 John Batka, Division 1 Dam Safety Engineer received a call from Randy Rhodes with Xcel Energy explaining that the hillside adjacent to the reservoir near the left abutment has shown signs of sliding and as a precaution the reservoir pool of Lower Cabin Creek was being lowered to a level approximately 13 feet below the emergency spillway. Mr. Rhodes further explained that the Colorado Department of Transportation, the Federal Highway Administration, and the owner's engineer are on site assessing the situation. Paul Perri, Design Review Engineer in the Denver office visited the site on August 21, 2009 to observe the situation. The owner's engineer recommended that the reservoir be further lowered to a storage level of about 250 acre-feet to minimize the impact of a landslide-caused wave in the reservoir.

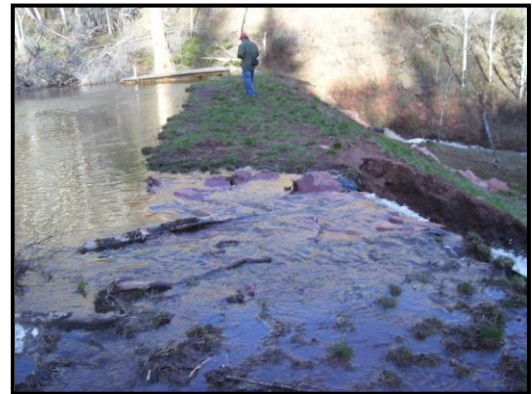
**Wing Lower Pond Dam
Garfield County
Non-Jurisdictional Dam**

Wing Lower Pond is a non-roster dam located in Garfield County. The dam is considered non-jurisdictional and impounds a small volume of water. On May 9, 2009 John Blair, Division 5 Dam Safety Engineer was contacted by Water Commissioner Brian Epstein explaining that the Wing Lower Pond was overtopping and could possibly fail. Mr. Blair visited the site to observe the condition of the dam. Mr. Blair observed about 0.2 feet of water flowing over the top of the dam with significant erosion occurring on the downstream slope of the dam progressing upstream. The owner was informed of the situation by Mr. Blair via certified mail on May 11, 2009, where the recommendation was made that the owner fully opens the outlet gate and to excavate a temporary emergency spillway to convey inflows and minimize the overtopping potential.

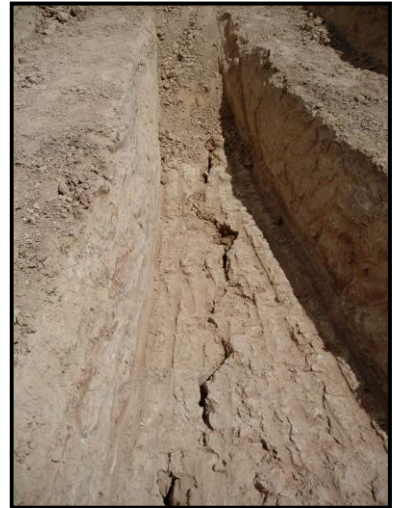
**Totten Dam
Montezuma County,
High Hazard**

Totten Dam is a Small size, High Hazard Dam located near the City of Cortez in Montezuma County in Division 7. The dam has a jurisdictional height of 35 feet and a normal storage pool volume 3,302 acre-feet. In the fall of 2007, Matt Gavin Division 3/7 Dam Safety Engineer discovered significant transverse cracking in the upper portion of the dam embankment. In 2009, additional cracking was discovered and at the direction of the State Engineer's Office, the owners prepared plans to conduct exploratory excavations into the embankment to determine the extent and severity of the cracking. Exploratory excavations conducted in September of 2009 revealed that transverse cracks extended deep into the embankment in at least one location. As a result of the exploratory excavations, a storage restriction of 5 feet below spill was imposed on Totten Dam. Presently, Mr. Gavin is working with the Owner's staff engineer to prepare plans for additional engineering and soils investigations, which are intended to pinpoint the cause of the cracks.
