**State Engineer's
26th Annual Report on Dam Safety
to the
Colorado General Assembly
Water Year 2009-10**

**Colorado Division of Water Resources
Office of the State Engineer**

**State Engineer's
26th Annual Report on Dam Safety
to the
Colorado General Assembly**

**For
Water Year 2009-10**

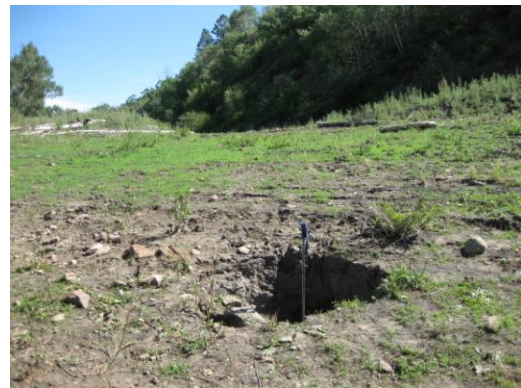
Beaver Park Dam, Division 3

Beaver Dam is classified as a Small size, High Hazard Dam and is located in Gunnison County. In July, during an annual SEED inspection Division 4 Dam Safety Engineer Jason Ward observed a sinkhole in an area near the emergency spillway at the right abutment. A design to repair the sinkhole was submitted in August and repairs were made in October.

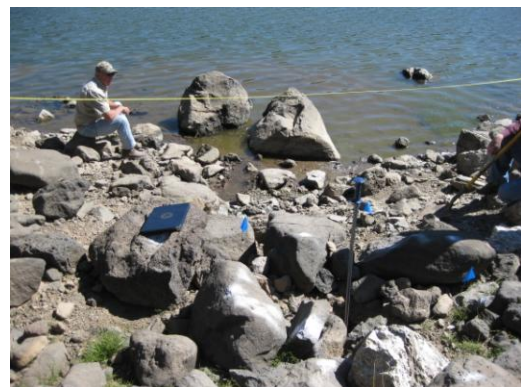
Cedar Mesa Dam, Division 4

Cedar Mesa is classified as a Small size, High Hazard Dam and is located in Delta County. In August, during an annual SEED inspection Division 4 Dam Safety Engineer Jason Ward observed a sinkhole approximately five feet below the emergency spillway crest. Design to repair the sinkhole was submitted and approved and the sinkhole was repaired in September.

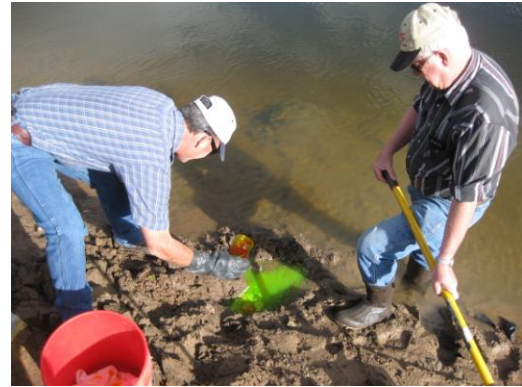
Youngs Creek #1/2 Dam, Division 4

Youngs Creek #1/#2 Dam is classified as a Small size, Significant Hazard Dam and is located in Delta County. In August, during an annual SEED inspection Division 4 Dam Safety Engineer Jason Ward observed a sinkhole approximately 100 feet upstream of the dam along the left reservoir bank. The sinkhole was investigated by pouring dye colored water into the sinkhole to attempt to identify an exit point. No exit point of the dye colored water was observed. The owner will continue to observe the condition of the sinkhole and notify Jason of any changed conditions.

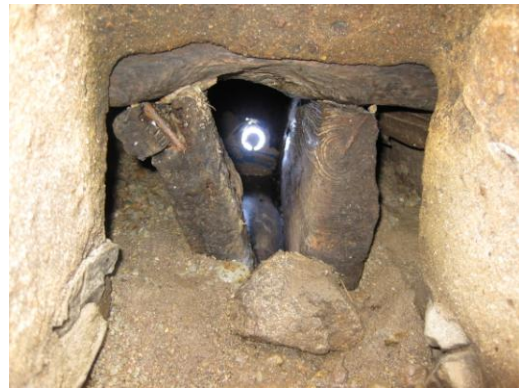
Leon Park Dam, Division 4

Leon Park Dam is classified as a Small size, Low Hazard Dam and is located in Mesa County. In August, during a routine SEED inspection Division 4 Dam Safety Engineer Jason Ward observed a partial failure of the exiting wooden outlet conduit. Jason recommended a zero storage restriction on the reservoir in which the State Engineer imposed.

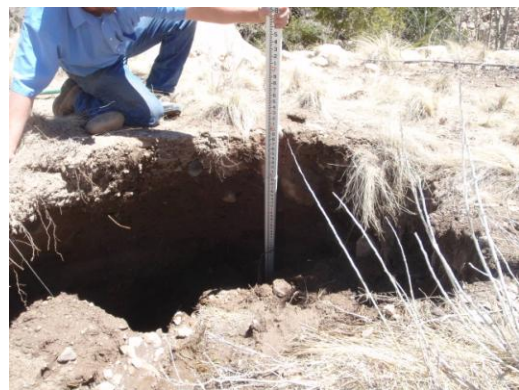
Beaver Park Dam, Division 3

Beaver Park Dam is classified as a Large size, High Hazard Dam and is located in Rio Grande County. In May, during an annual SEED inspection Division 3 & 7 Dam Safety Engineer Matt Gavin observed a sinkhole on the downstream bench below the rock and earth fill berm that was placed on top of the dam to provide additional freeboard. The sinkhole is located near the left abutment of the dam. The Division of Wildlife, owner of the dam, has retained an engineer to investigate the cause of the sinkhole. Matt recommended a 20 foot (below the crest of the emergency spillway) storage restriction in which the State Engineer imposed.

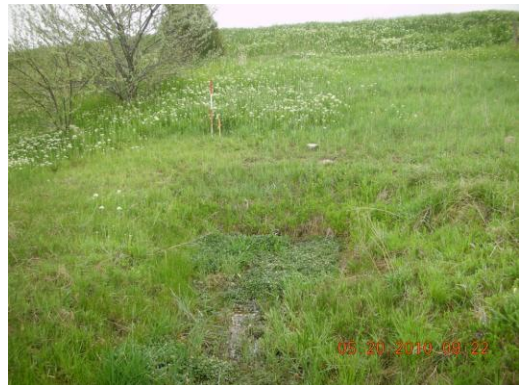
South Gray Dam, Division 1

South Gray Dam is a Small size, Significant Hazard Dam and is located in Larimer County. In May 2010, Dam Safety Engineer Jeremy Franz observed a sinkhole over the existing toe drain system. The owner agreed to lower the reservoir until repairs could be made to the toe drain system.

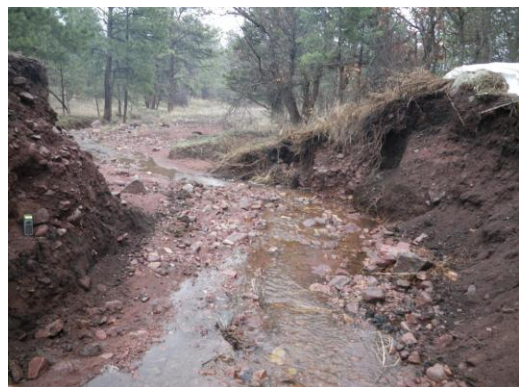
Illegal dam failure, Division 2

In April 2010, Dam Safety Engineer Mark Perry was notified that a dam had failed near Beulah, Colorado. The dam was a non-roster structure and Mark Perry provided documentation to the owner on the requirements of the State of Colorado as it pertains to Dam Safety and Dam Construction.

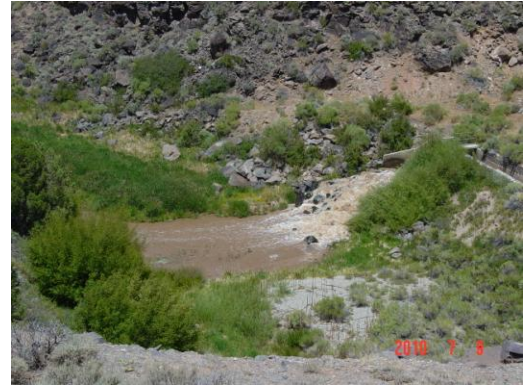
Mountain Home Dam, Division 3

In July 2010, Dam Safety Engineer Mark Perry responded to a call from the owner of Mountain Home Dam, a Large size, High Hazard dam located in Costilla County. The owner report turbid flows from the main outlet of the dam. As a result of observations made in the field and discussions with the owner it was determined that the turbid water was the result of a thunderstorm and subsequent runoff carrying sediment was the cause.

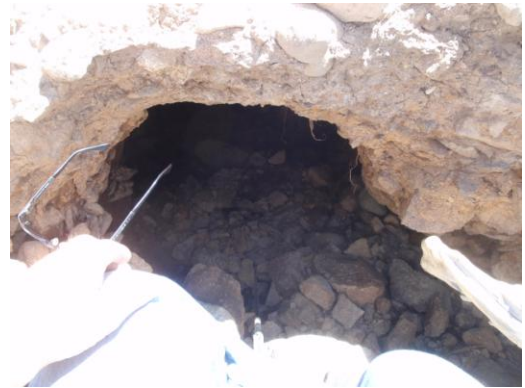
Trujillo Meadows Dam, Division 3

In the spring of 2010, Dam Safety Engineer Matt Gavin observed two sinkholes downstream of the crest in the emergency spillway. The sinkholes were located on the right side of the channel. To avoid additional discharges in to the sinkhole the owner has proposed to place a dike around the sinkholes until further investigations and a proposed method of repair can be accomplished. The sinkholes were subsequently excavated, re-compacted with low permeable fill material and a PVC liner was placed over the area.
