State of Colorado 2006 Flood Documentation Reports

Prepared by: ICON Engineering, Inc 8100 S. Akron St. Suite 300 Centennial, CO 80112 303-221-0802

Prepared for: Colorado Water Conservation Board 1313 Sherman St. Room 721 Denver, CO 80203 303-866-3441

June 2007

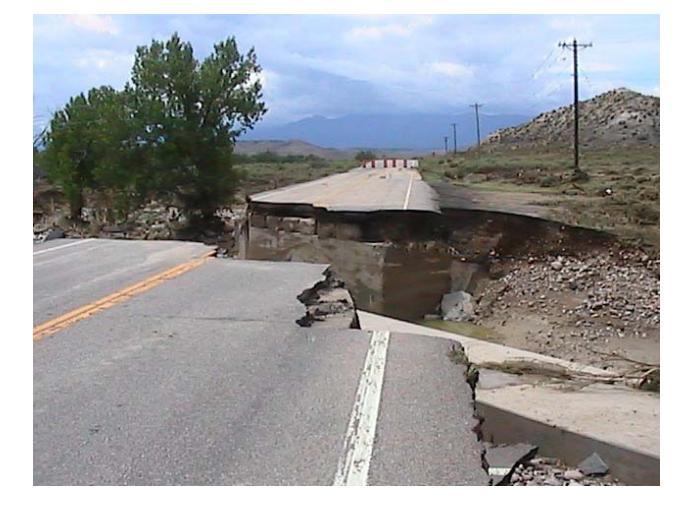
Figure 1.22 – Brush Hollow Creek Highway 115 Culvert Overtopping

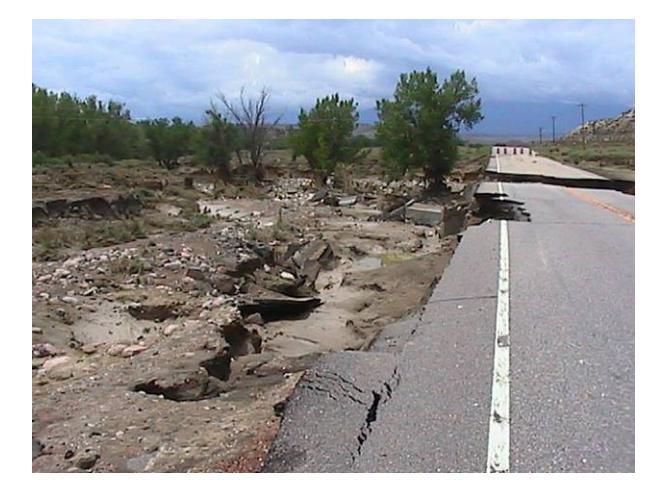
Figure 1.23 – Brush Hollow Creek Highway 115 Road Damage

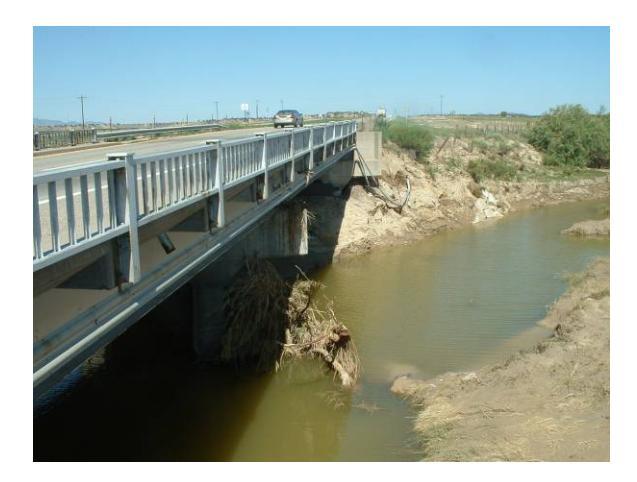
Figure 1.24 – Brush Hollow Creek Highway 50 Bridge Looking Upstream Note: high-water came up to low steel elevation resulting in minor overtopping of westbound lanes.

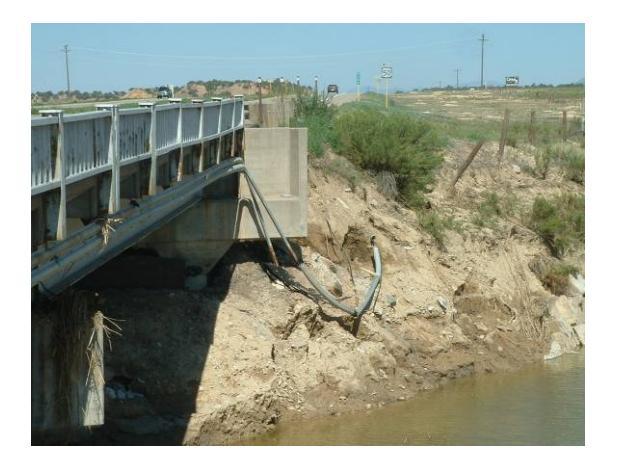
Figure 1.25 -- Brush Hollow Creek Highway 50 Bridge Looking Upstream – Utility Damage

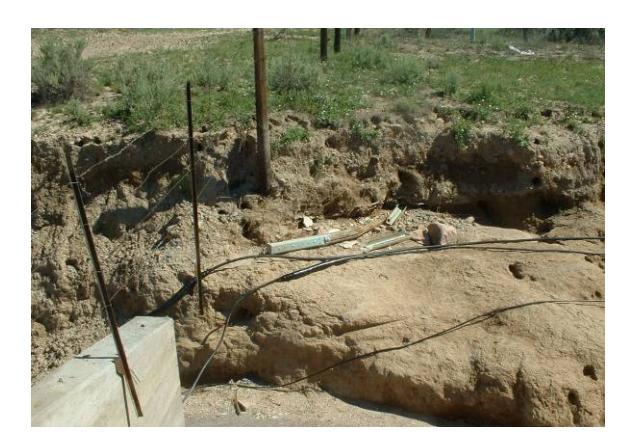
Figure 1.26 – Brush Hollow Creek Highway 50 Bridge Utility Damage, Westbound Bridge

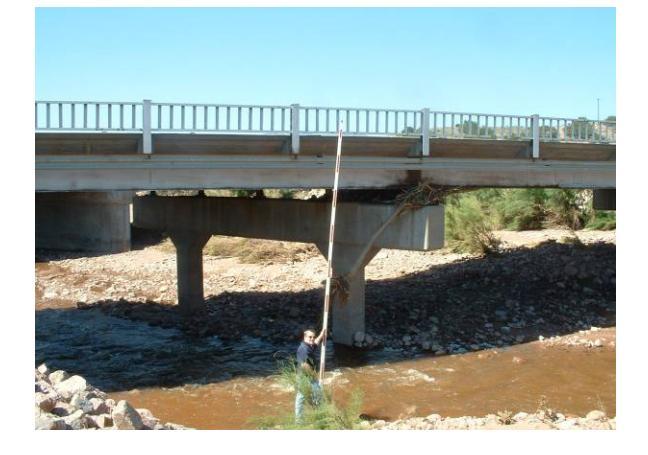
Figure 1.28 – Highway 50 Bridge – Eightmile Creek Looking Downstream Note debris on top of pier cap.

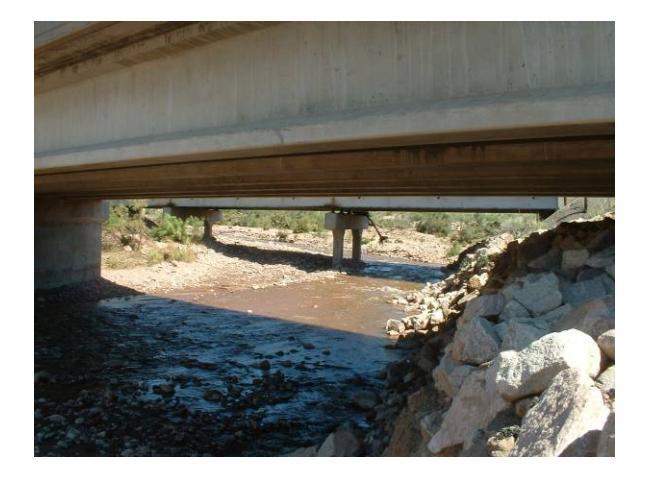
Figure 1.29 – Highway 50 Bridge – Eightmile Creek Looking Upstream Note minor erosion along toe of slope.

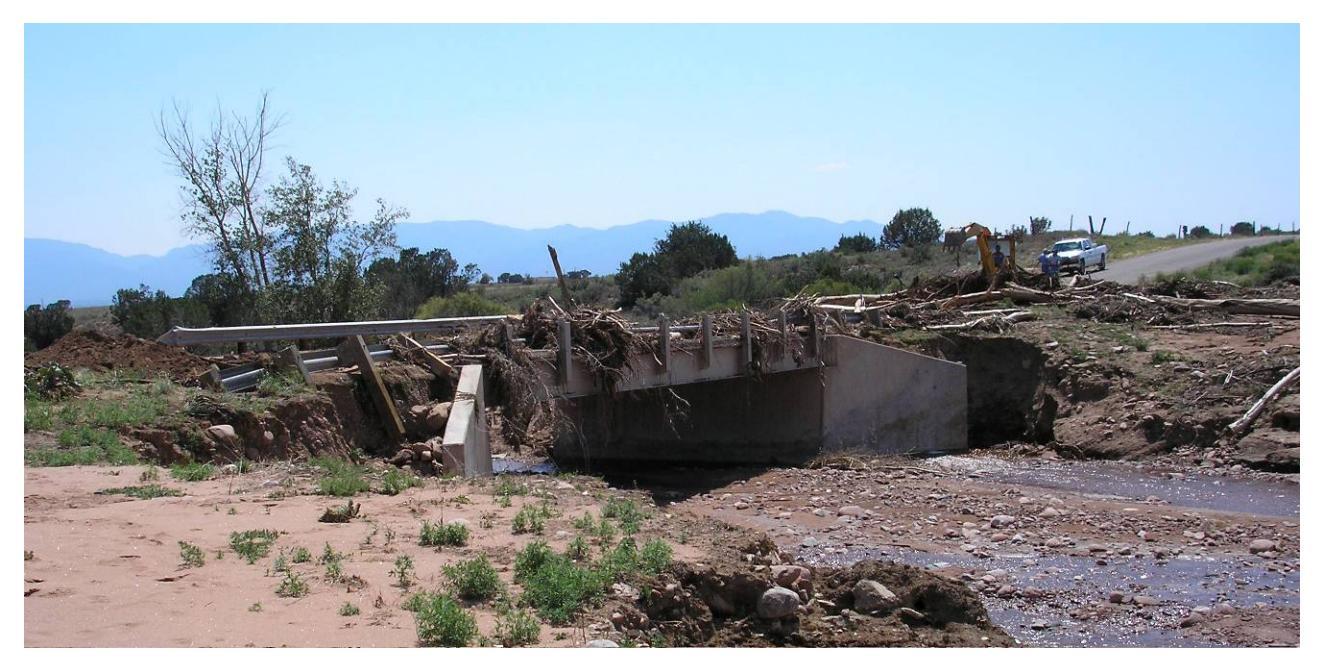
Figure 1.30 – County Road 123 at Eightmile Creek Bridge, Overtopping Upstream Face.

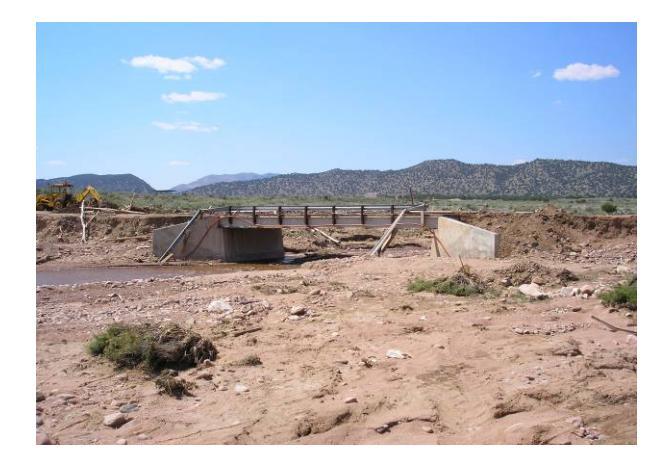
Figure 1.31 – County Road 123 Bridge – Eightmile Creek Bridge Overtopping, Downstream Face

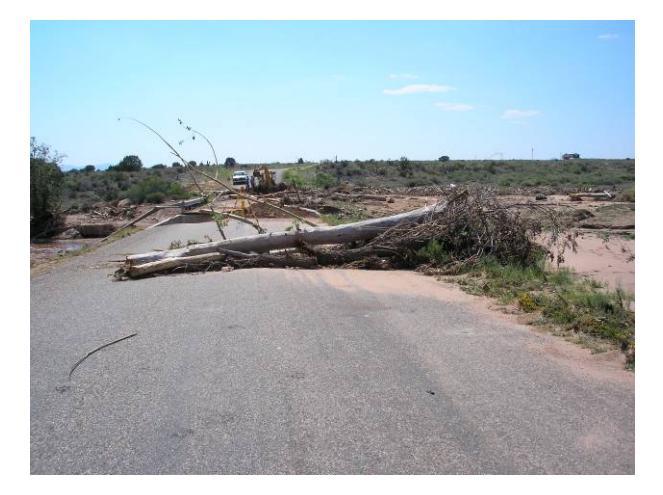
Figure 1.33 – County Road 123 at Eightmile Creek Bridge Overtopping, Crest of Road at Bridge

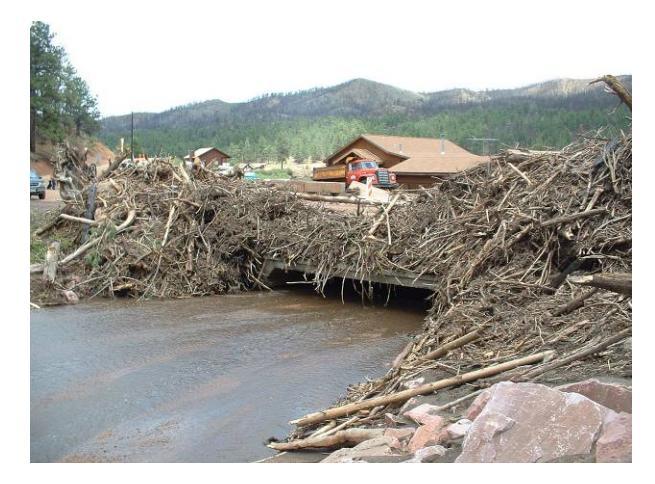
Figure 2.22 – West Creek – Bailey Residence at 15590 West Creek Road. Box culvert is 16' x 6' in size. Water surface was 6 to 8-inches above first floor level in house.

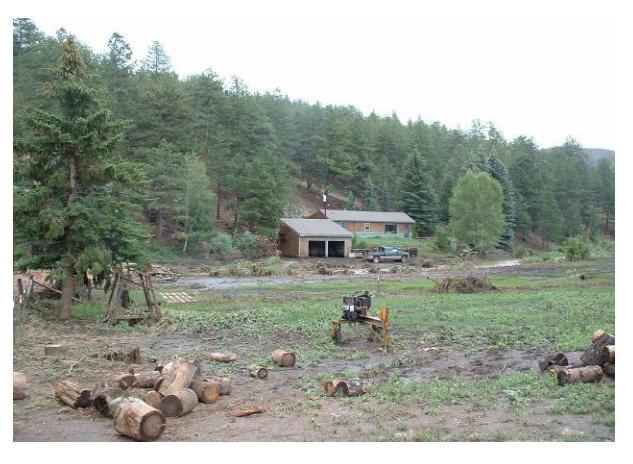
Figure 2.26 – West Creek – Miller Residence at 14570 West Creek Road. Water ponded behind Abbey Road up to approximately 4-feet above garage slab.

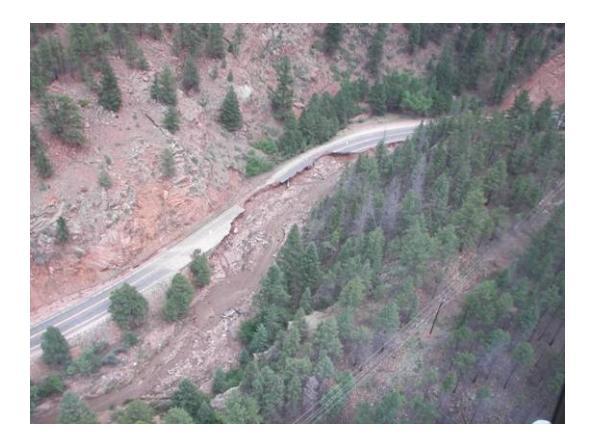
Figure 2.28 – West Creek - Highway 67 Shoulder Damage Photo courtesy of CDOT

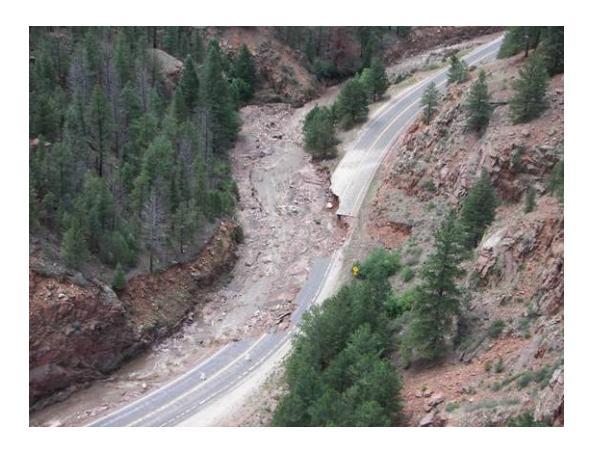
Figure 2.29 – West Creek Highway 67 Shoulder Damage Photo courtesy of CDOT

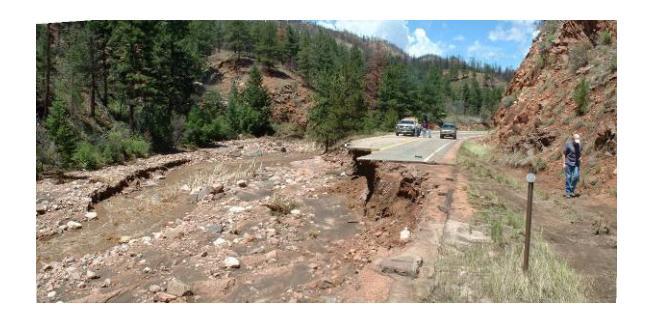
Figure 2.30 – West Creek Highway 67 Road Damage

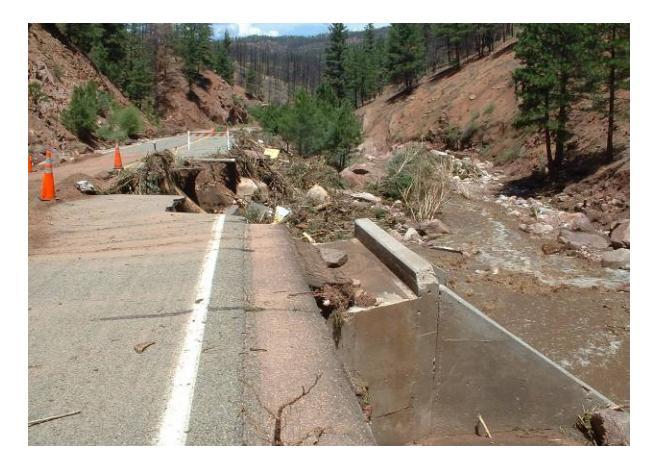
Figure 2.31 – West Creek - Highway 67 Box Culvert Damage

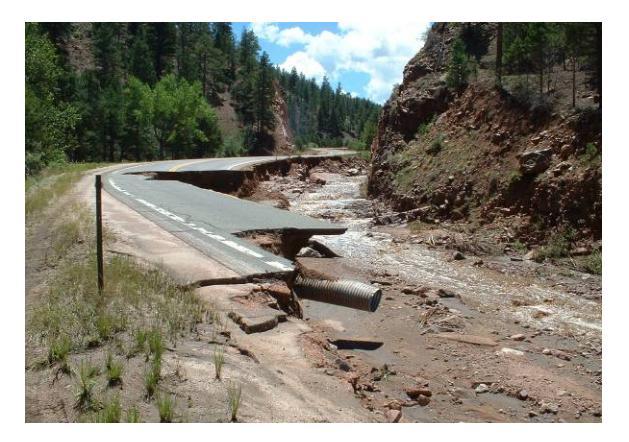
Figure 2.32 – West Creek - Highway 67 Damage

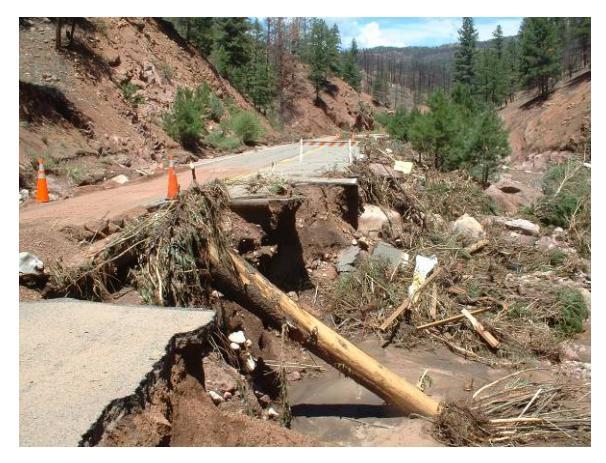
Figure 2.33 – West Creek - Highway 67 Damage

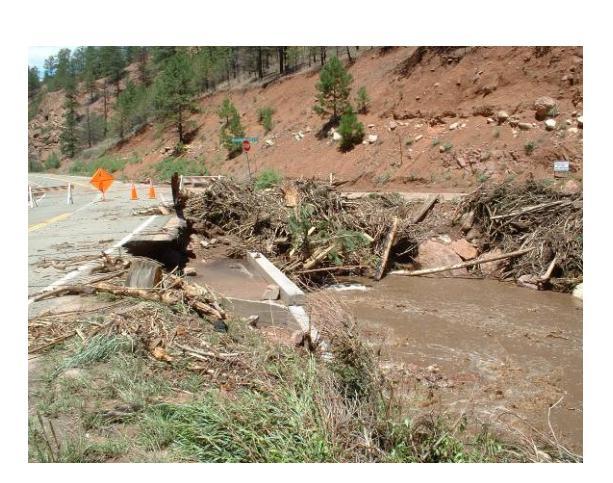
Figure 2.34 – West Creek - Highway 67 Damage

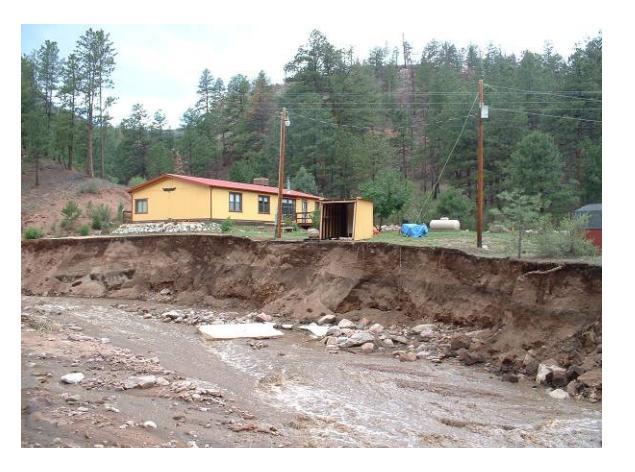
Figure 2.35 – West Creek – Private Road Crossing. Note proximity of Hayman burn.

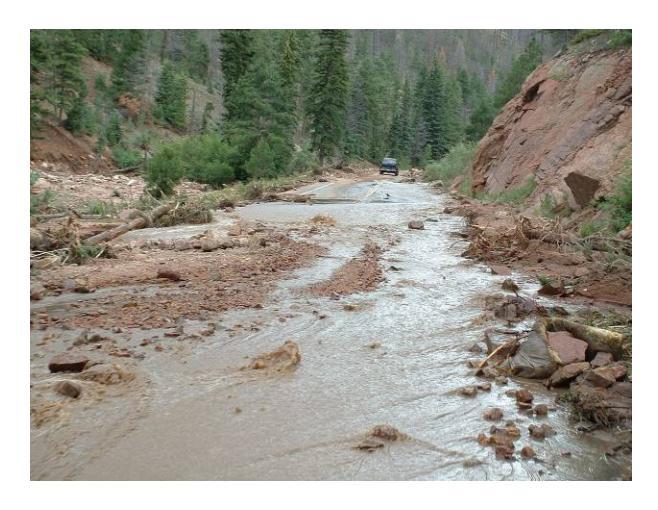
Figure 2.37 – West Creek – Highway 67 Road Overtopping

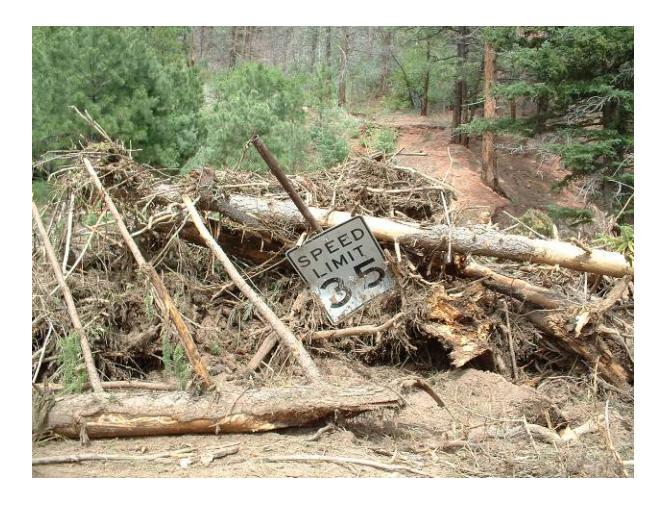
Figure 2.38 – West Creek – Highway 67 Road Damage
