**STREAM HABITAT INVESTIGATIONS AND ASSISTANCE  
PROJECT SUMMARY**

2025 Progress Report

Colorado Parks & Wildlife

Kemp-Breeze State Wildlife Area Habitat Project, Colorado River

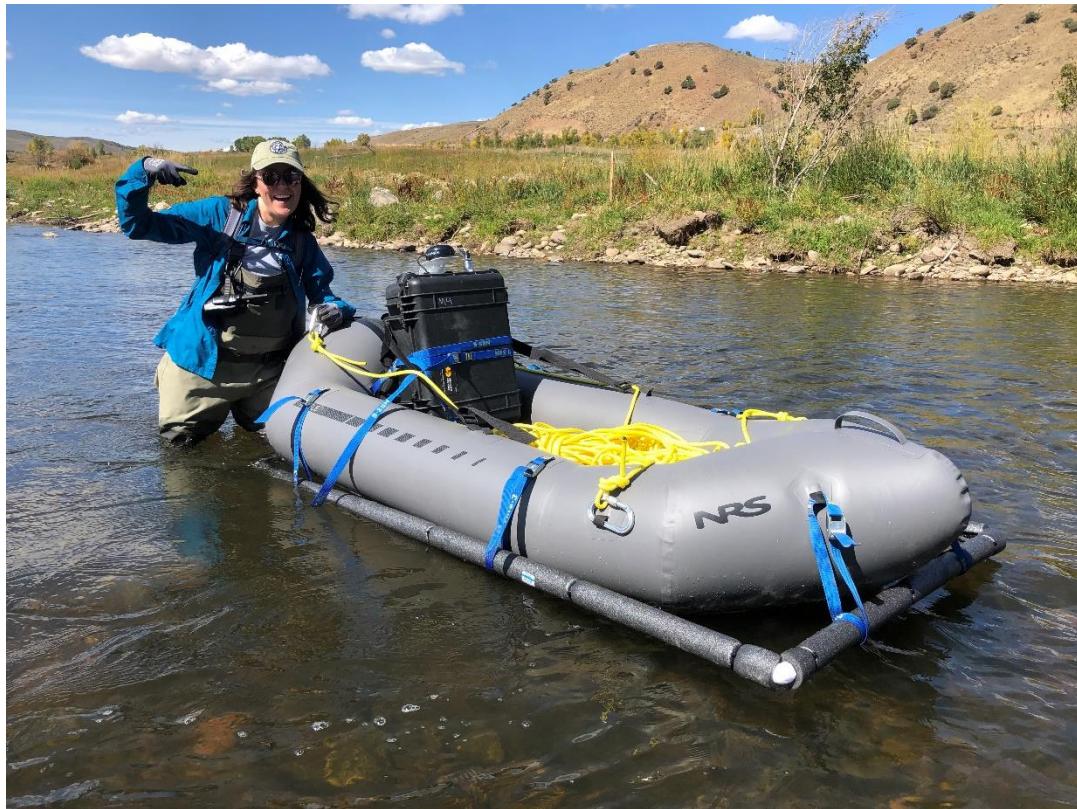
**Figure 10.** New pack-raft antenna system used to relocate PIT-tagged tracer rocks in 2024.

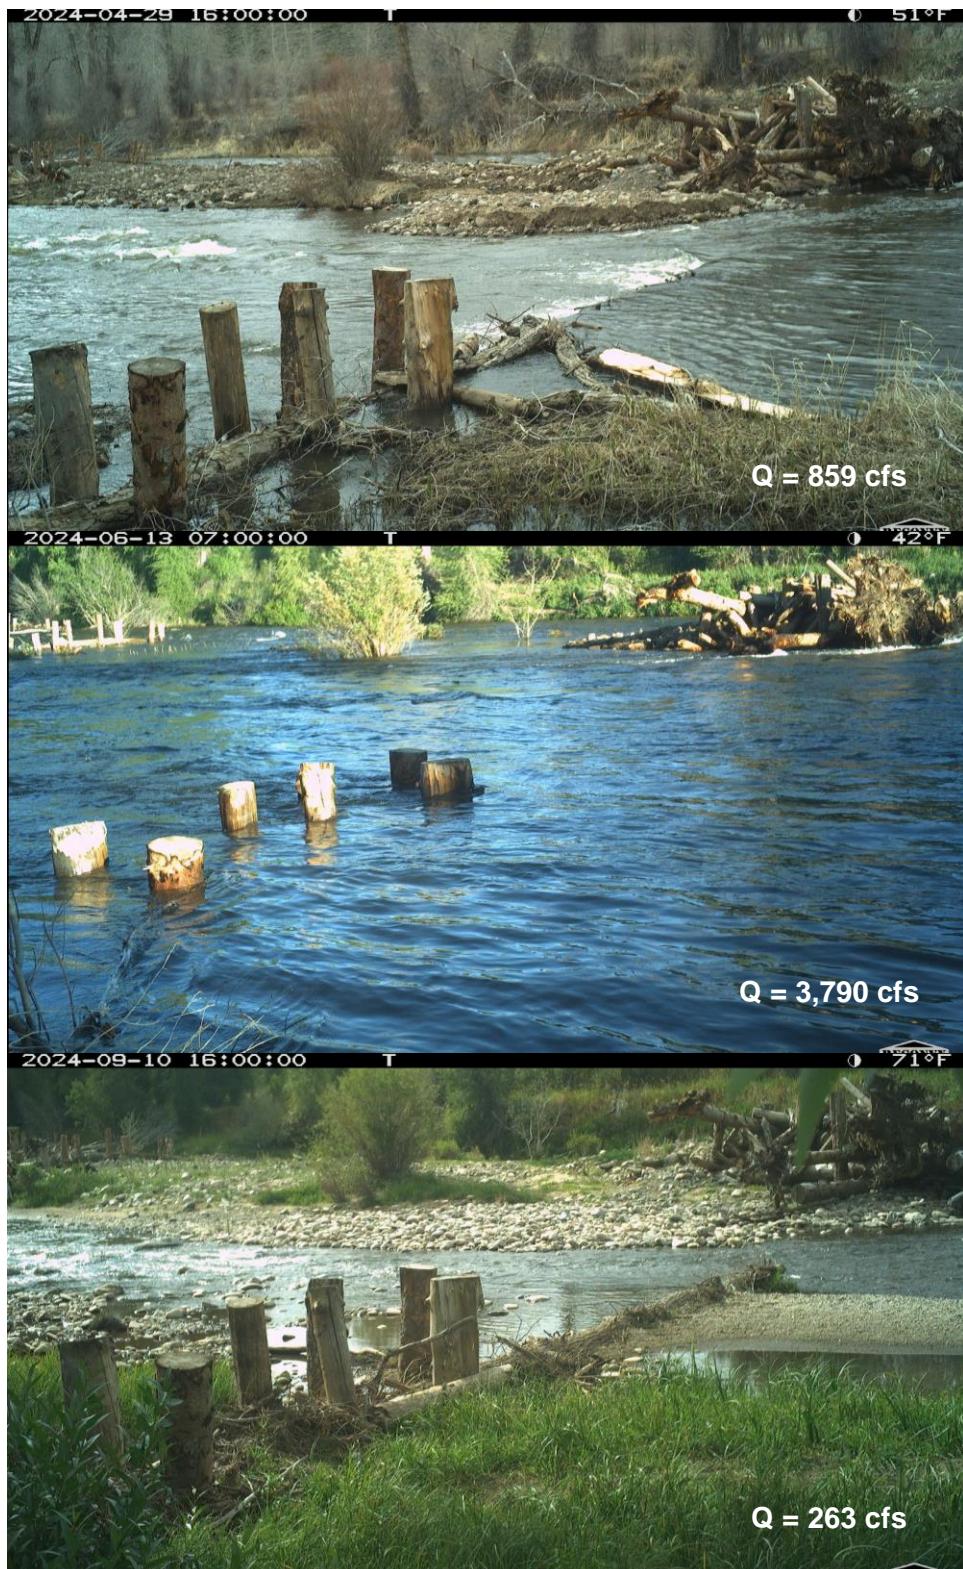
**Figure 11.** Select photos showing flows (Q) in the Phase 2 project reach of the Kemp-Breeze SWA Habitat project during 2024, including a downed cottonwood tree in the foreground, as well as a gravel augmentation pile, constructed island, and bar-apex jam in the background.

Flows were higher than average in 2024 and peaked around 3,908 cfs (Figure 6), inundating the constructed islands and floodplains (Figure 11). Some bank erosion was evident after the 7-year flood event, and 16% of the structures were ranked as damaged, impaired, or failed during the 2024 assessment. Five structures were flagged for additional monitoring due to compromised integrity, but those structures were still providing beneficial functions and maintenance is not recommended at this time. Maintenance was recommended for another four structures due significant damage or failure and loss of beneficial functions. However, as access roads have already been restored, the amount of disturbance to the floodplain and channel from accessing the structure sites was considered prohibitive. As such, those structures were considered a loss and no maintenance activities are planned at this time.

Minor erosion and deposition was common at log jams following the high flows of 2024, occurring at 74% and 63% of the structures, respectively. Moderate to severe erosion was observed at 18 structures (26%), while moderate to severe deposition occurred at 37% of the log jams. No structures were considered a risk to fish passage. Habitat assessment indicated that 66% of the log jams provided overhead cover for fish, 57% created complex habitat, 46% provided depth cover, 53% provided juvenile refuge for trout, 59% provided foraging habitat, and 33% provided rearing habitat for trout fry. Habitat scores were lower for log-jam structures in 2024 when compared to 2023 due to the addition of 10 floodplain structures in the Phase 2 reach that were dry on the day of the assessment. The percentage of structures that received poor vegetation rankings decreased from 71% during the previous survey to 64% in the most recent survey. The number of structures that received vegetation rankings of fair to good increased from 28% to 35%, indicating that riparian vegetation cover was improving. The growth of riparian vegetation is also evident in Figure 11.

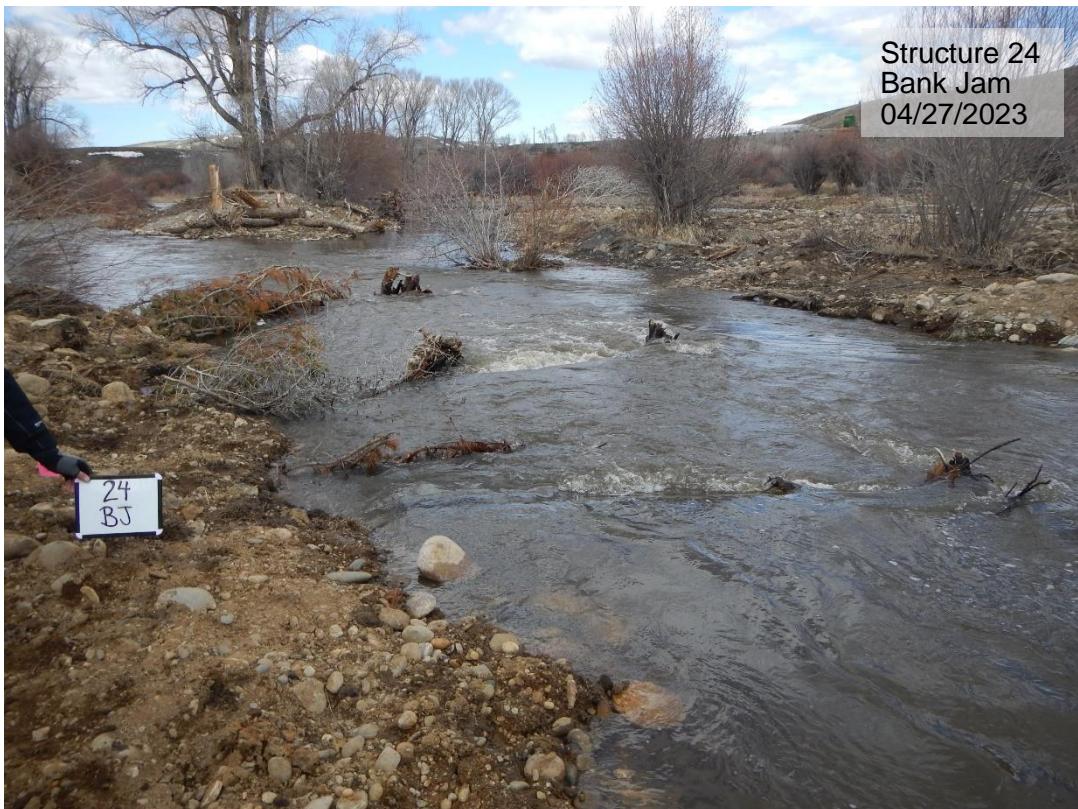
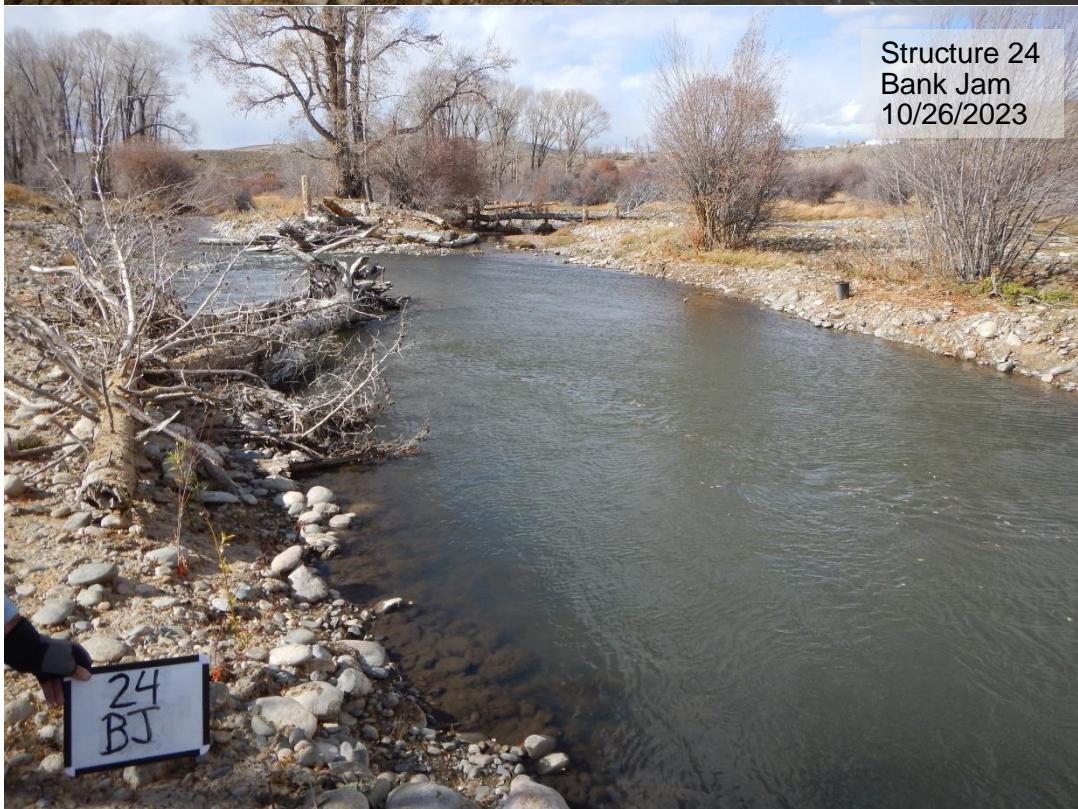
**Figure 12.** Example of failed bank-jam structure from log-jam assessments at the Kemp-Breeze SWA Habitat Project on the Colorado River.

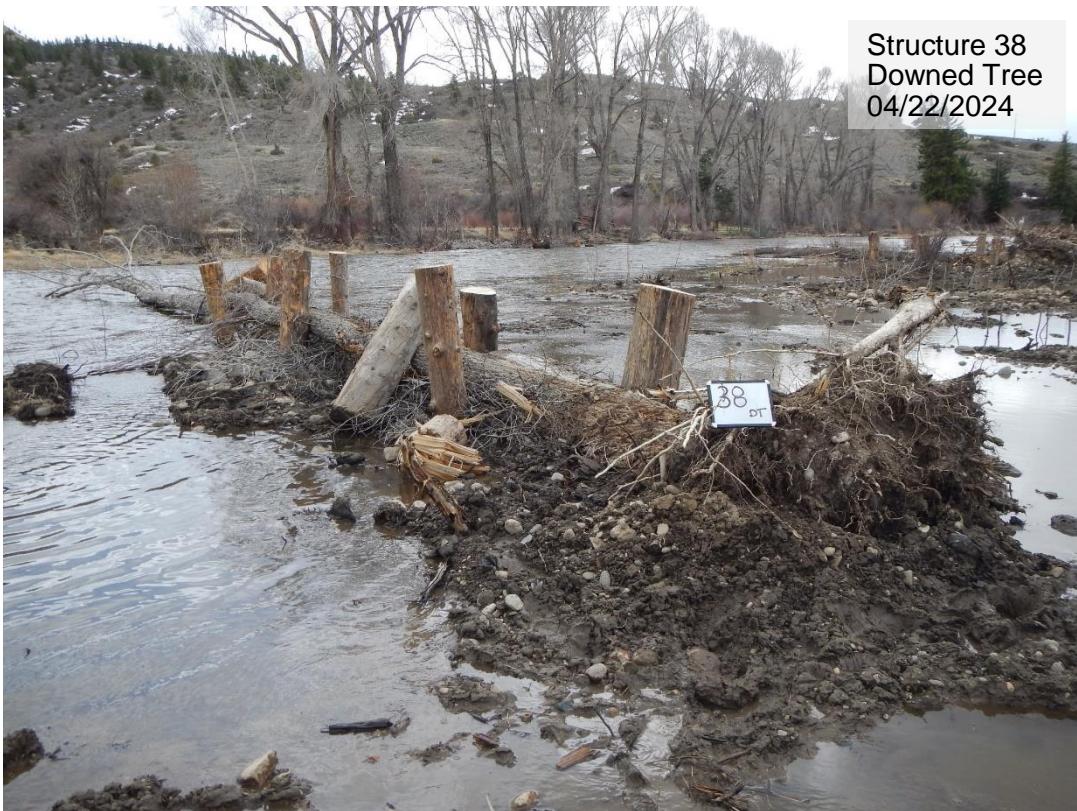
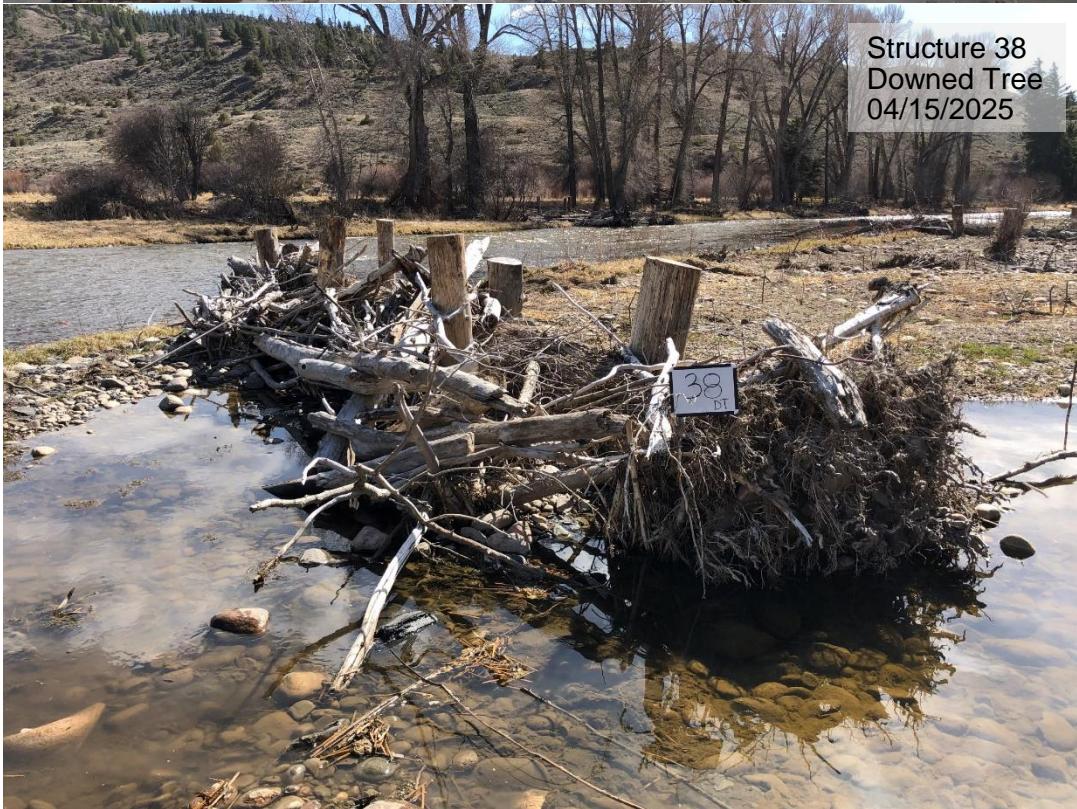
**Figure 13.** Example of wood racking on a downed cottonwood tree from log-jam assessments at the Kemp-Breeze SWA Habitat Project on the Colorado River.

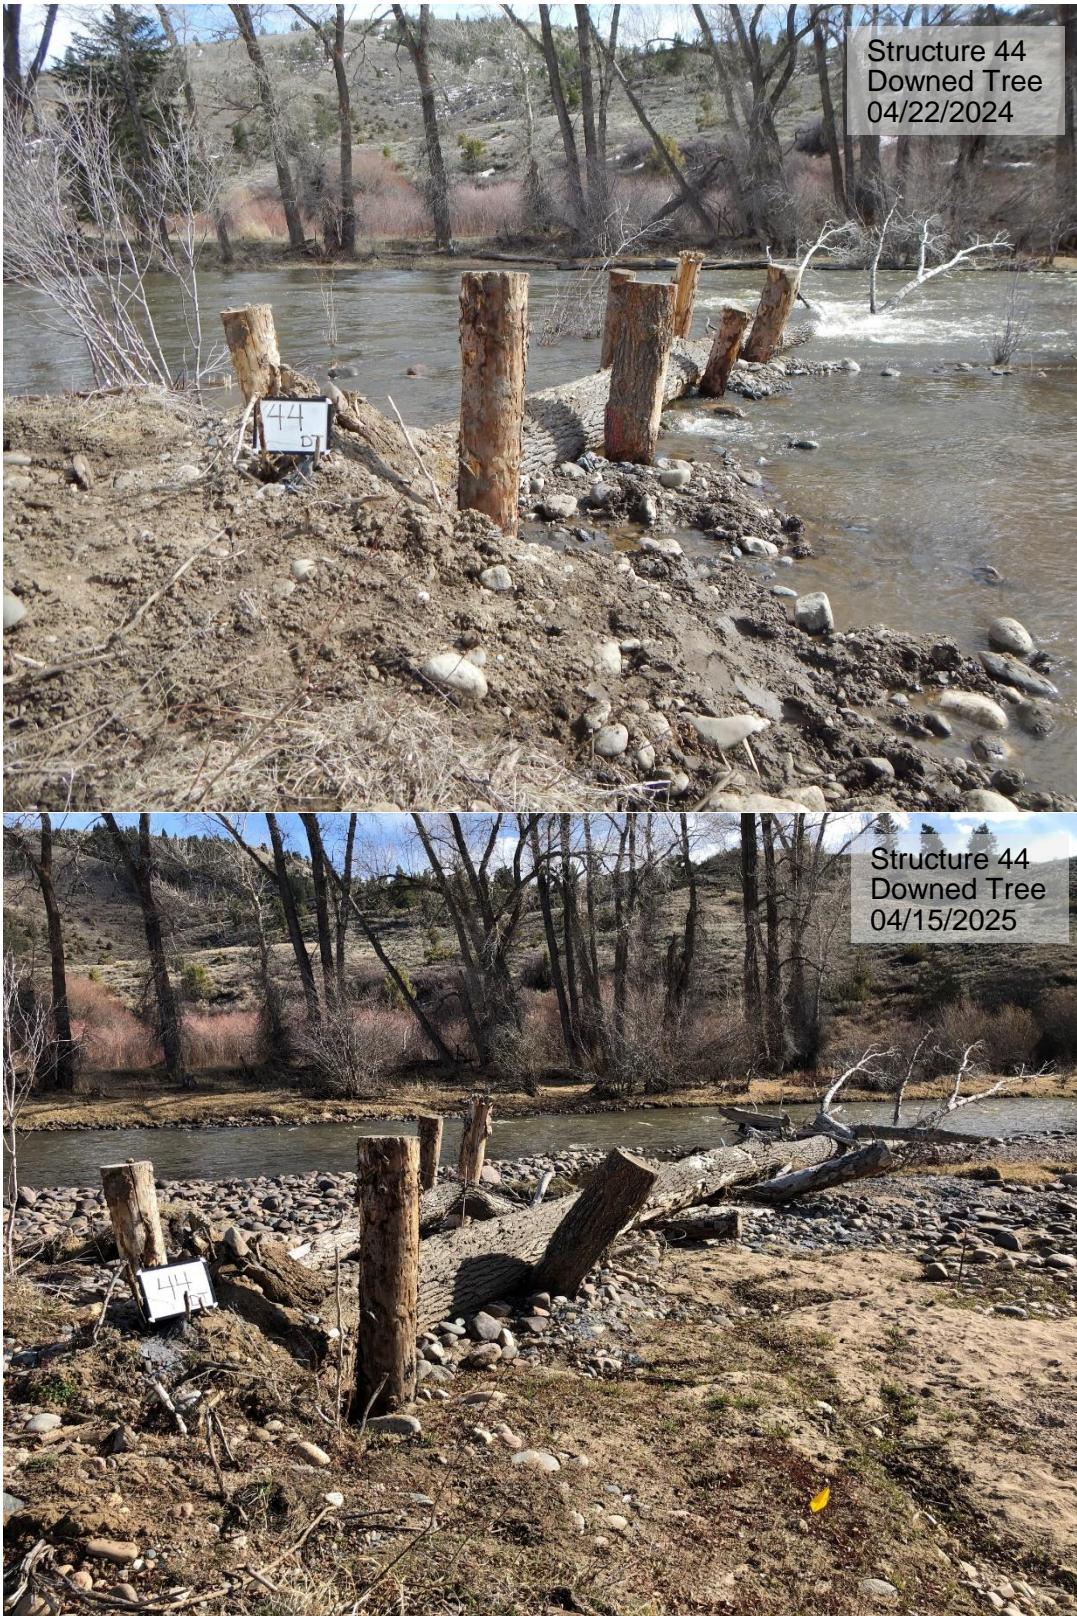
**Figure 14.** Example of failed piles at a downed cottonwood tree observed during log-jam assessments at the Kemp-Breeze SWA Habitat Project on the Colorado River.

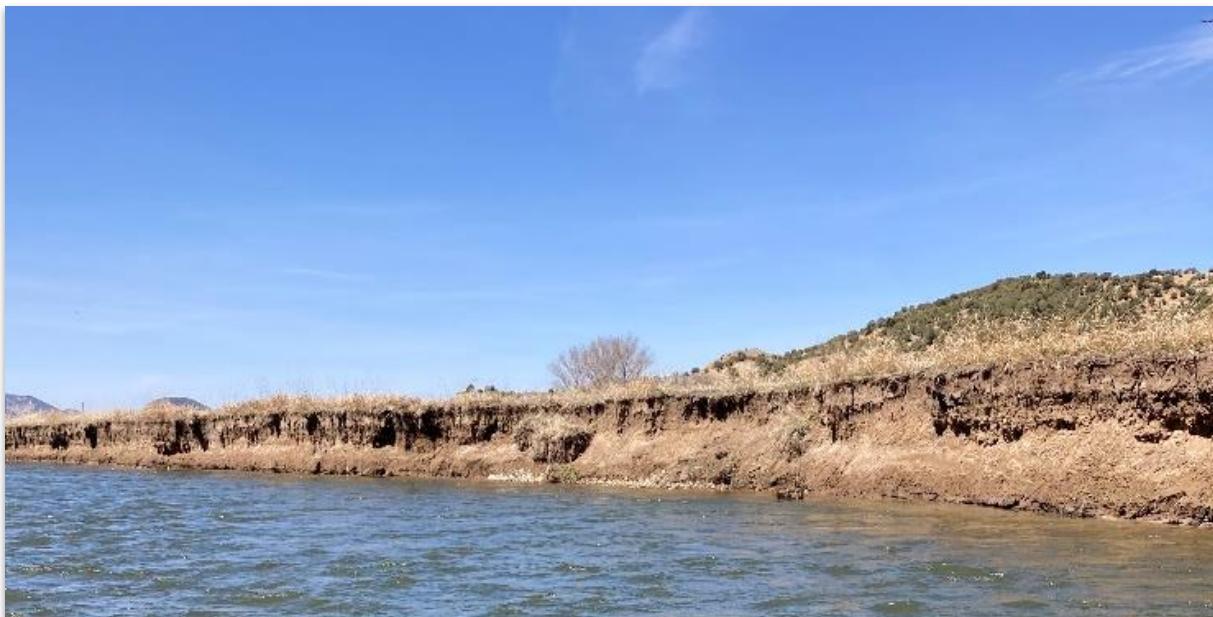
**Figure 17.** Accelerated erosion on a 550 ft long bank of the Rio Blanco Lake SWA.

The 550-ft section of the White River on the Rio Blanco Lake SWA is experiencing accelerated erosion (averaging over 10 ft of bank loss per year) due to historical agricultural practices, loss of deep-rooted vegetation, and improperly installed instream grade-control structures (Figures 17-18). The river is becoming increasingly over-wide and shallow, as well as experiencing a decrease

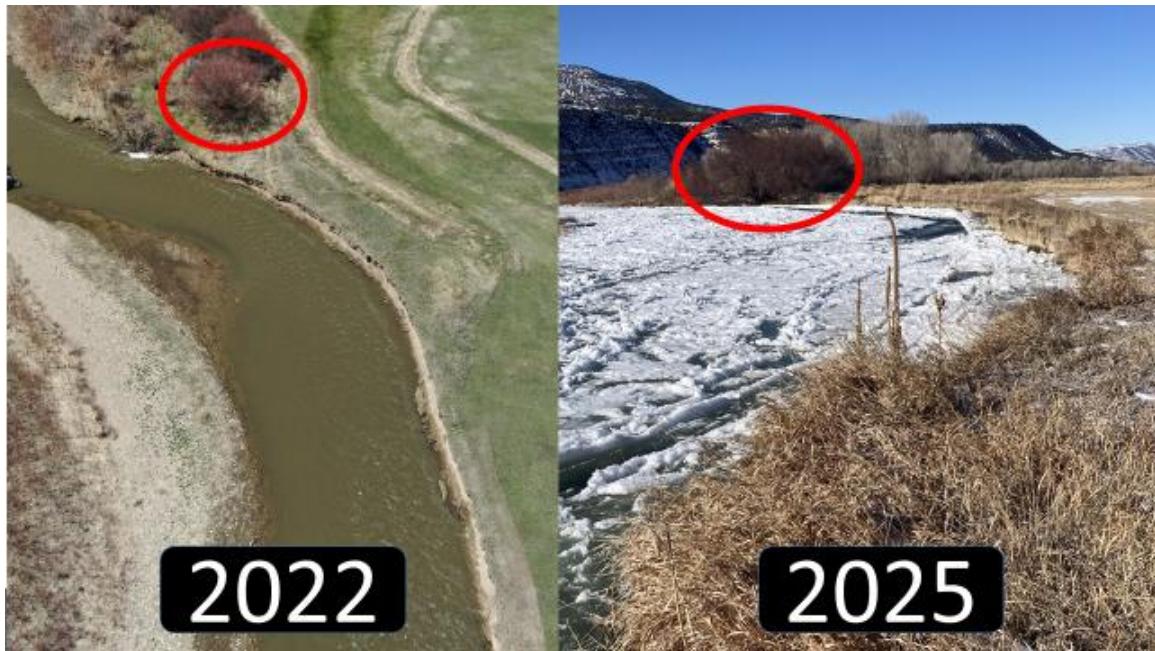
**Figure 18.** Accelerated erosion on a 550 ft long bank of the Rio Blanco Lake SWA. Over thirty feet of bank loss in three years (2022-2025) using a River Birch (red circle) as an indicator.

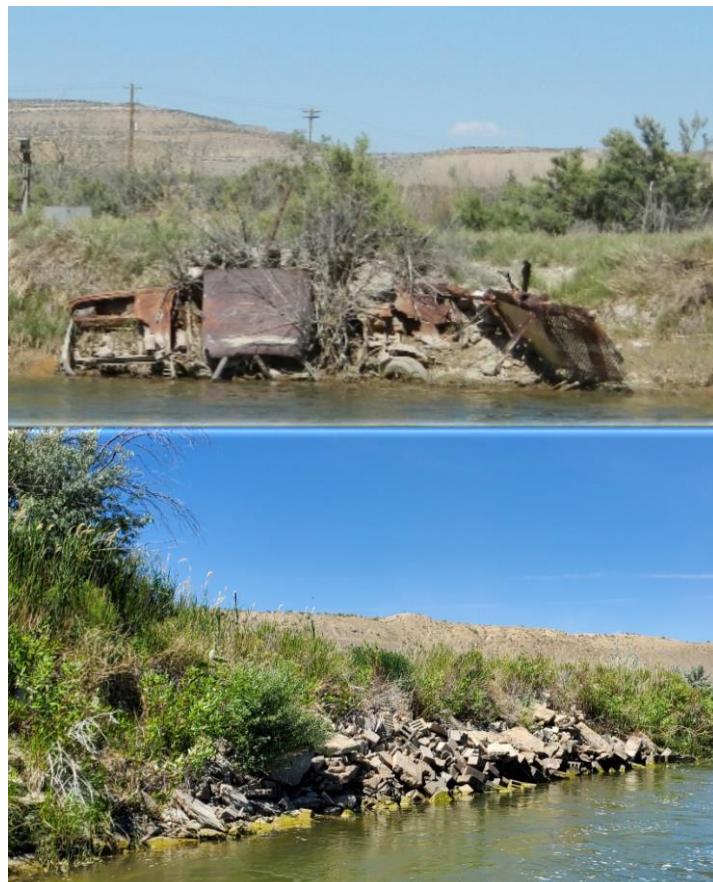
**Figure 19.** Bank stabilizing techniques typical of the White River downstream of Meeker, Colorado, including use of car bodies and concrete rubble.

in substrate size due to the erosional issue on the SWA. We plan to address the erosional issue to restore the proper geomorphology of the river, while also increasing native aquatic species habitat in the form of increased riparian vegetation and instream wood. Over the past century, throughout most of the United States, humans have removed much of the instream wood that would normally migrate downstream and form log jams. This instream wood is vital for increasing habitat complexity and enhancing geomorphic functions. Along with the supporting evidence of fish preference for instream wood from our work in South Park, our local fisheries biologists note that they commonly find a high abundance of our focal species in log jams, so we anticipate that this project will provide beneficial habitat. The project will also reduce the width-to-depth ratio of the stream and increase substrate size, thus reducing water temperature and increasing interstitial habitat for benthic macroinvertebrates and foraging opportunities for our focal species. Another potential benefit of this project is to provide a showcase example of how toe wood can be used as an alternative to typical bank stabilizing techniques practiced on the White River, such as using car bodies, riprap, and concrete rubble (Figure 19).

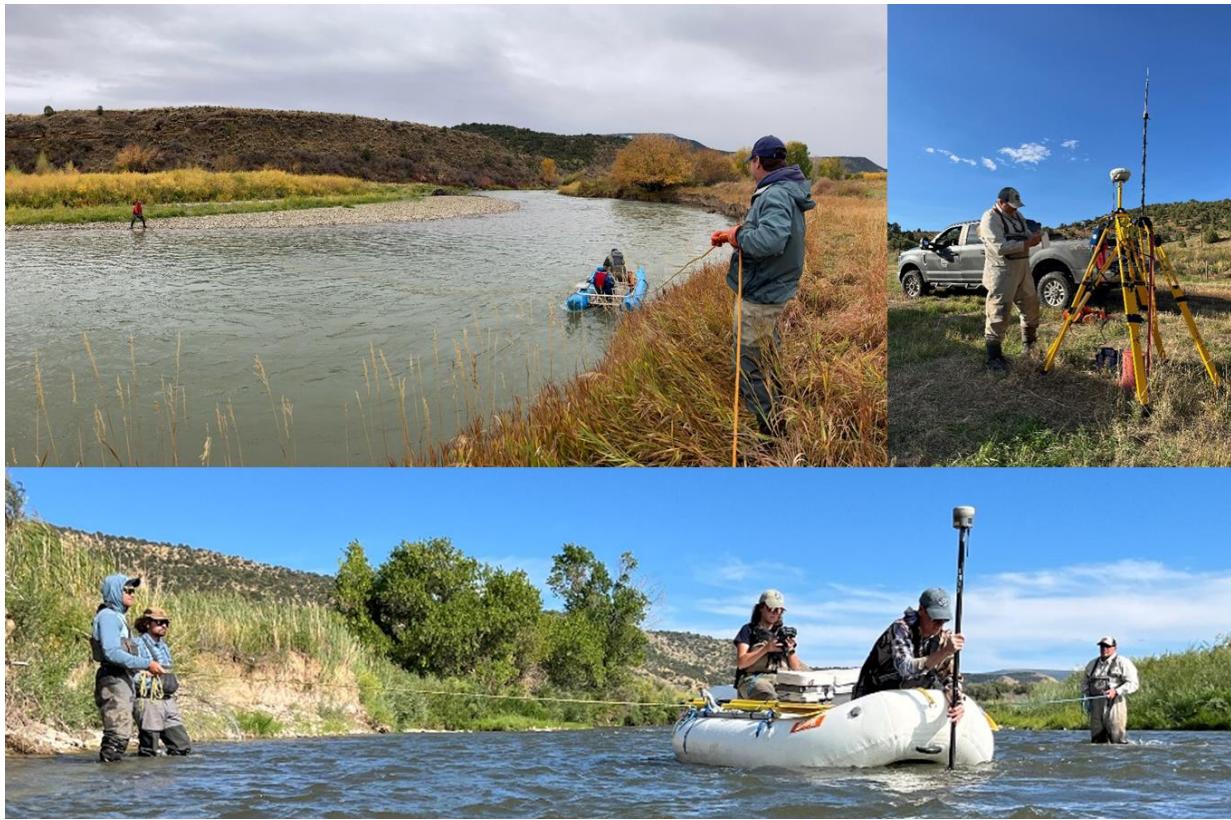
**Figure 20.** Collecting baseline geomorphic data in October 2023 and 2024.

Hydraulic, geomorphic, and topographic surveys of the treatment site and upstream/downstream control sites began in October 2023 and was completed in October 2024 (Figure 20). Baseline fish population surveys (Figure 21) began in October 2023 and will continue until construction begins in the fall of 2026. We intend to collect up to three years of baseline data on fish populations prior to construction if flow conditions permit. Upon completion of construction, we plan to conduct the same sampling; 1 year, 3 years, 5 years, and 10 years after construction is complete to monitor the fish community and geomorphic response through time.

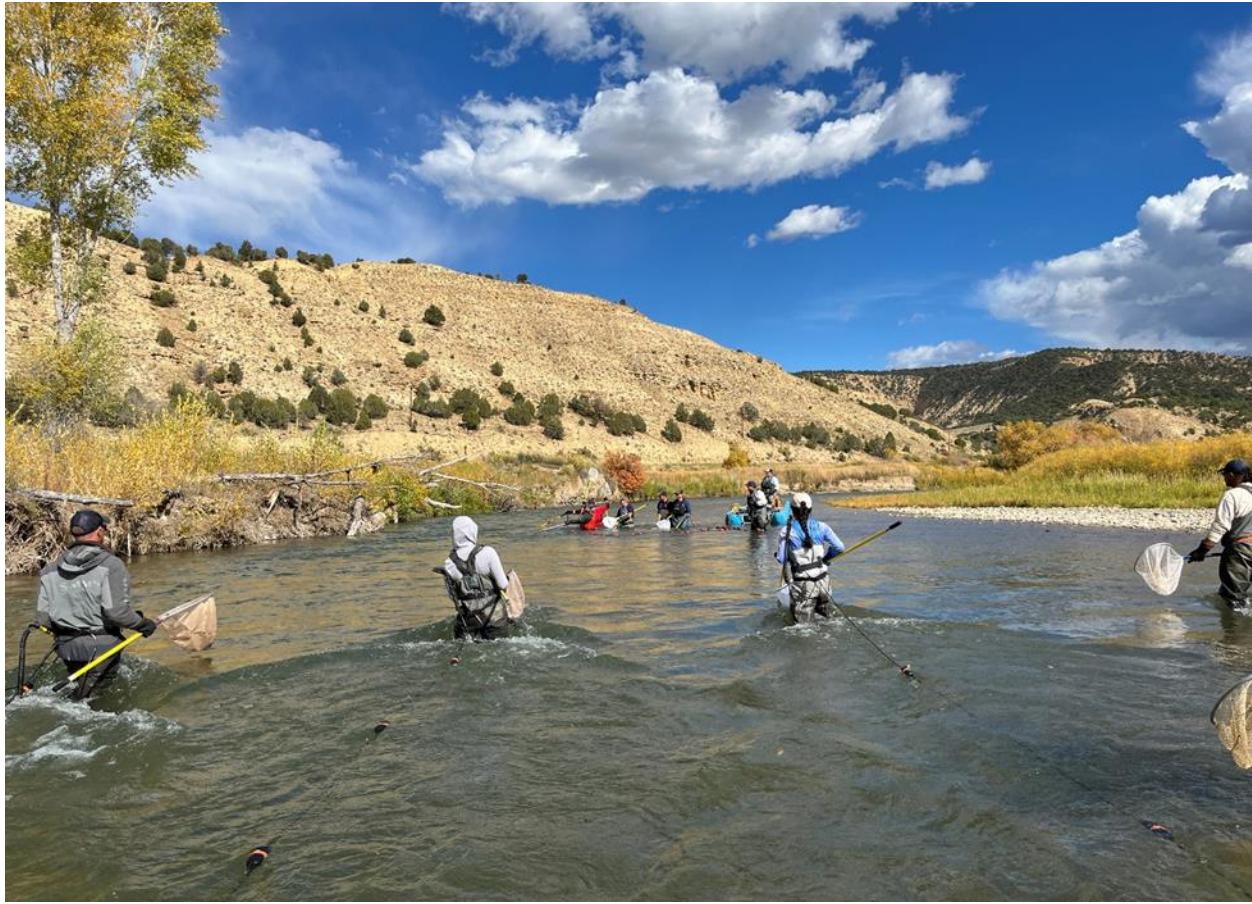
**Figure 21.** Collecting baseline fish population data using a barge electrofishing unit in October 2023 under high-flow conditions approaching 400 cfs.

Fish sampling methods have evolved from our first attempt to sample the population in October 2023 using two barge electrofishing units equipped with five electrodes each and deployment of downstream block nets (Figure 21). Population estimates within individual pools were estimated using depletion methods. In 2023, flow conditions in the White River were very high, running at nearly 400 cfs during the time of sampling. Under these flow conditions, we found that the river was nearly un-wadable (too deep and fast) and yet the length of our pools was too short to employ mark-recapture techniques for population estimation. As a compromise, we modified our fish sampling techniques and changed to using a raft equipped with a thrown electrode in 2024 (Figure 23). A large crew (>10 people) deployed a 100 foot seine downstream, stretched across the river to serve as a block net and meet our assumption of closure. We then fished from upstream to downstream toward the block net for each pass. All fish that were captured were identified, weighed, and measured (TL). In addition, any native fish or sportfish (Rainbow Trout and Brown Trout) over 150 mm TL were PIT tagged using Biomark 12 mm tags.

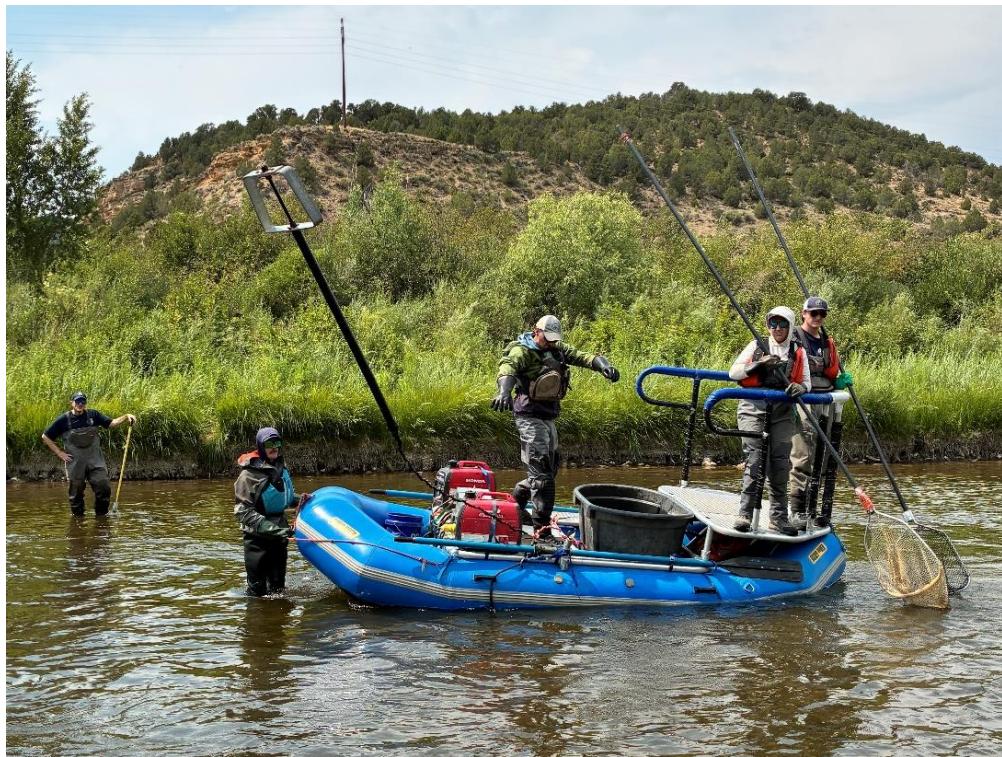
**Figure 23.** Collecting baseline fish population data using an electrofishing raft with thrown electrode at baseflow conditions of approximately 100 cfs.

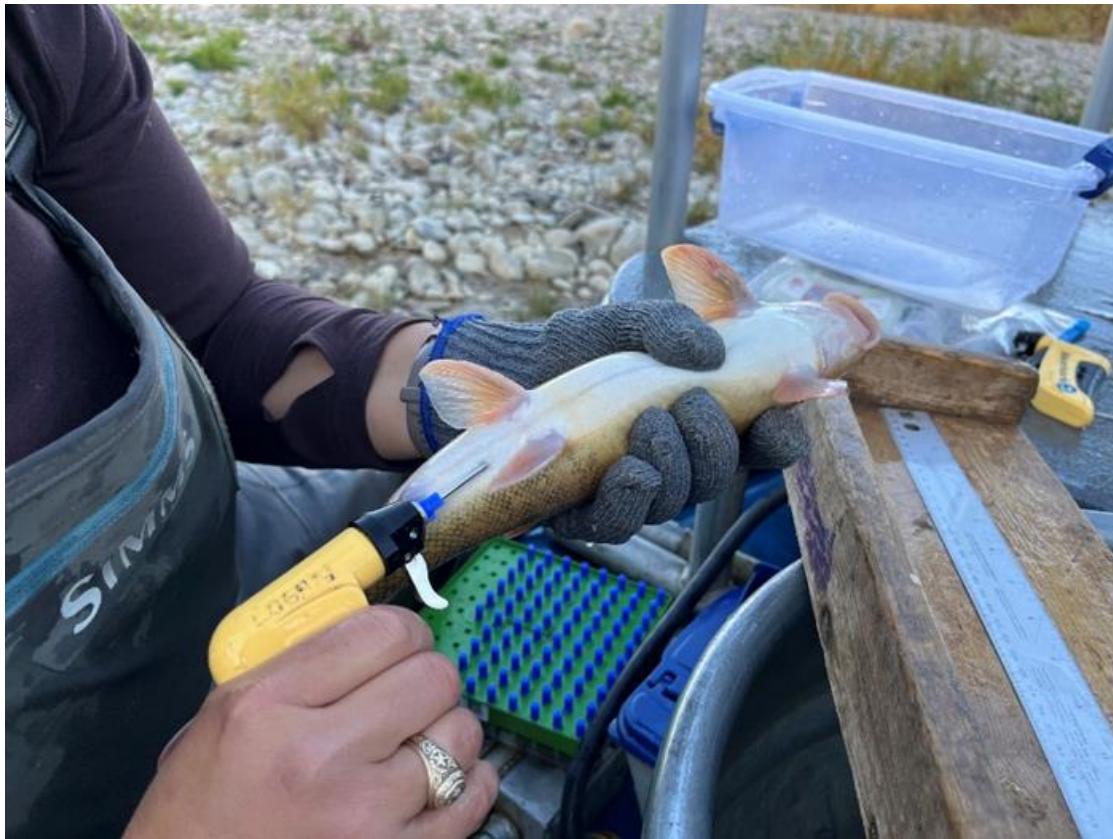
**Figure 24.** PIT tagging a Bluehead Sucker using pre-loaded Biomark 12 mm RFID tags

As part of our effort to estimate movement and survival for our species of interest, we PIT tagged over 1,200 fish in 2024 (Figure 24) and placed 3 ft Biomark submersible antennas at the upstream and downstream boundaries of each of our three study reaches (upstream, treatment, and downstream; Figure 25). We PIT tagged a total of 1,210 individual fish in 2024 that included Mountain Whitefish (75%), Bluehead Sucker (9%), Brown Trout (8%), Rainbow Trout including hybrids (6%), and Roundtail Chub, Cutthroat Trout *Oncorhynchus clarkii*, Flannelmouth Sucker, Mountain Sucker *Catostomus platyrhynchus*, and Sculpin *Cottus* spp. (all 1% or less). Fish were PIT tagged using 12 mm Biomark RFID tags. Fish movements were monitored from late August 2024 until ice formation in early November 2024. PIT tag antennas were again deployed in spring 2025 and will remain in place until ice forms this year.

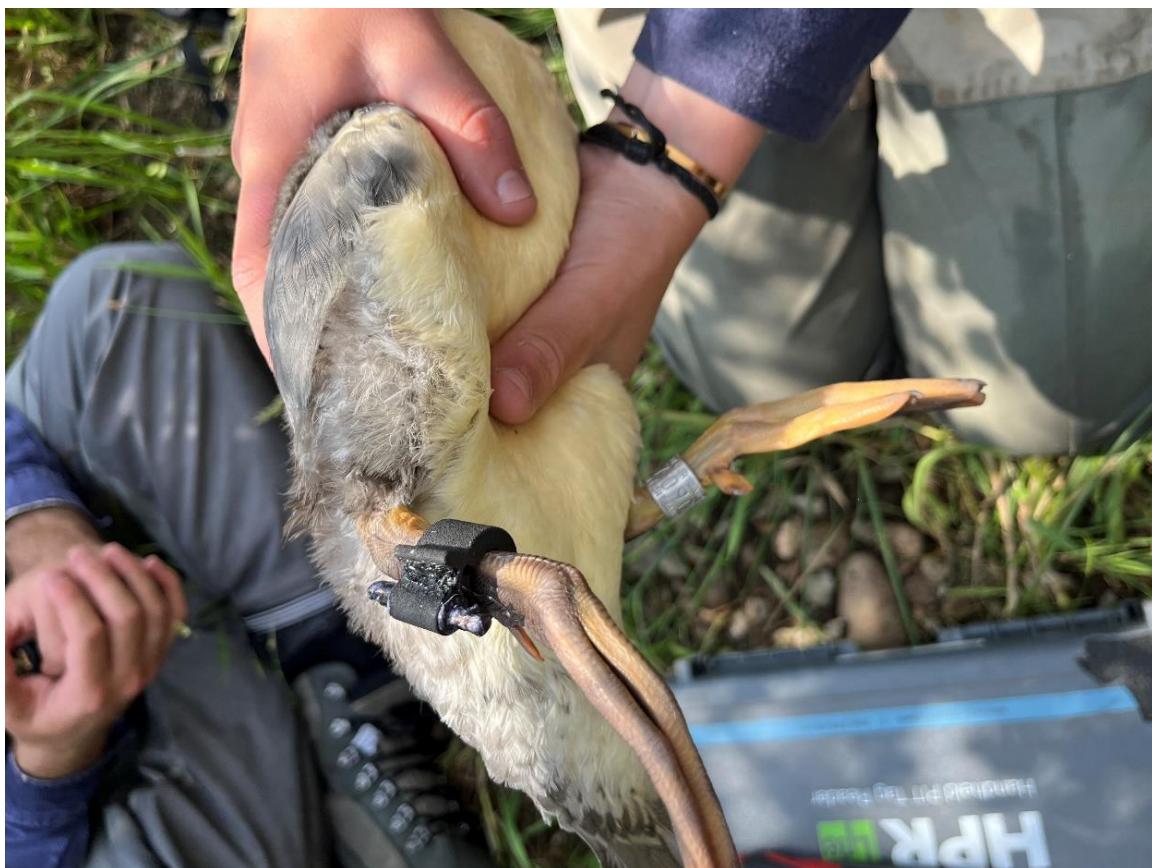
**Figure 29.** Close up photo of the 3D printed plastic leg band fitted with a 32 mm PIT tag on the leg of a captured Common Merganser.

We plan to use a variety of methods (Richer and Kondratieff 2023) as needed to attempt to capture up to 20 Common Mergansers across four years (20 total birds; 2023 through 2026). All captures will take place during the breeding season (April-September). After capture, all birds will be banded on one leg with a standard size 7A aluminum numbered U.S. Geological Survey band, issued by the Bird Banding Laboratory. On the other leg, birds will be tagged using a 3D-printed plastic leg band with an affixed 32 mm PIT tag (Figure 29). The unnumbered plain plastic 3D printed band will contain a 32 mm PIT tag attached to the band with epoxy. Leg bands will be located in closer proximity to the antenna than subcutaneous tags, giving leg bands a higher detection probability. PIT tags have been used successfully in a wide variety of bird applications with few drawbacks reported (Bonter and Bridge 2011). Bird processing should take less than five minutes and birds will be released at the same location where they were captured. Equipment used in contact with birds will be disinfected between uses to reduce the chance of spreading disease.

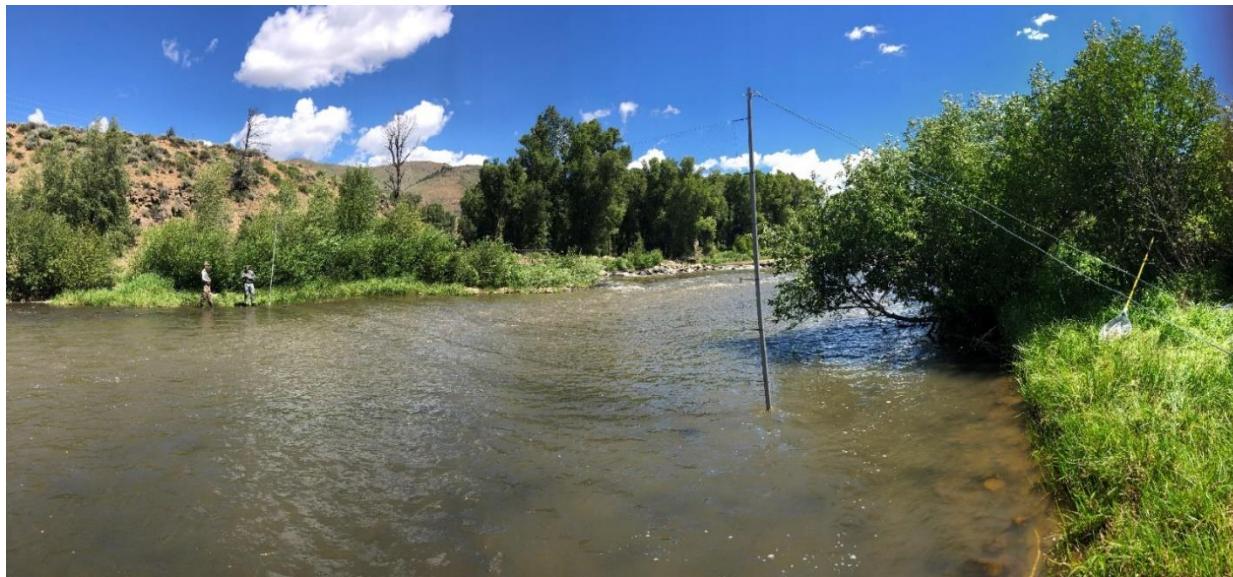
**Figure 30.** Mist net deployed on the Colorado River to capture Common Mergansers for tagging.

Our preferred alternative to capture Common Mergansers is the mist net (Figure 30). We will search for Mergansers within the fish-movement study reach. Once Mergansers have been sighted, we will confirm their identities using binoculars and multiple observers. Mist nets will be deployed approximately 100-500 m away from the bird(s). Mist nets over water have been used successfully to capture Common Mergansers as well as other ducks (Bengtson 1972; Briggs 1977; Brodeur et al. 2008; Smith et al. 2015). We will attempt to set up the net across the river as close to the bird as possible without altering the bird's behavior or causing the bird to leave the area. Smith et al. (2015) reported that capture of Harlequin Ducks *Histrionicus histrionicus* using this technique was slightly more effective when setting up downstream of target birds but the upstream side also worked. We will select a site to set up the net where it is shallow enough to wade across the river and the current does not pose a threat to personnel safety. We will use an 18 m by 2.6 m mist net with 127 mm nylon mesh. If that is not long enough to span the entire river, we will add an additional 6 m mist net to increase total length. The bottom of the net will be located as close to the water surface as possible without contacting flowing water. Once driving rods are securely pounded into the riverbed, we will slide aluminum poles over the top of rod to provide supports for mist net suspension. Once the net is deployed, upstream and downstream spotters equipped with radios will be stationed approximately 200 yards upstream or downstream of the net to alert the mist-net crew of any birds approaching the mist net so that the crew can operate the net accordingly. Once Mergansers have been observed in the vicinity, personnel will walk to the far side of the birds and attempt to flush the them into the net. After the bird has become captured, we will immediately wade out into the river to remove the bird from the net, carry it to shore, and tag it. After the bird is removed from the net, we will immediately remove or collapse the net by pushing the top and bottom together on the poles to prevent additional birds from being captured while we process the captured bird. Processing consists of recording the date and capture location as well as the bird's age, sex, mass, tarsus and wing cord lengths, and tag numbers for the aluminum band and PIT tag (Figure 31). After recording data for the captured bird, the bird will be released in close proximity to where it was captured ( $\pm 100$  m).

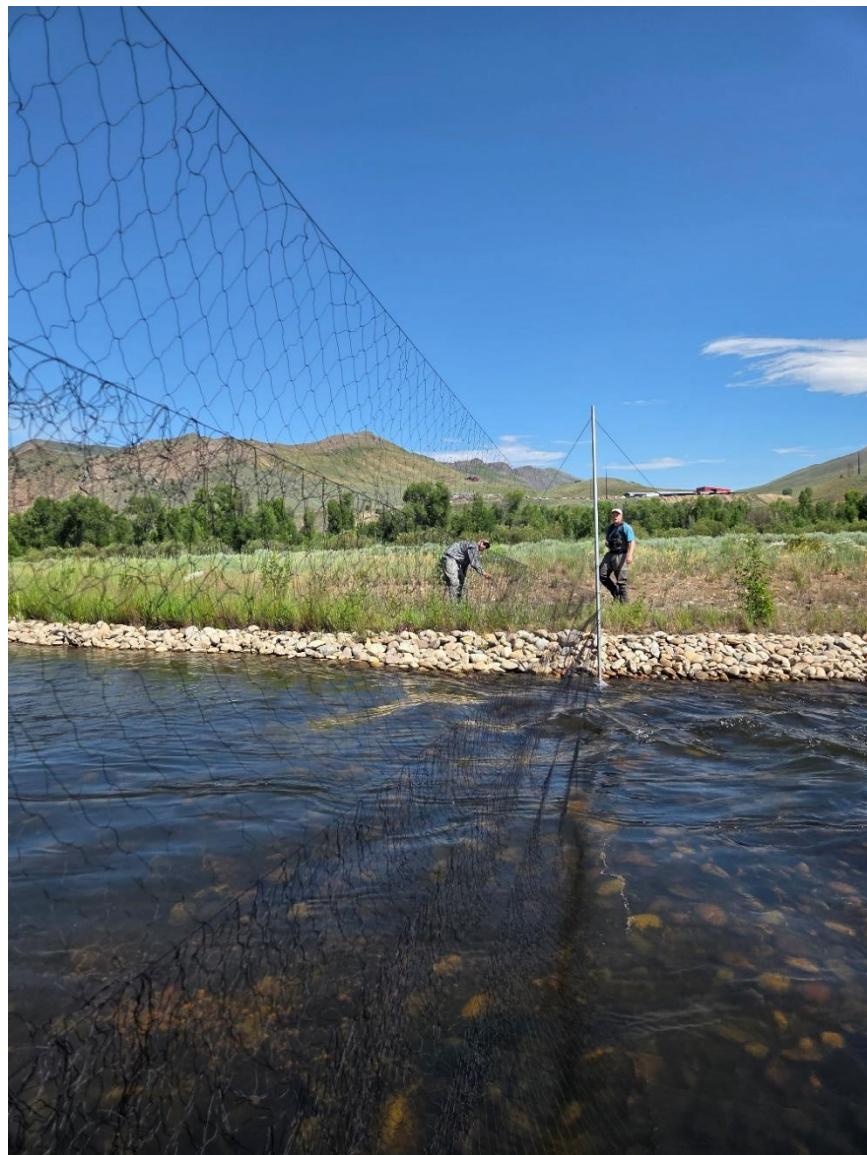
**Figure 33.** Mist net set up on the Colorado River Connectivity Channel downstream of fixed antenna site CD.

We conducted two additional trapping excursions in 2025 on July 15 and August 6. In July, we deployed the mist net near the fixed antenna site located near the downstream end of the CRCC (site CD). A hen Common Merganser and seven fledglings were located near this site. We determined that the Mergansers were using this location from our camera trap at the CD antenna site. We planned our netting concurrently with mobile antenna surveys so that personnel on the rafts could communicate with the Merganser crew via radio if any Common Mergansers were observed as they floated downstream. The plan worked well as Mergansers were observed ahead of the rafts when floating down the CRCC and Colorado River above the Red Barn antenna site, allowing the Merganser crew to prepare for the birds moving downstream in response the rafts. Unfortunately, we were unsuccessful at netting and capturing birds along the CRCC (Figure 33).

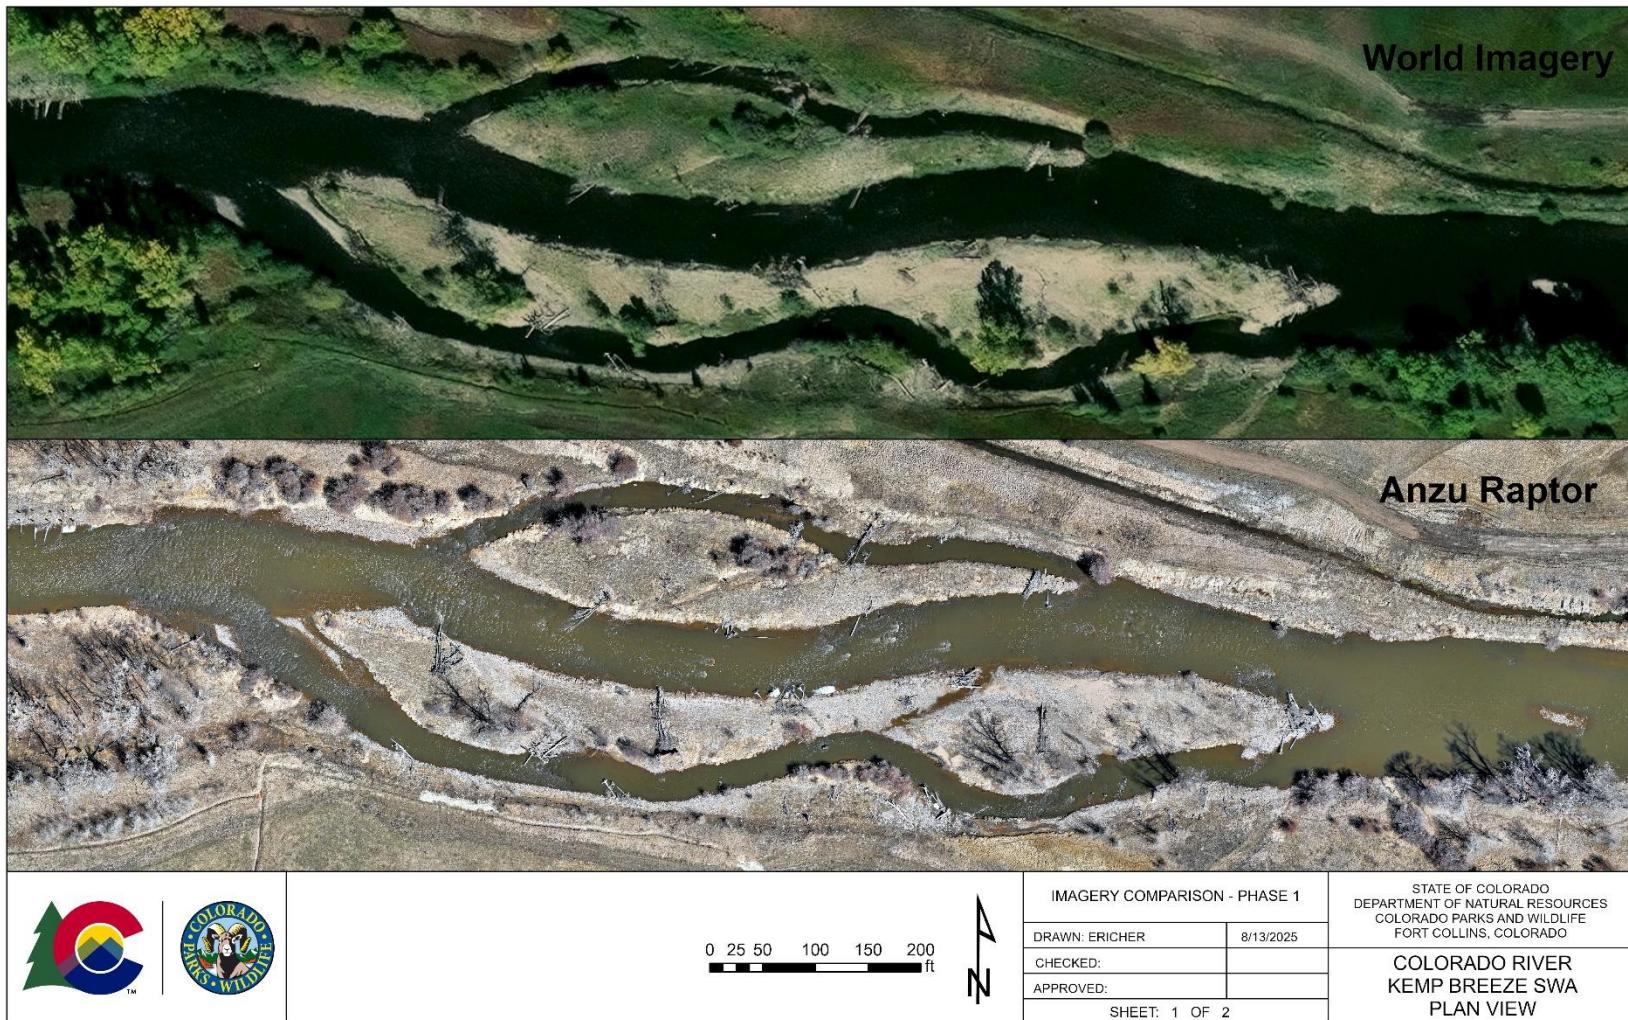
**Figure A3.** Comparison of standard world imagery basemap (resolution = 0.5 m) and unmanned aerial system (Anzu Raptor) imagery (resolution = 0.02 m) for the Kemp-Breeze SWA Habitat Project, Phase 1 reach.
