State of Colorado 2002 Flood Documentation Report

Prepared by:
ICON Engineering, Inc
8100 S. Akron St. Suite 300
Centennial, CO 80112
303-221-0802

Prepared for:
Colorado Water Conservation Board
1313 Sherman St. Room 721
Denver, CO 80203
303-866-3441

January 2003

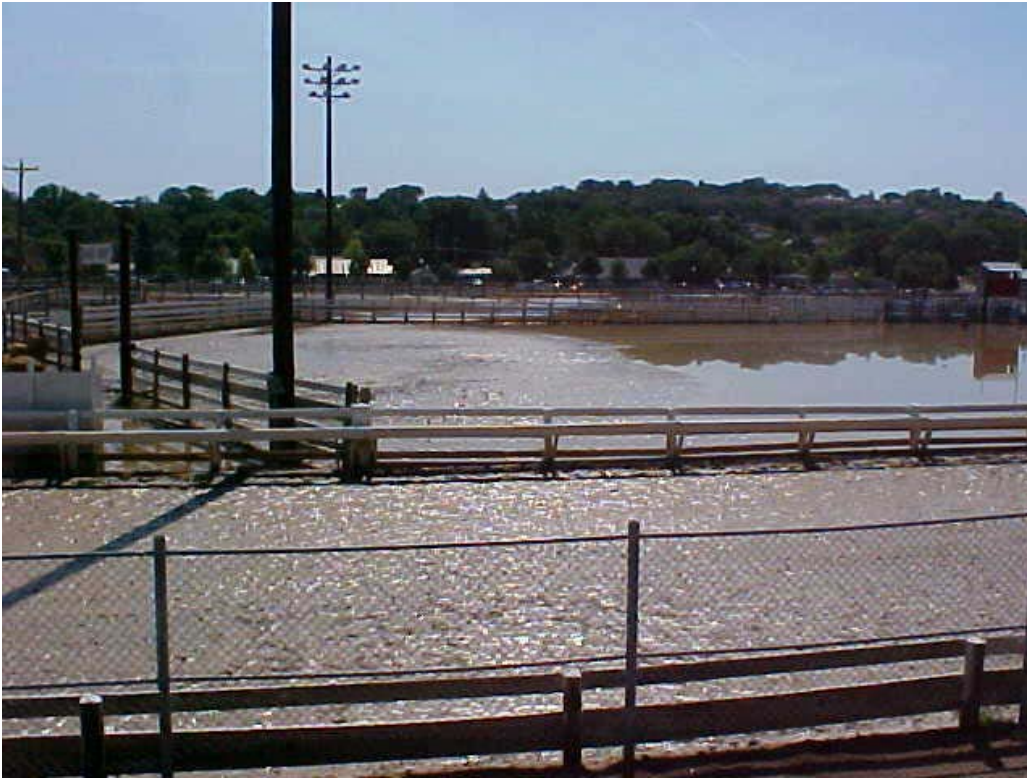
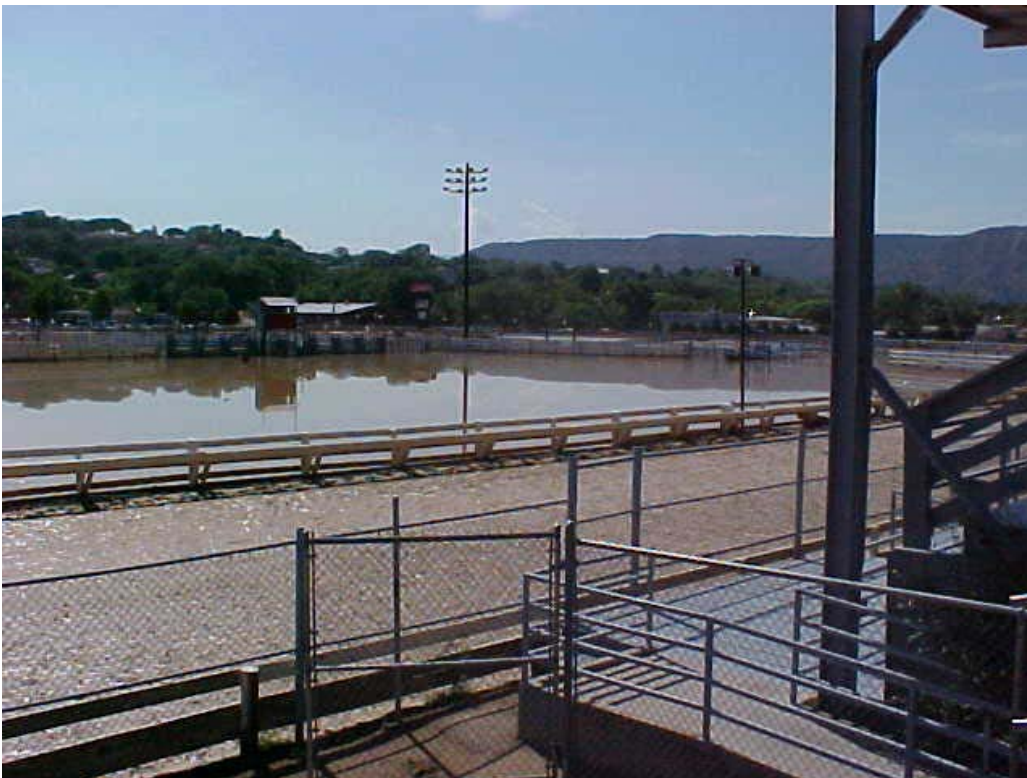
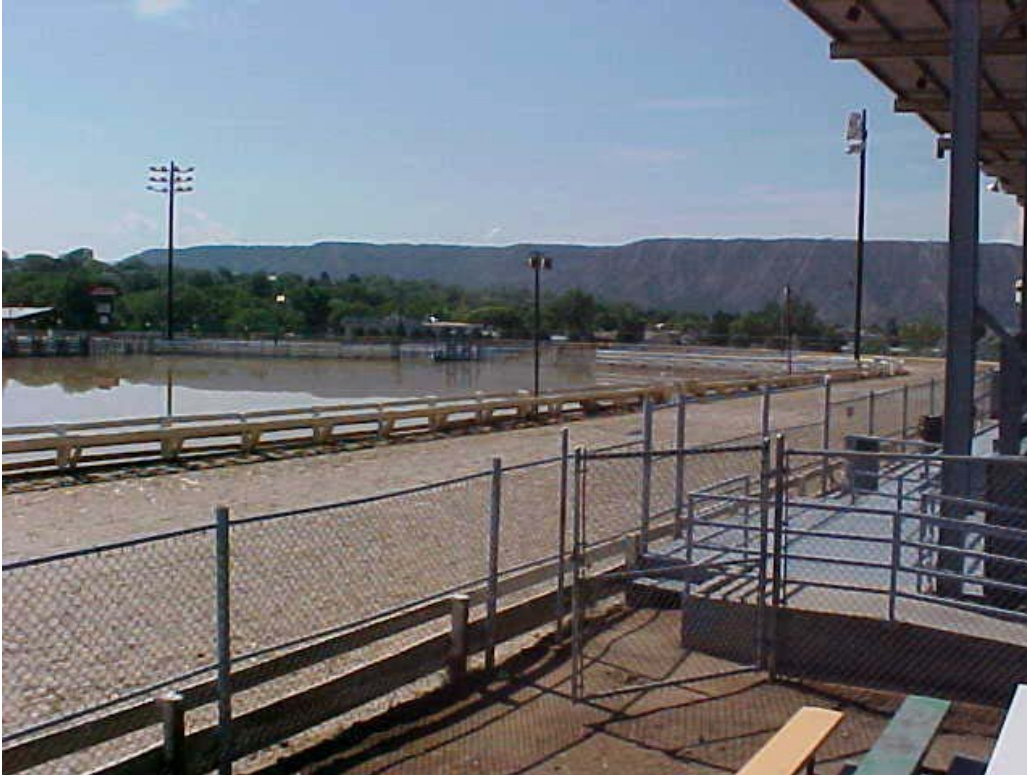
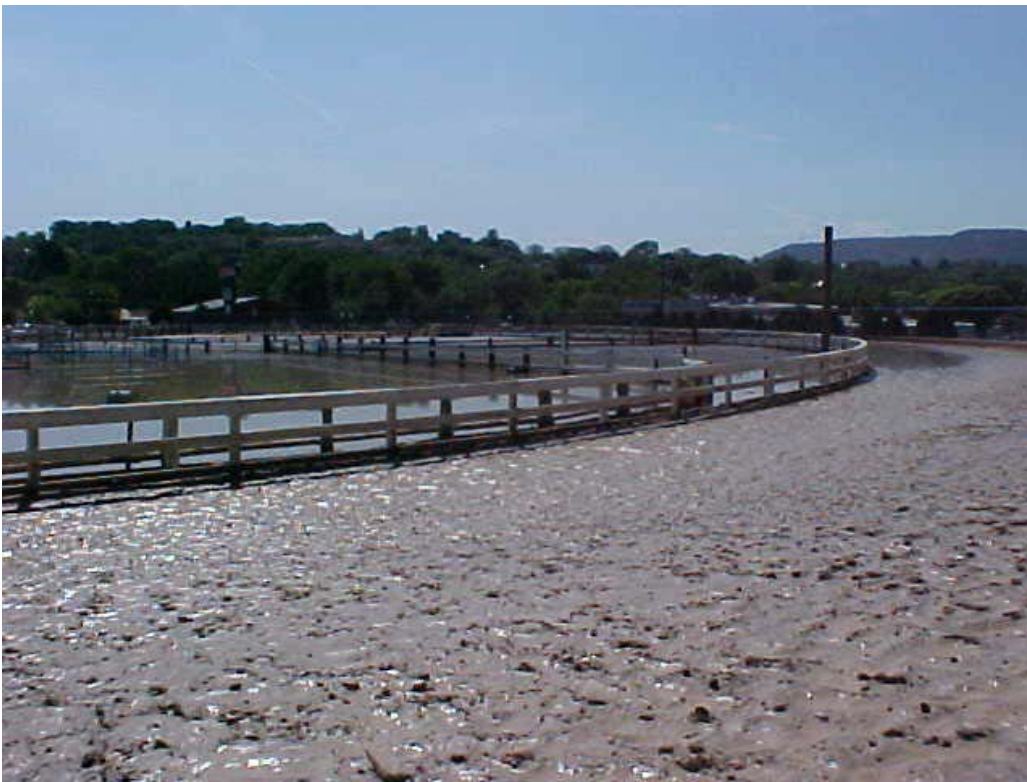
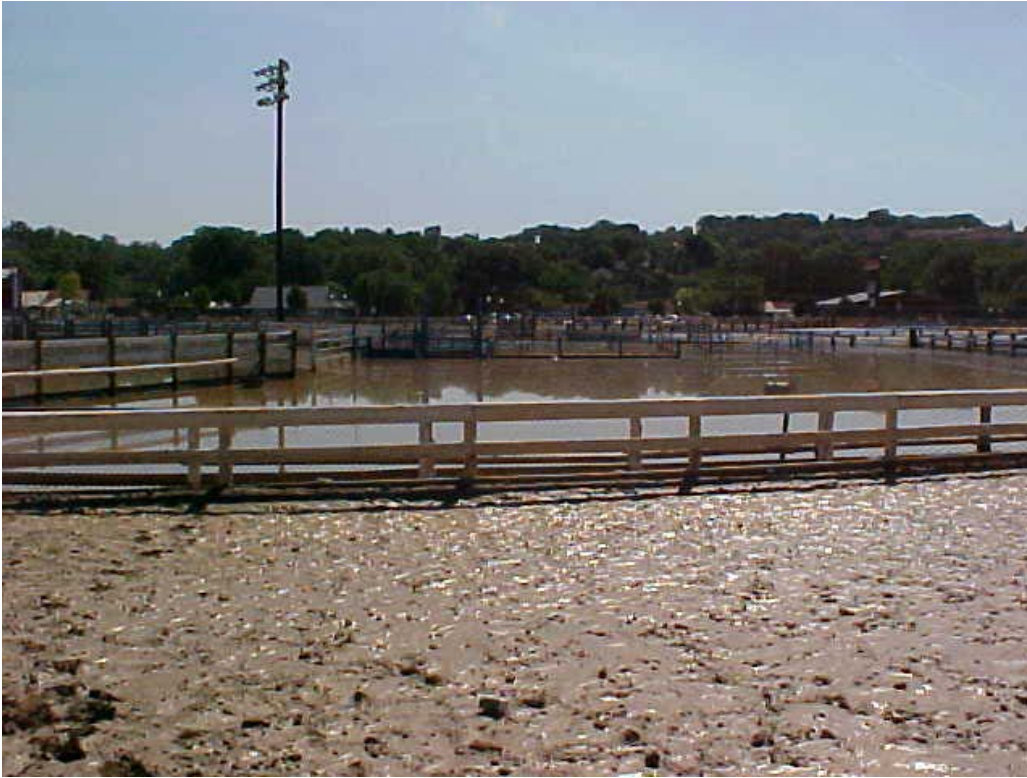
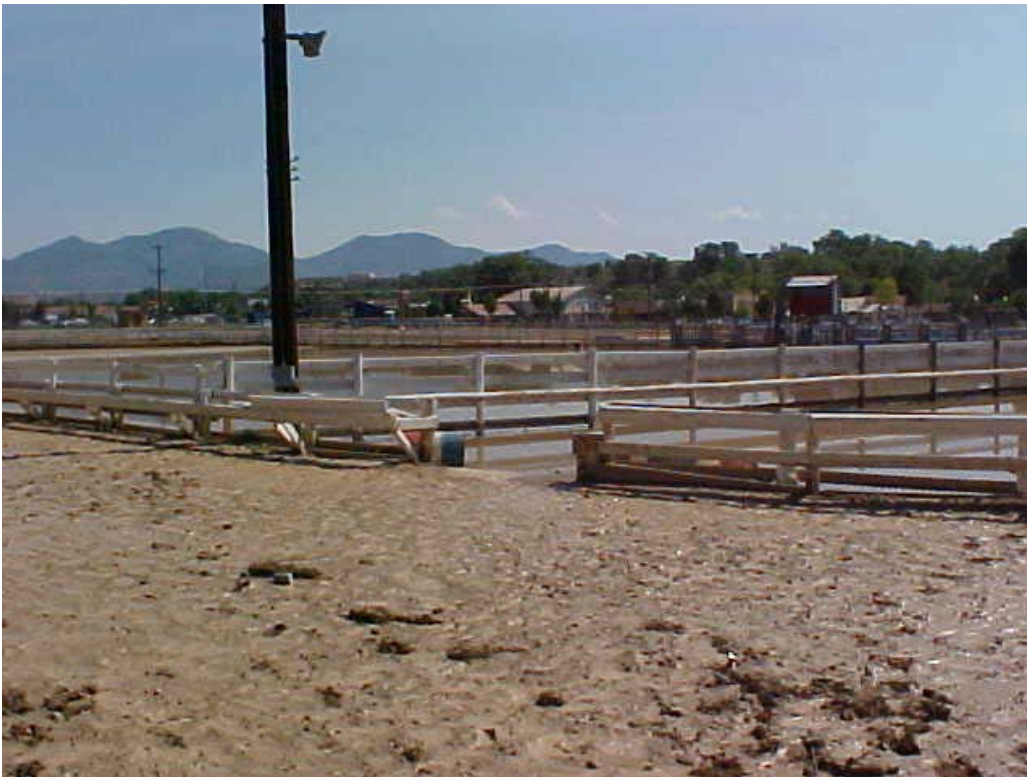
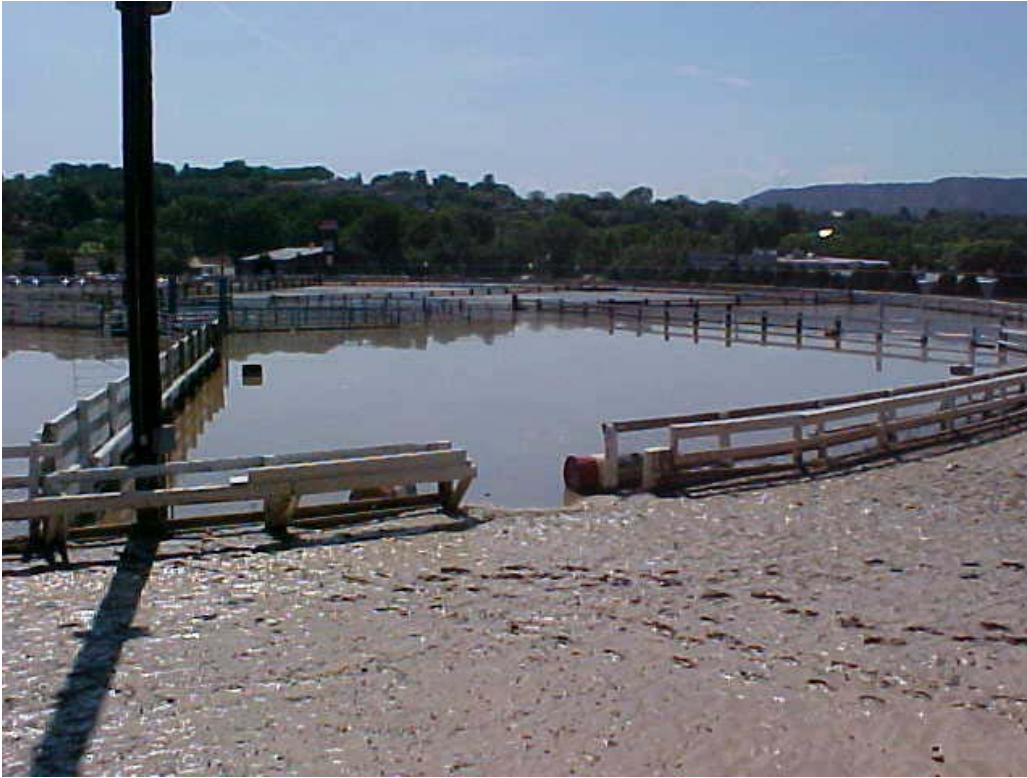
Figure 2.11 – Rifle Fairgrounds Damage Picture 1.

Figure 2.12 – Rifle Fairgrounds Damage Picture 2.

Figure 2.13 – Rifle Fairgrounds Damage Picture 3.

Figure 2.14 – Rifle Fairgrounds Damage Picture 4.

Figure 2.15 – Rifle Fairgrounds Damage Picture 5.

Figure 2.16 – Rifle Fairgrounds Damage Picture 6.

Figure 2.17 – Rifle Fairgrounds Damage Picture 7.

Damage estimates were obtained through Mr. Denney with the Office of Emergency Management. The fairgrounds estimated damage at \$28,000, which included the replacement of a culvert and a walking bridge. Pictures of the fairgrounds damage are included in the Additional Support Information section of this chapter, courtesy of Mr. Denney.

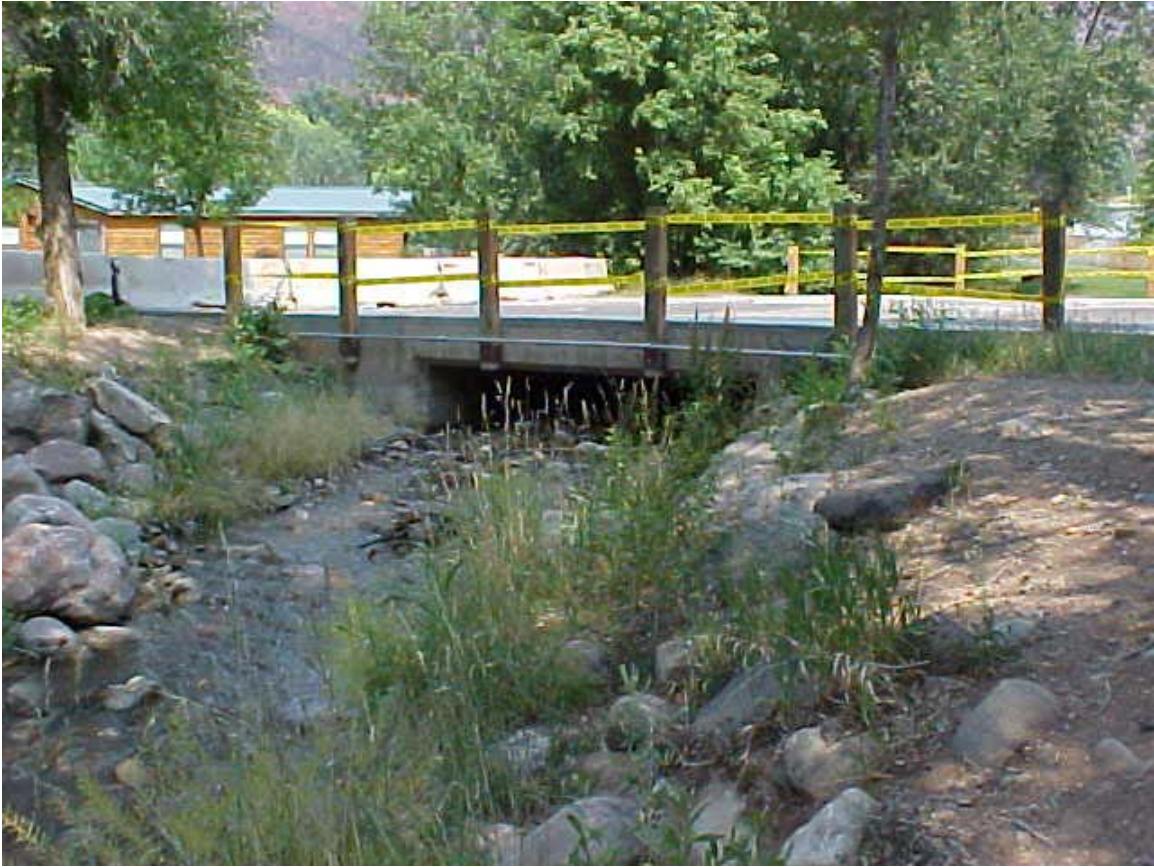
Figure 5.17 – Picture of Center Street Bridge Over Mitchell Creek During Mitigation Effort.

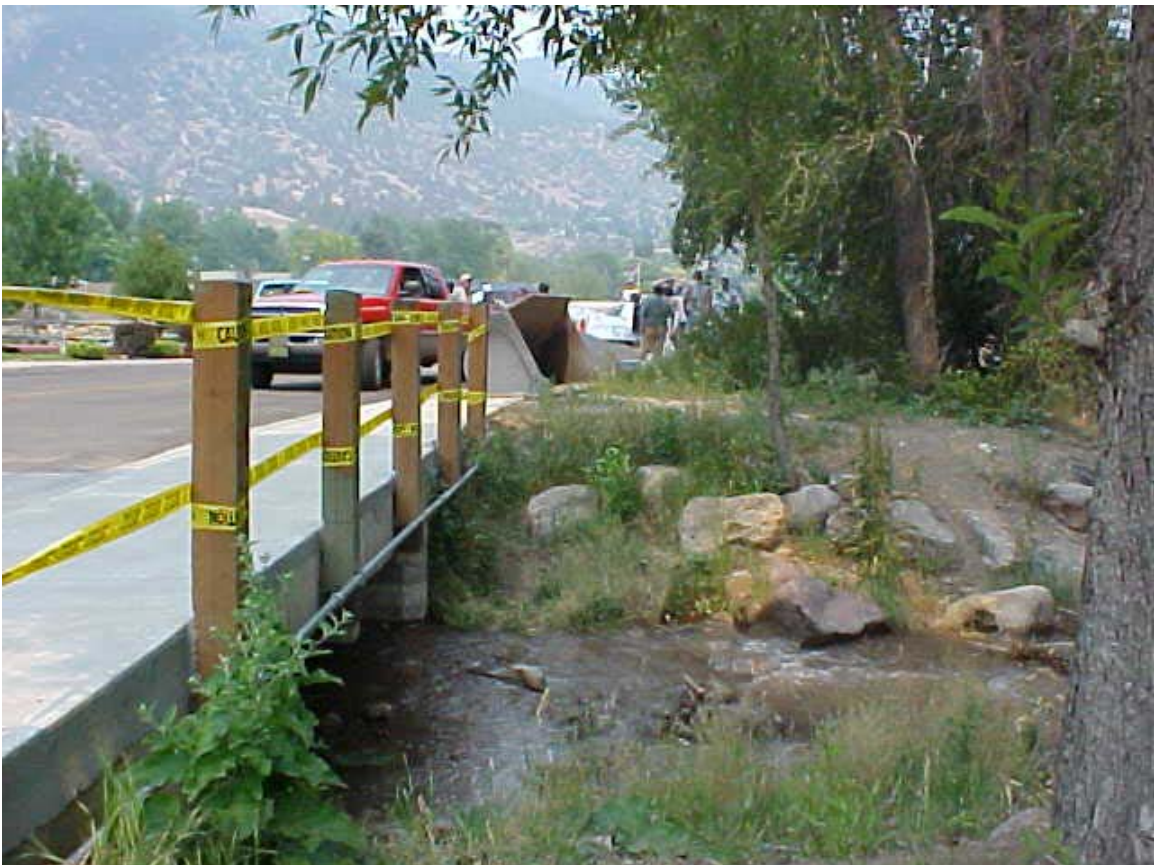
Figure 5.18 – Picture #2 of Center Street Bridge Over Mitchell Creek During Mitigation Effort.

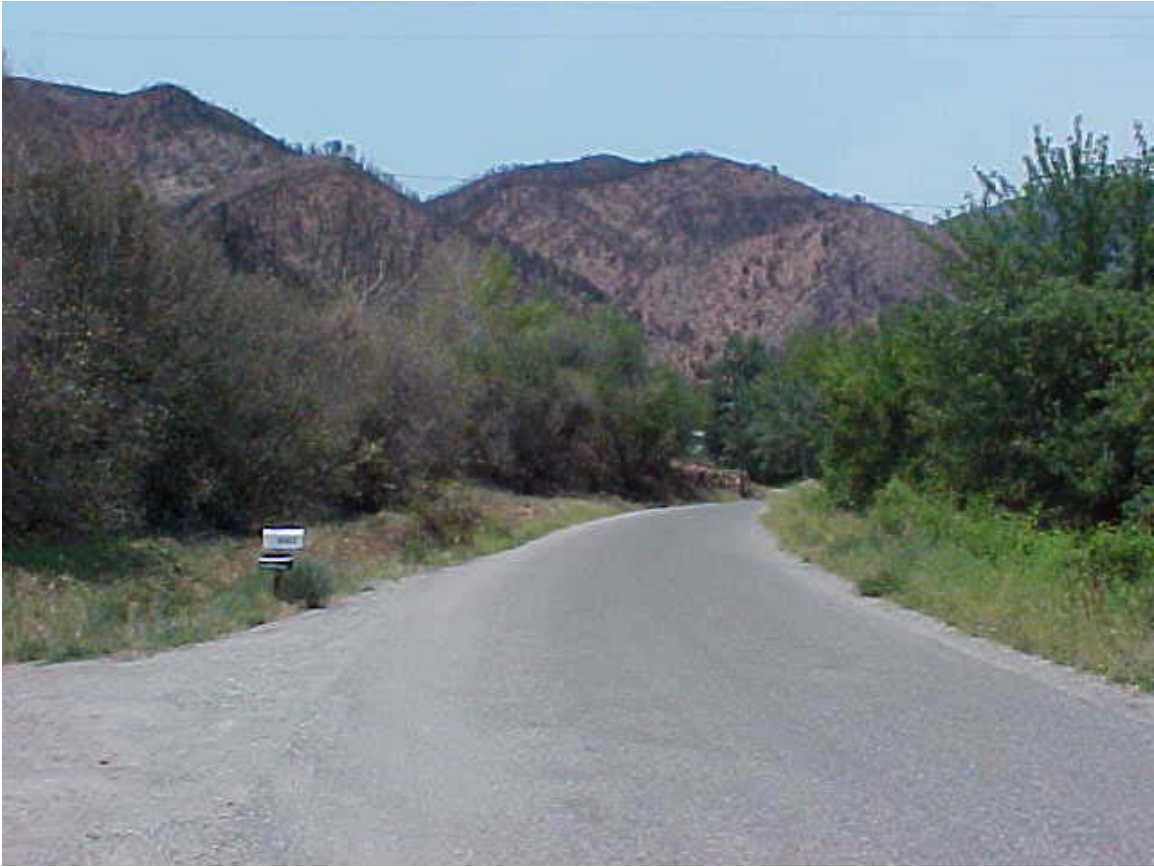
Figure 5.19 – Picture of Mitchell Creek Road Looking West During Mitigation Effort.

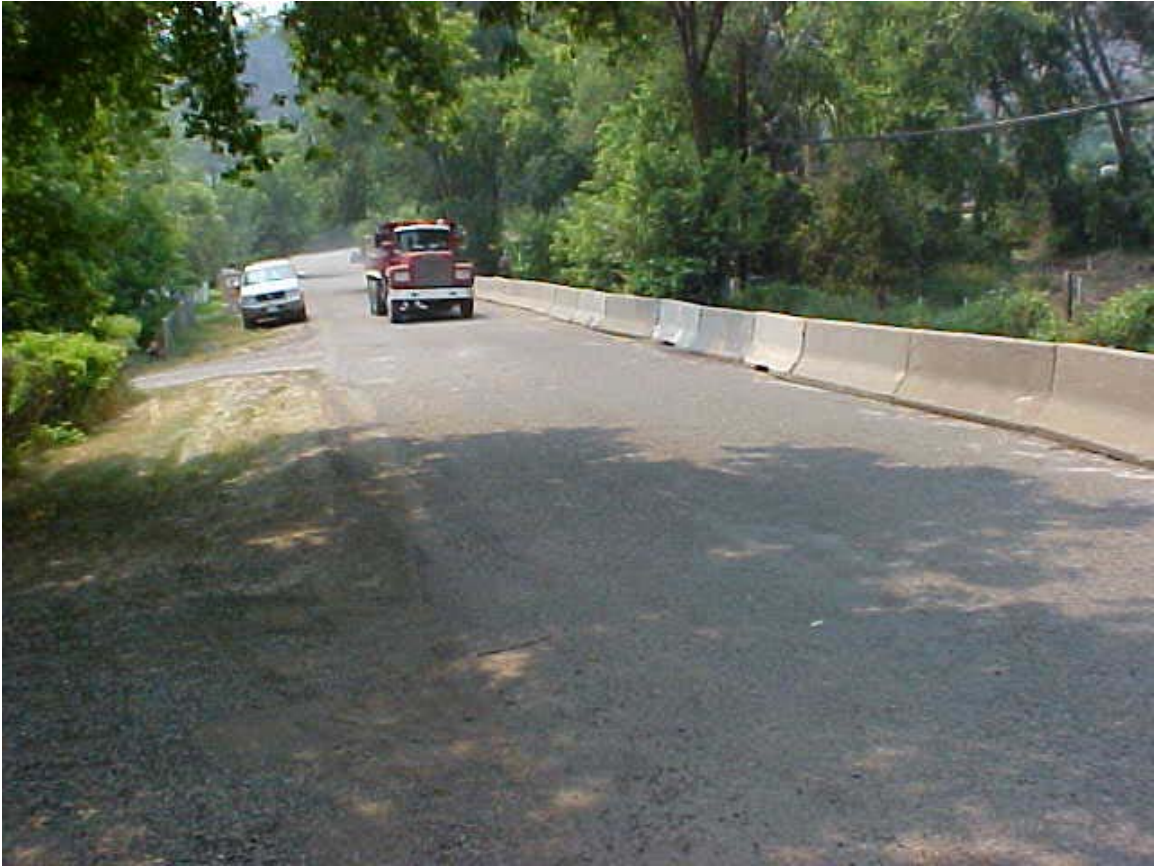
Figure 5.21 – Picture of Donagan Road with Jersey Barriers Installed During Mitigation Effort.

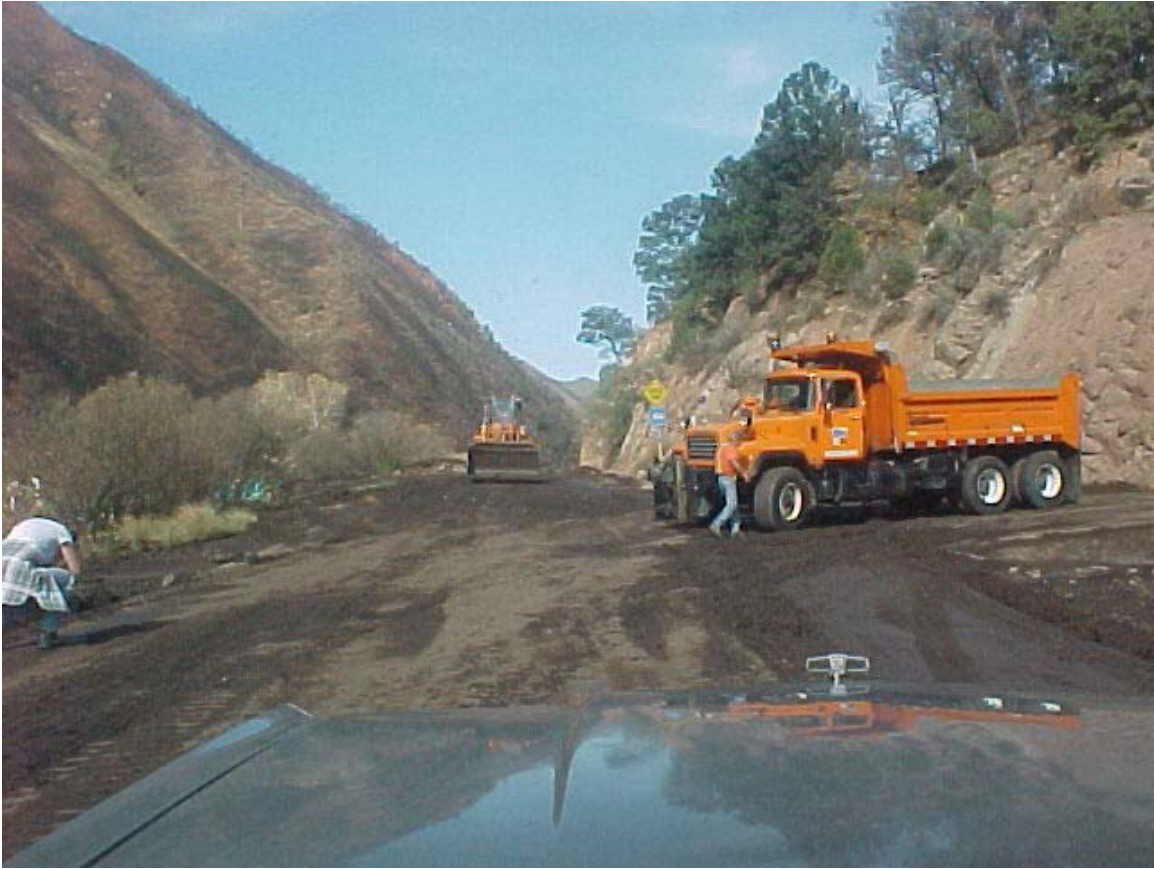
Figure 5.23 – Picture #2 of Mitchell Creek Road During Cleanup Efforts After the Event.

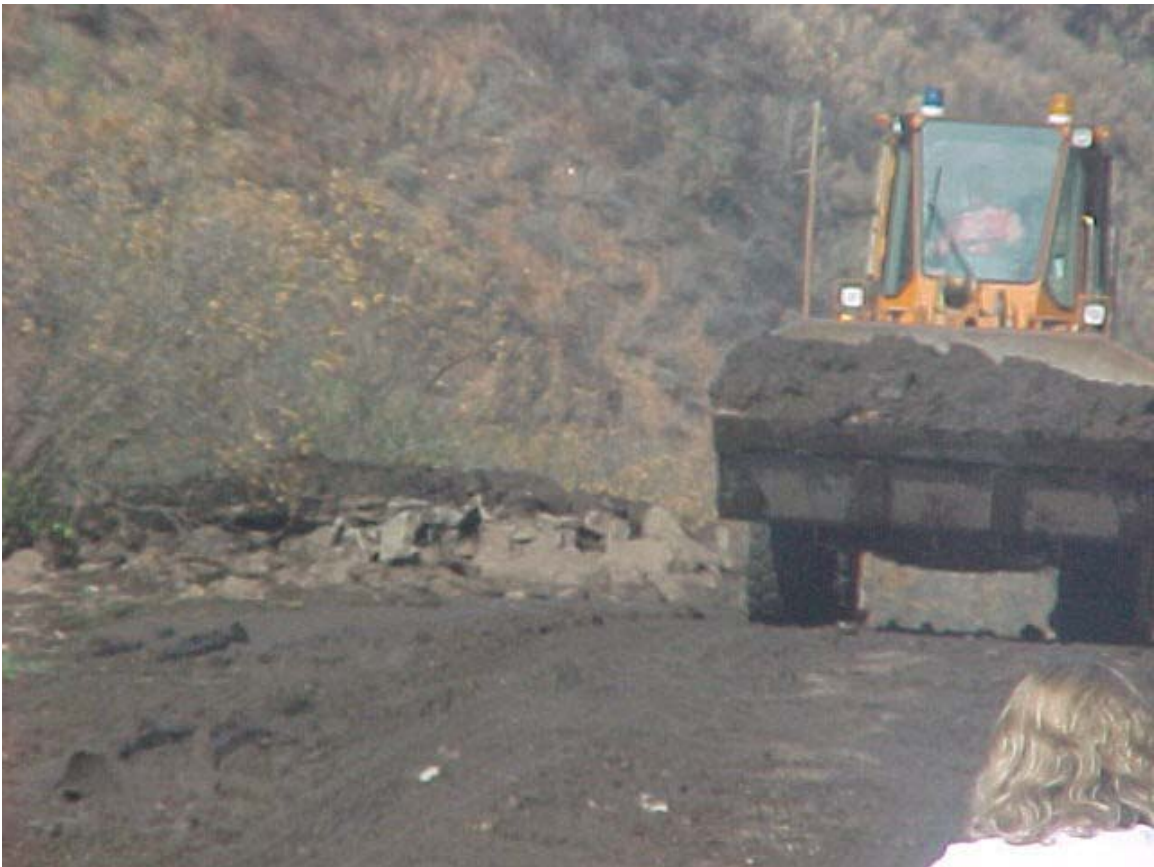
Figure 5.24 – Picture #3 of Mitchell Creek Road During Cleanup Efforts After the Event.

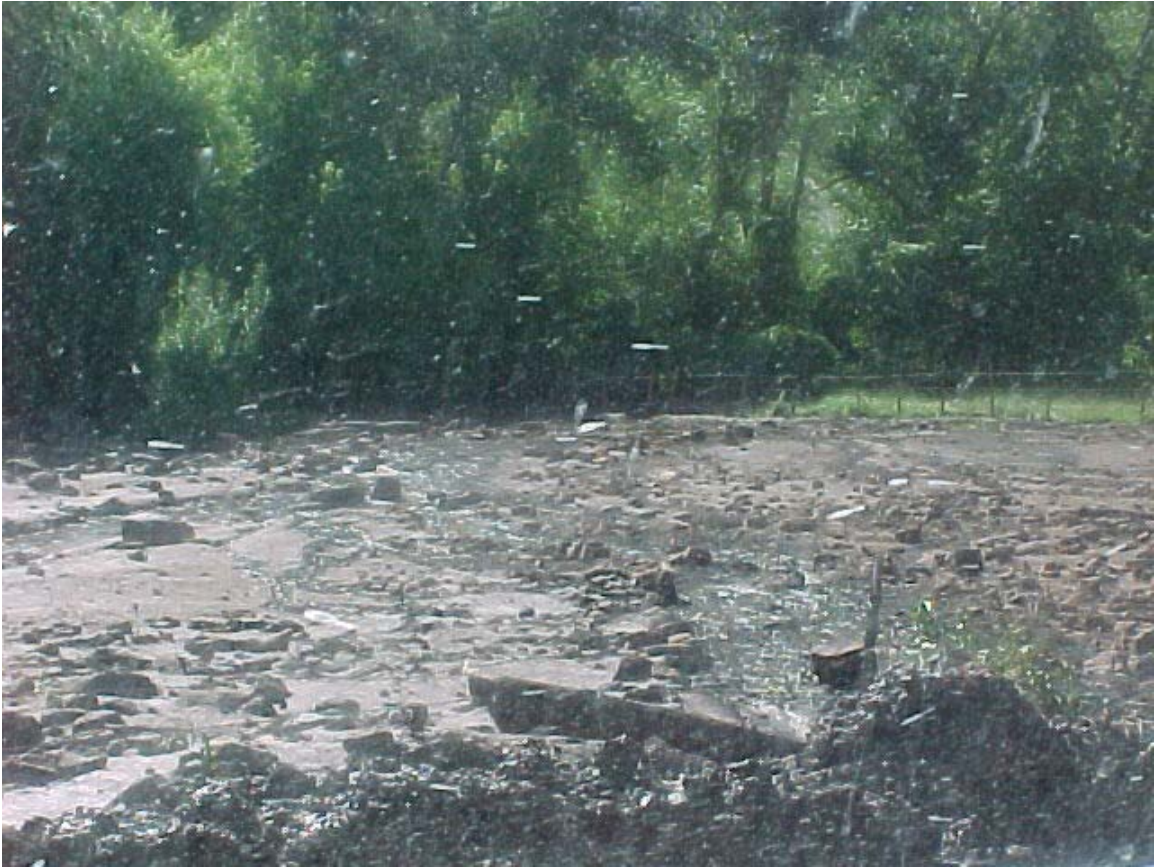
Figure 5.25 – Picture #4 of Mitchell Creek Road During Cleanup Efforts After the Event.

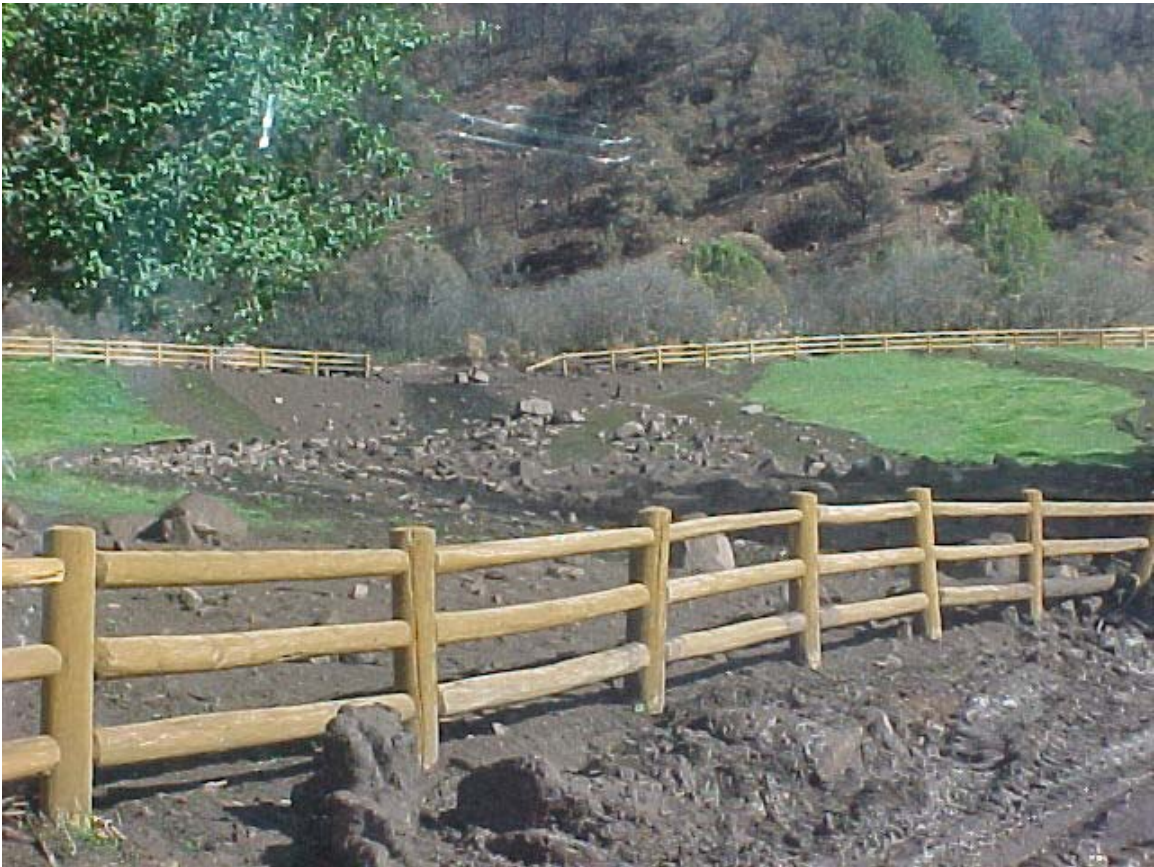
Figure 5.26 – Picture of Mud’s Flow Path Down to Mitchell Creek Road During Cleanup Effort.

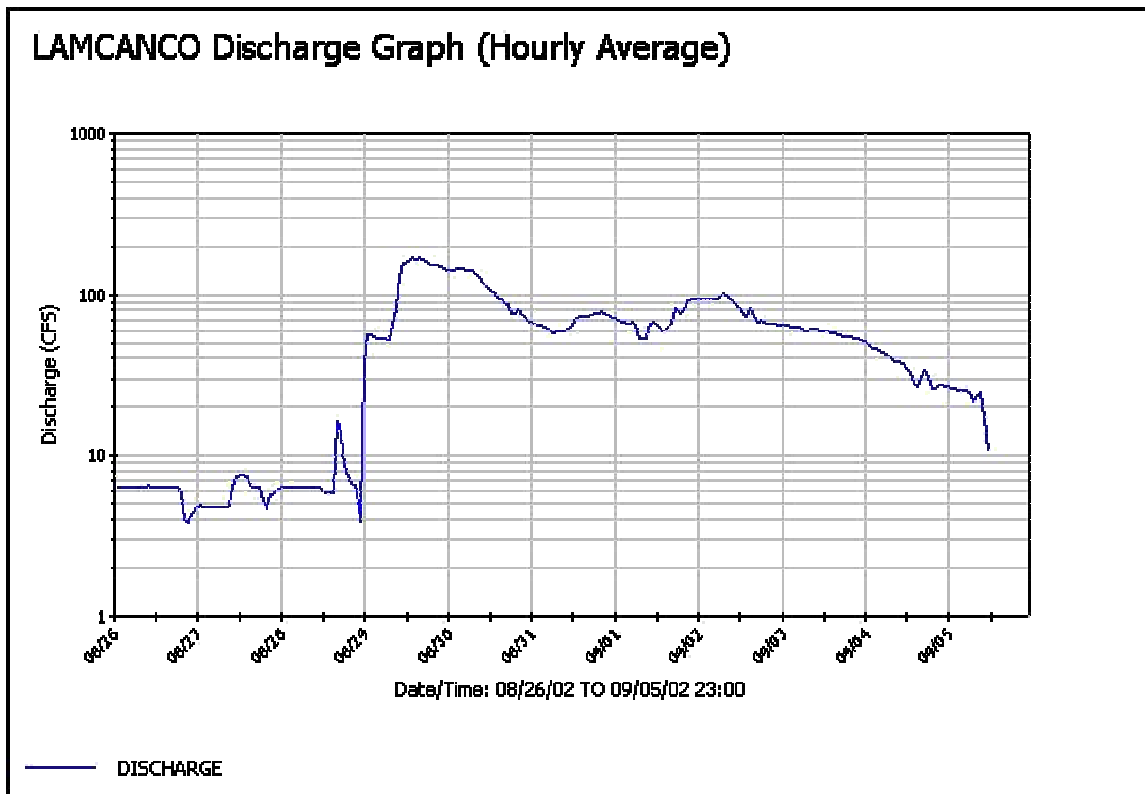
Figure 6.17 – Flow Gage Data for the Lamar Canal.
Graph courtesy of the Colorado Division of Water Resources website.

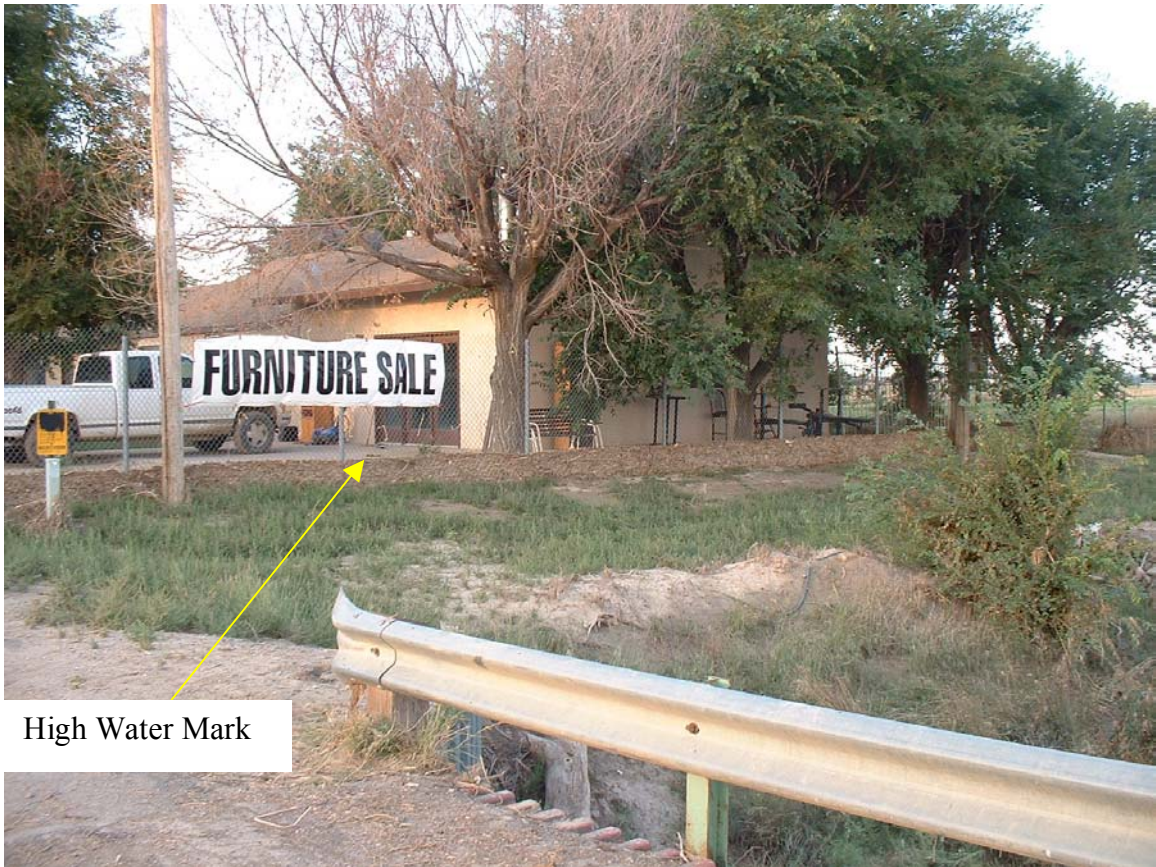
Figure 6.29 – High-Water Debris Line in Chain-Link Fence along Highway 50 in Lamar.

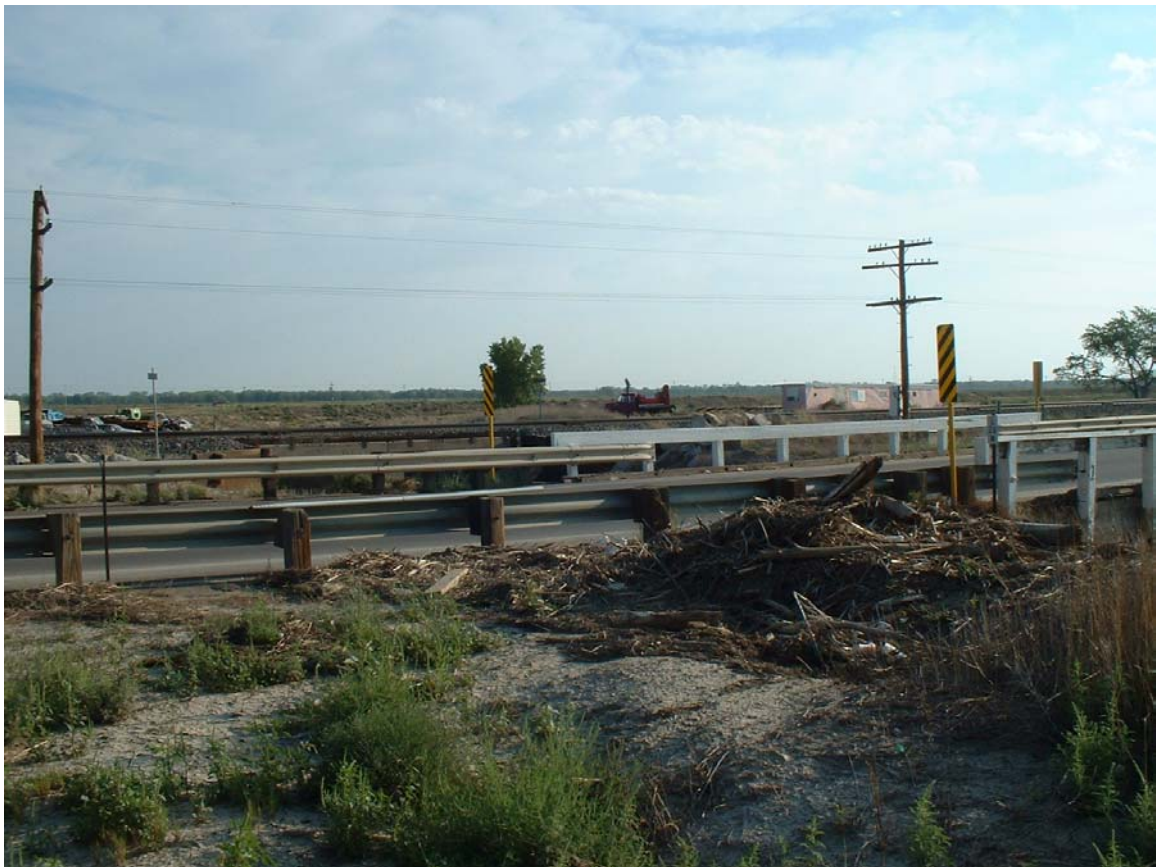
Figure 6.30 – Looking North at Debris Pile along Highway 50 in Lamar, Colorado.

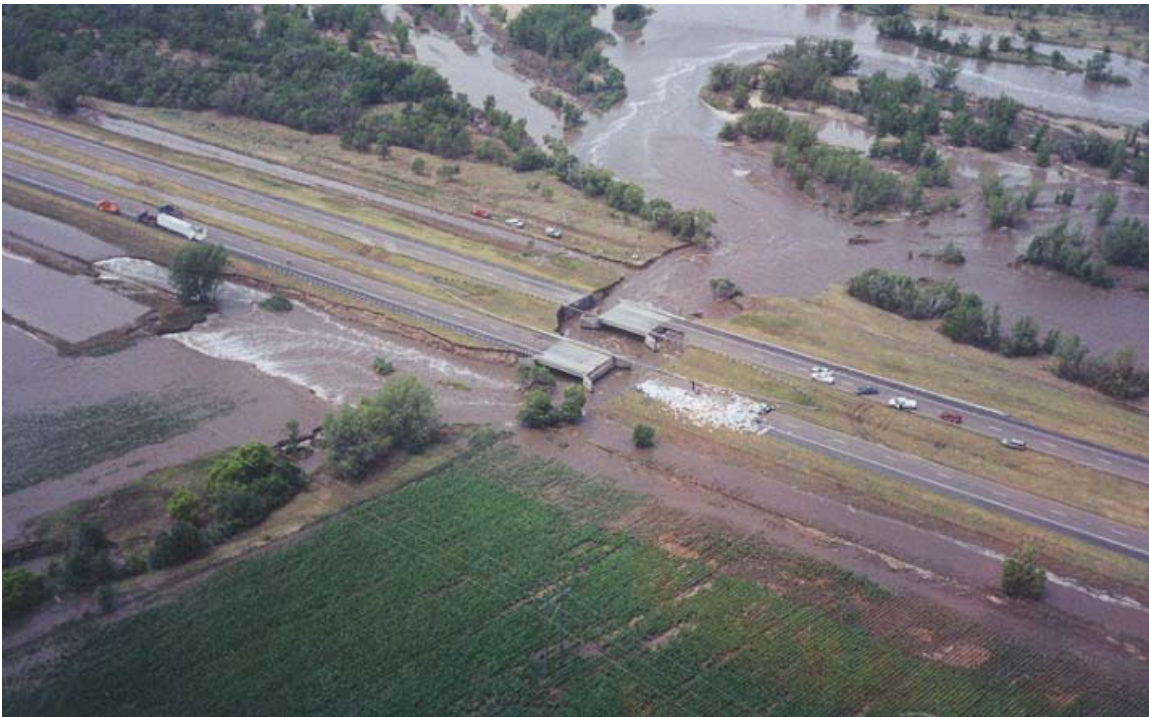
Figure 7.23 – Aerial Picture of Rural Flood Damage to Two Bridges on I-80.
Picture courtesy of the Nebraska DOT.

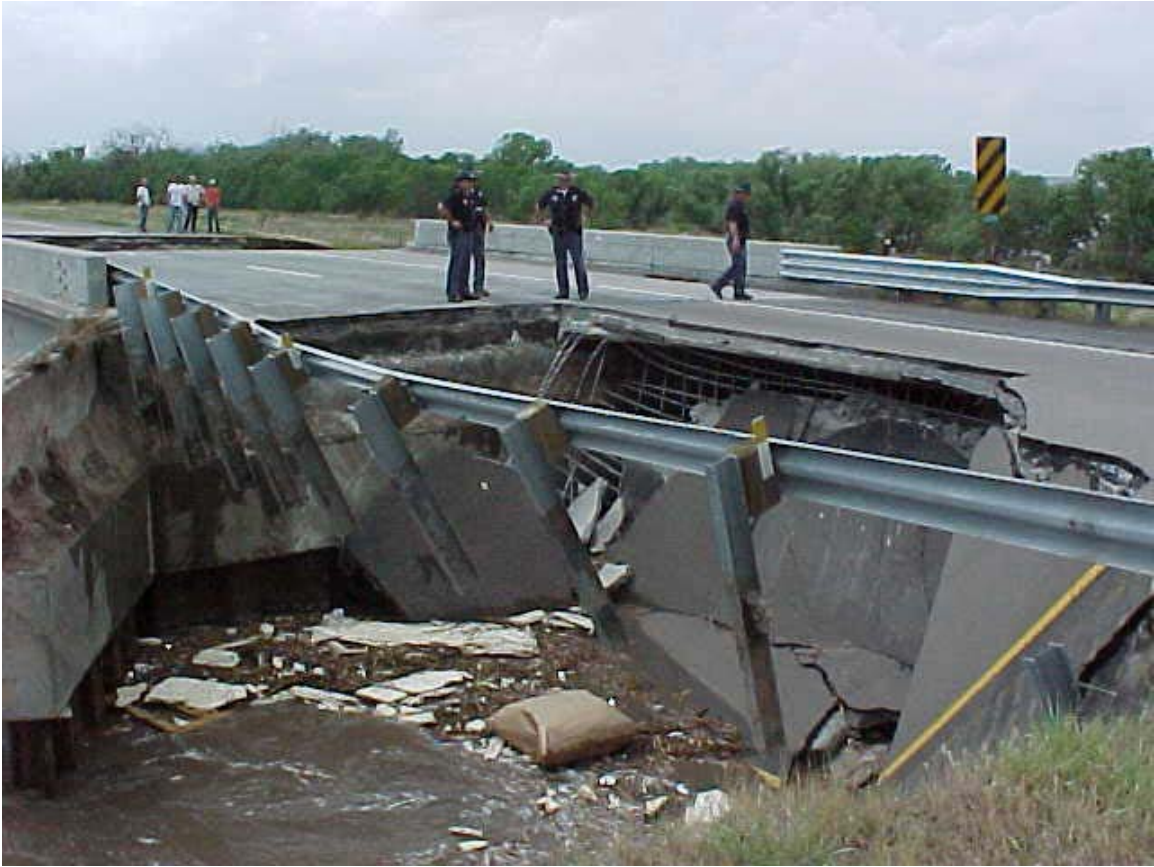
Figure 7.24 – Close-Up Picture of Flood Damage to Bridge on I-80.
Picture courtesy of the Nebraska DOT.

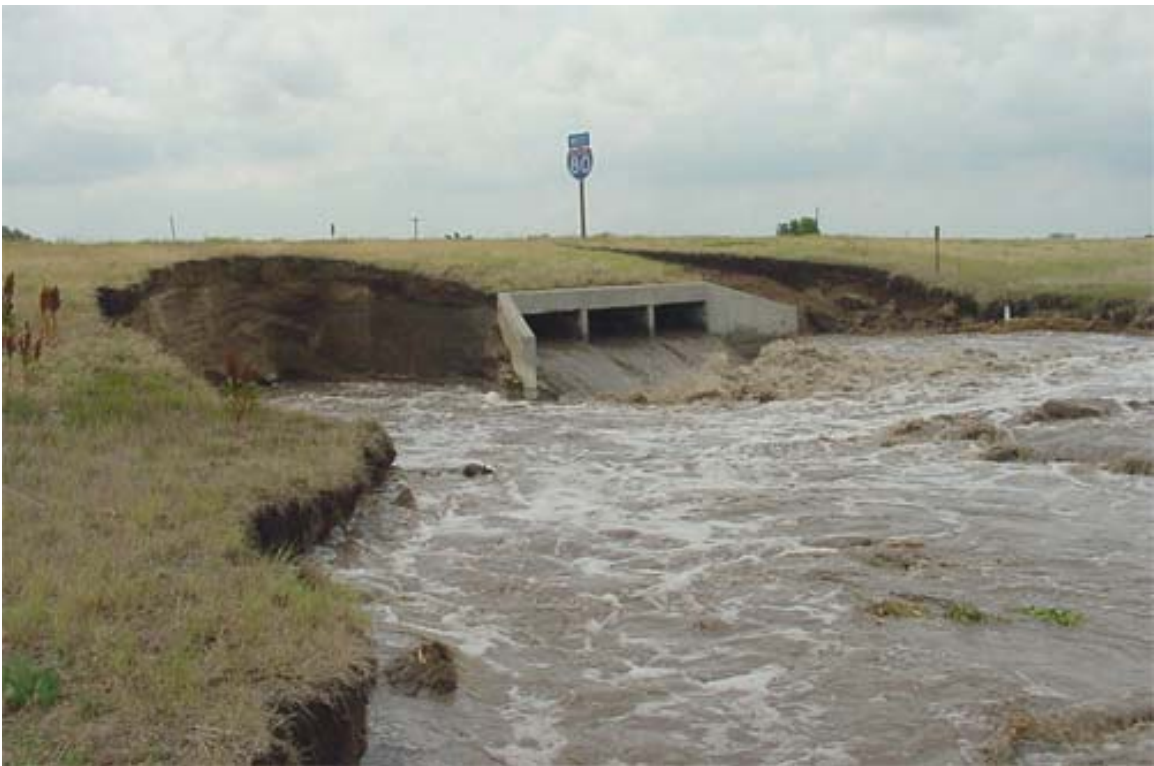
Figure 7.29 – Erosion Damaged Spillway Along Interstate 80.
Picture courtesy of the Nebraska DOT.

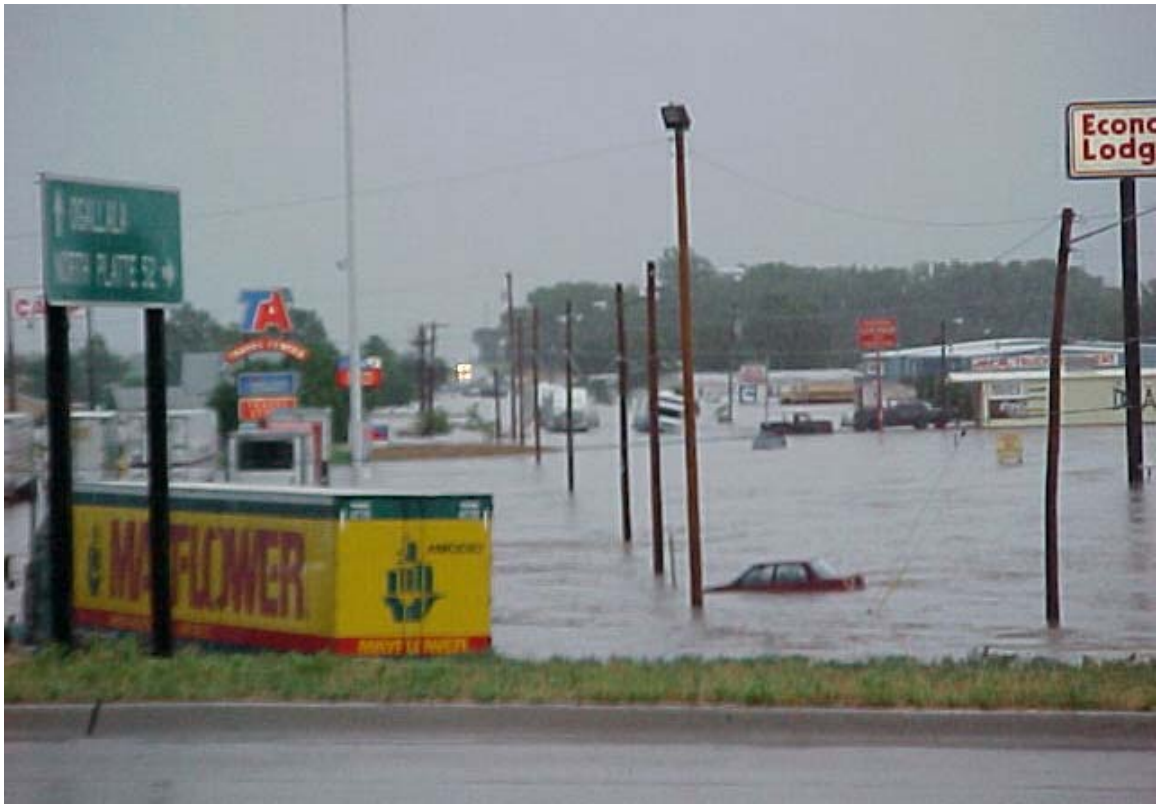
Figure 7.30 – Flooded Area Near Ogallala.
Picture courtesy of the Nebraska DOT.

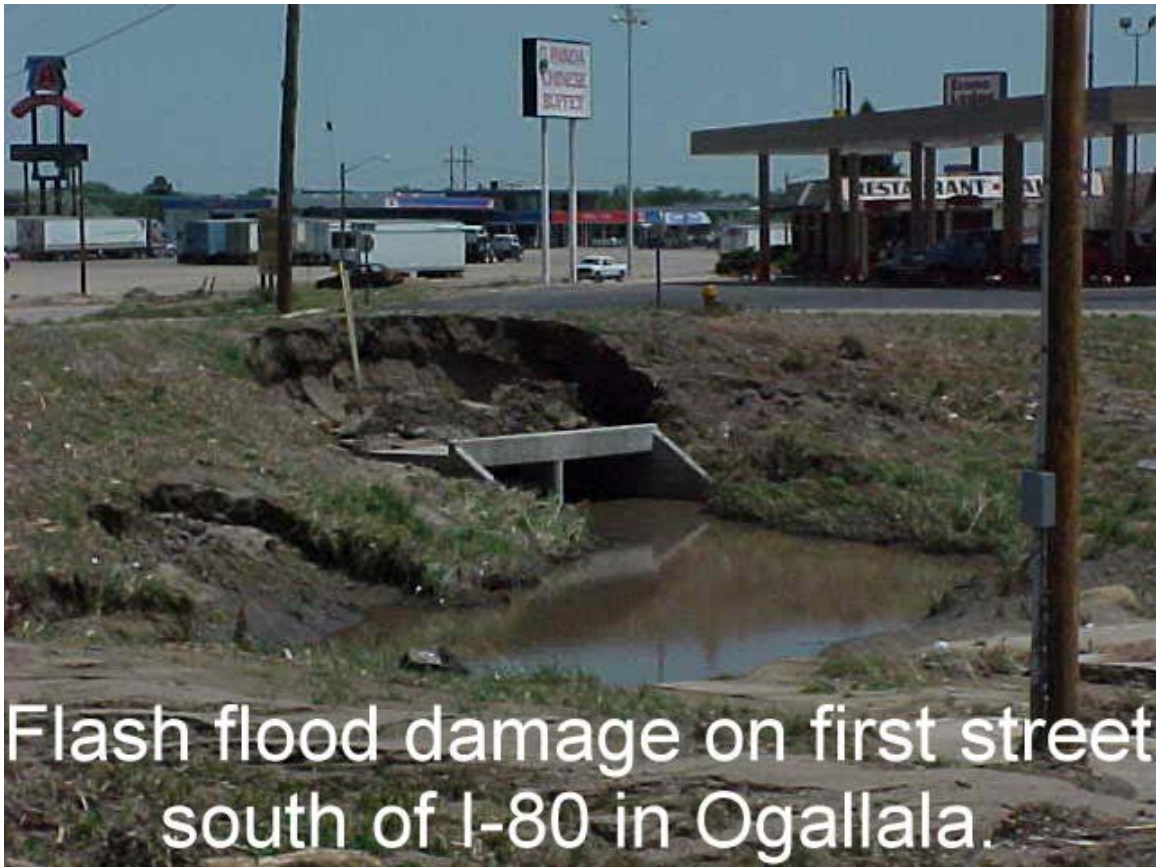
Flash flood damage on first street south of I-80 in Ogallala.

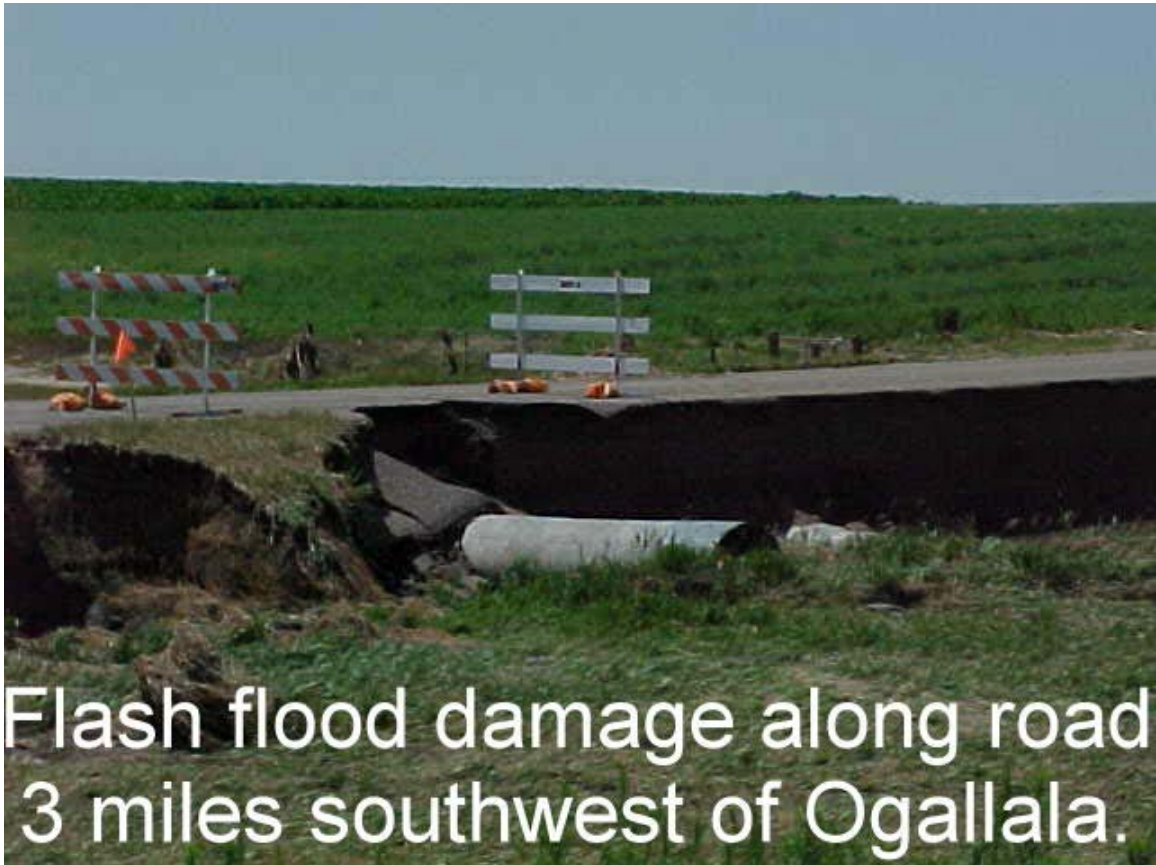
Flash flood damage along road 3 miles southwest of Ogallala.
