State of Colorado 2002 Flood Documentation Report

Prepared by:
ICON Engineering, Inc
8100 S. Akron St. Suite 300
Centennial, CO 80112
303-221-0802

Prepared for:
Colorado Water Conservation Board
1313 Sherman St. Room 721
Denver, CO 80203
303-866-3441

January 2003

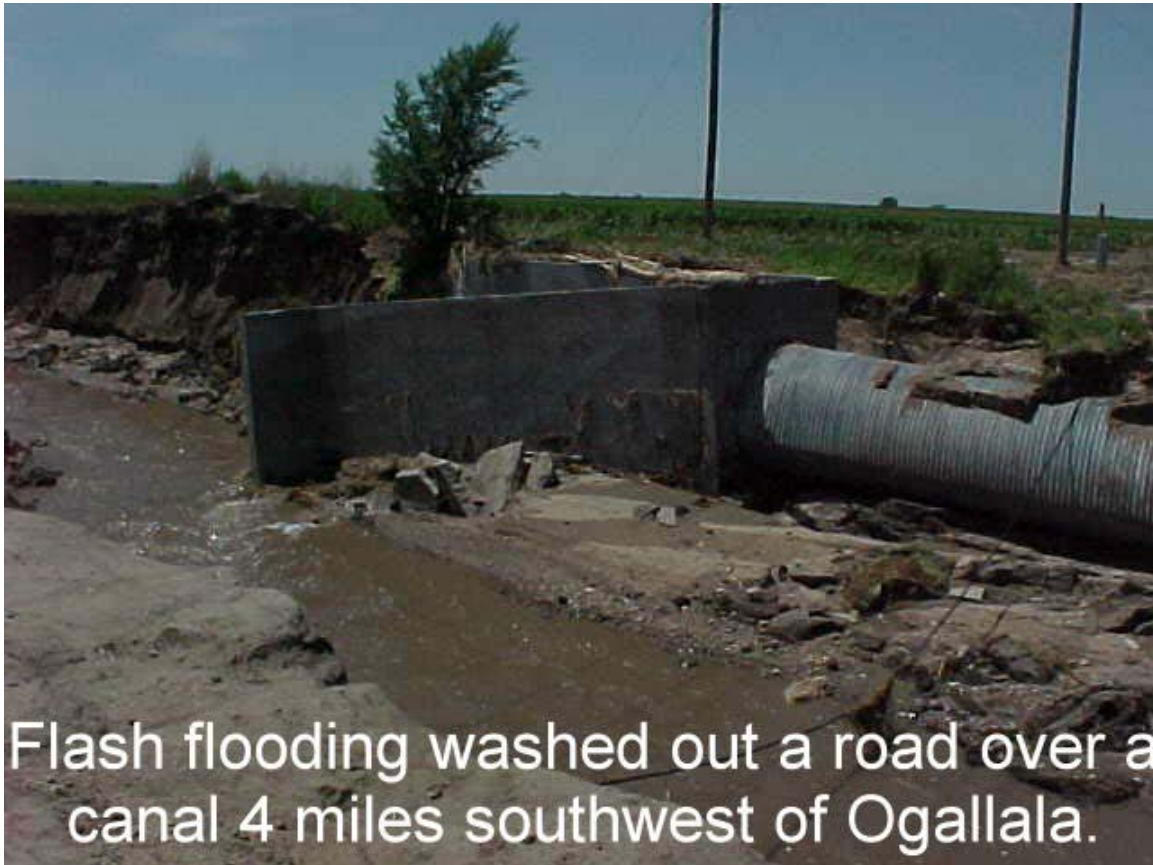
Flash flooding washed out a road over a canal 4 miles southwest of Ogallala.
