# State of Colorado 2003 Flood Documentation Report

Vail, Colorado Flood of May 31st, 2003  
I-70 Drainage Culvert – Bighorn Creek Confluence with Gore Creek  
Photo Courtesy of Colorado Department of Transportation.

Prepared by:  
ICON Engineering, Inc  
8100 S. Akron St. Suite 300  
Centennial, CO 80112  
303-221-0802

## Vail, Colorado Flood of May 31<sup>st</sup>, 2003 I-70 Drainage Culvert – Bighorn Creek’s Confluence with Gore Creek (Eagle County, Colorado)

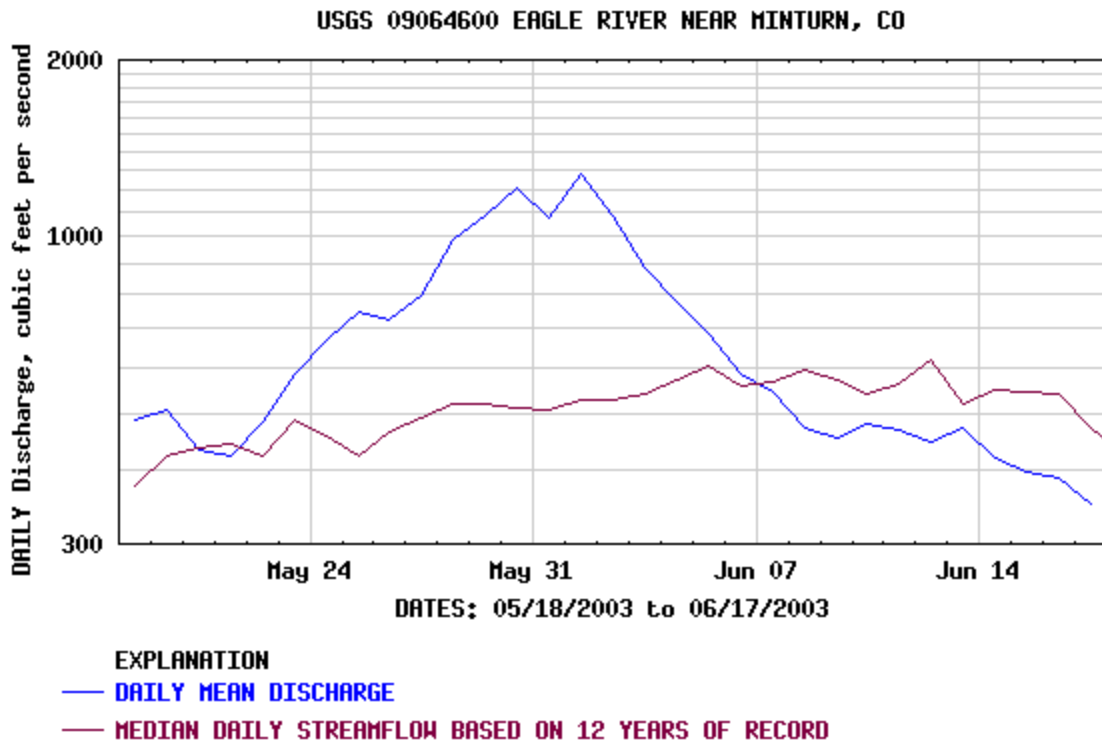
Figure 1.16 – Graph of Daily Discharge for USGS Flow Gage on Eagle River.

Based on the forgoing table, it is apparent that the peak flow was near the estimated 10-year event from the Flood Insurance Study. Additional flow gage data was available for creeks and rivers in the area. These gages did show a peak discharge occurring on the date of the storm and are included in the Additional Support Information section of this chapter for reference purposes only.

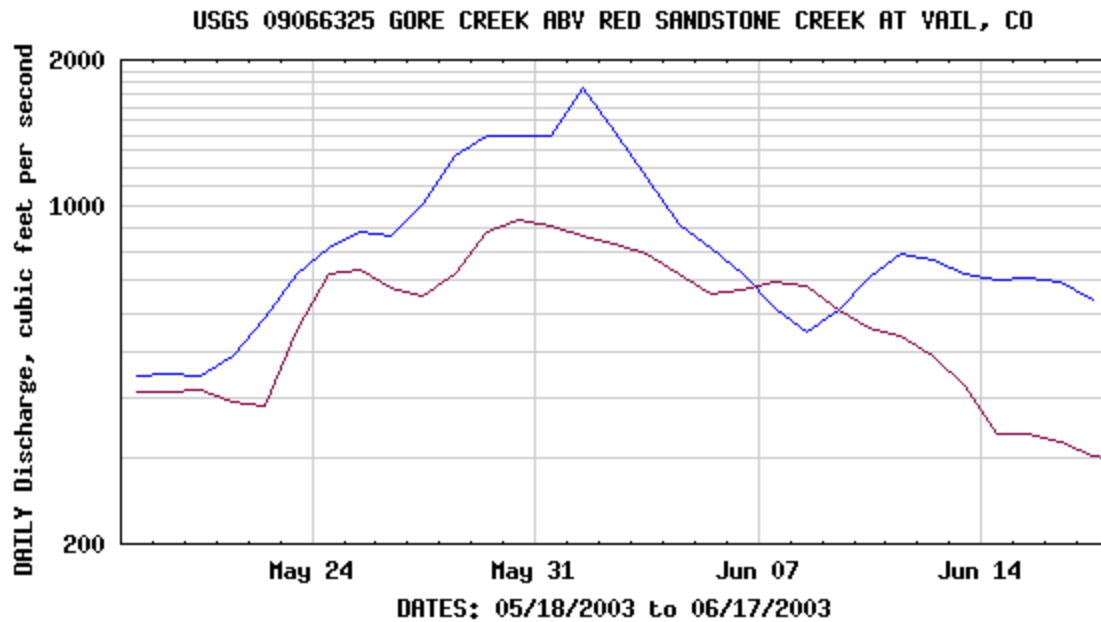
**EXPLANATION**  
 — **DAILY MEAN DISCHARGE**  
 — **MEDIAN DAILY STREAMFLOW BASED ON 2 YEARS OF RECORD**

Figure 1.19 – Graph of Daily Discharge for USGS Flow Gage on Gore Creek Above Red Sandstone Creek.

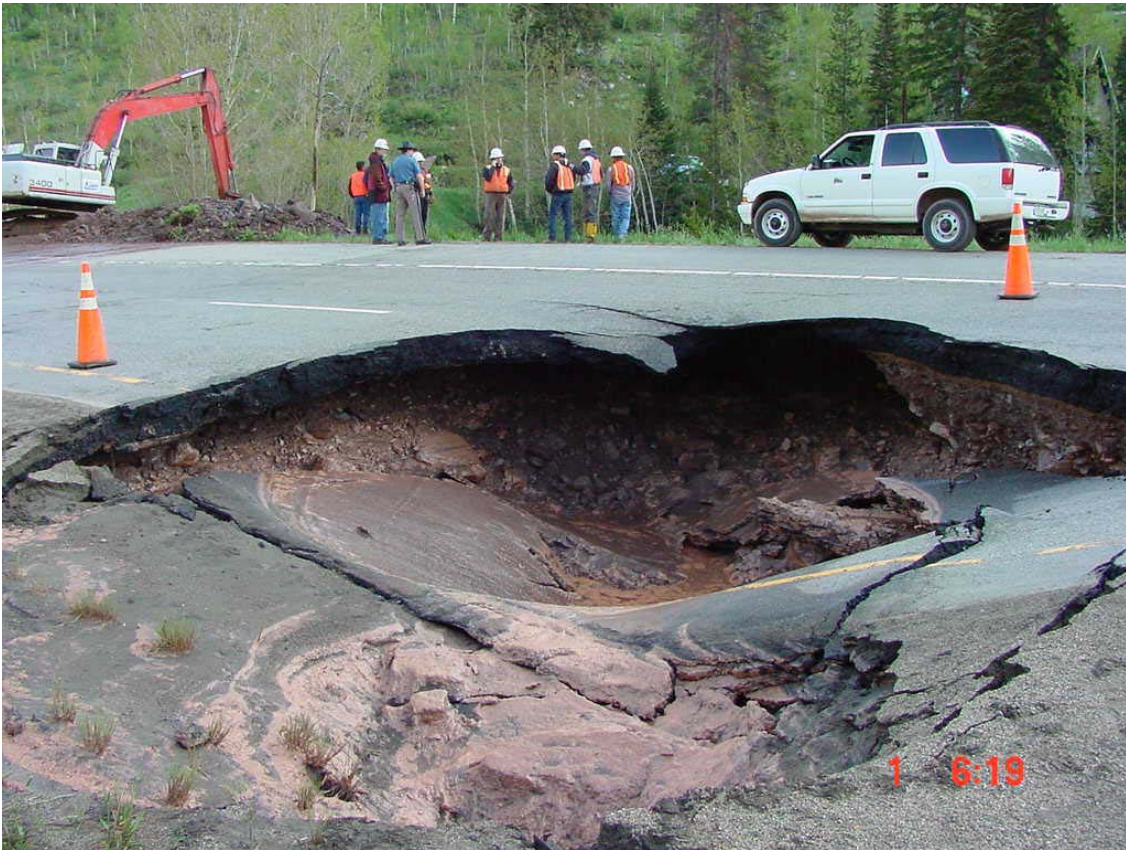
Several special factors were thought to have contributed to the effects of the flood. The major factor being the failure of a Corrugated Metal Pipe (CMP) that crosses under the interstate. This failure caused a 20 by 20-foot sinkhole to form under I-70 closing the interstate to all traffic for several days. The culvert failure also caused Bighorn Creek to leave its flow path inundating the eastern part of Vail. Once the culvert failed and water began to pool along I-70, the flow traveled northwest until it encountered the box culvert at the Columbine Street Underpass. The water traveled through the culvert and emptied into the East Vail neighborhood flowing through local streets and residences before finally emptying into Gore Creek once again.

**Figure 1.24 –Picture of Interstate 70 Sinkhole**  
Courtesy of Colorado Department of Transportation

A site visit was conducted on Tuesday June 19, 2003 by several ICON Engineering personnel. At that time, repair of the CMP was still actively underway. In fact, construction of the repairs continued on a 24-hour basis, seven days a week for a six week period. Enclosed with this report are several pictures of the area that was impacted by the flooding. The pictures are provided by the City of Vail, and by ICON Engineering as noted. Additional information was provided courtesy of CDOT.

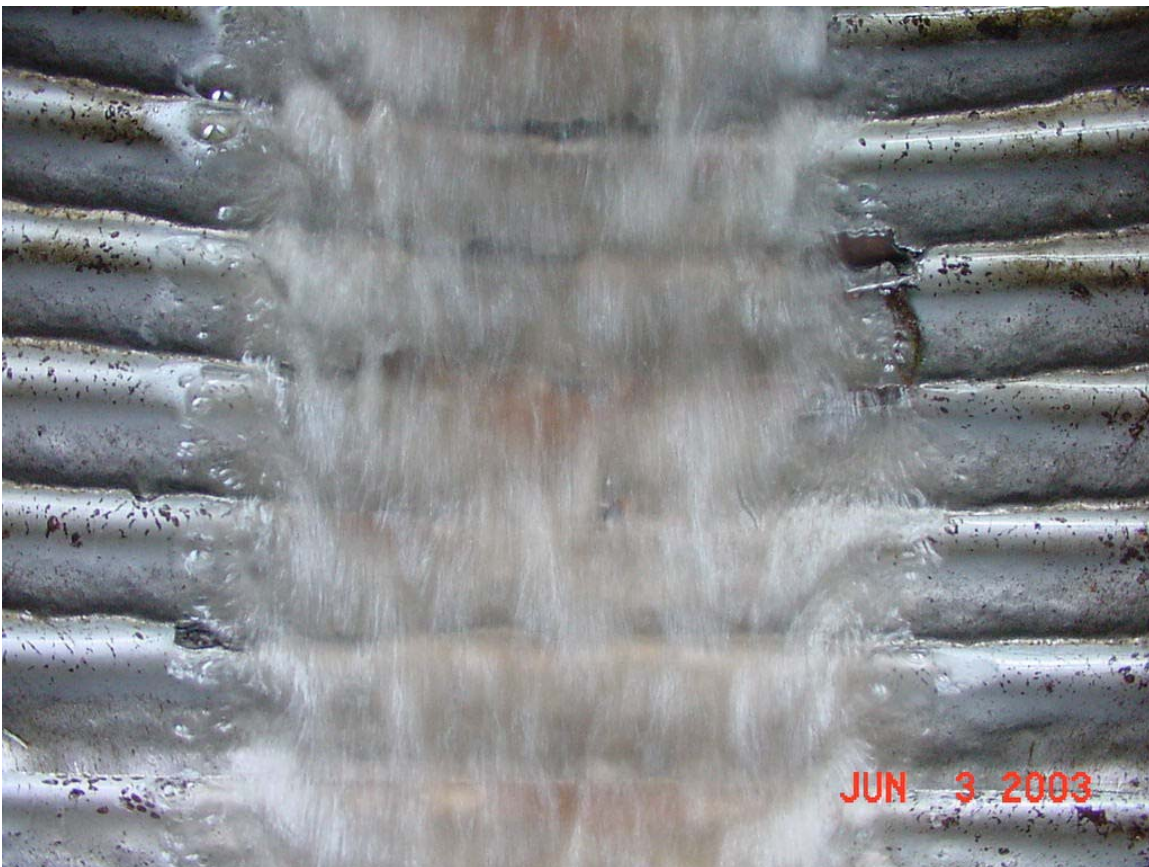
Based upon information provided by CDOT, and based upon the data provided by the USGS gage station on Bighorn Creek, it is apparent that the design capacity of the culvert under I-70 was not exceeded. Rather, it is believed that abrasion and corrosion occurred in the pipe invert, resulting from potentially years of high flow velocities coupled with high sediment bed load. It is further believed that a grade break in the pipe slope may have contributed to failure at a pipe joint. The original pipe was a 66-inch CMP laid at a slope varying from 8% to 15%. Bury depth of the pipe was approximately 40-feet deep. It is believed that the pipe invert buckled upwards, allowing flows along the outside of the pipe, which washed away soil supporting the pipe, creating the sinkhole.

**Figure 1.25 –Picture of Corrugated Metal Pipe Degradation at I-70 Culvert**  
Courtesy of Colorado Department of Transportation

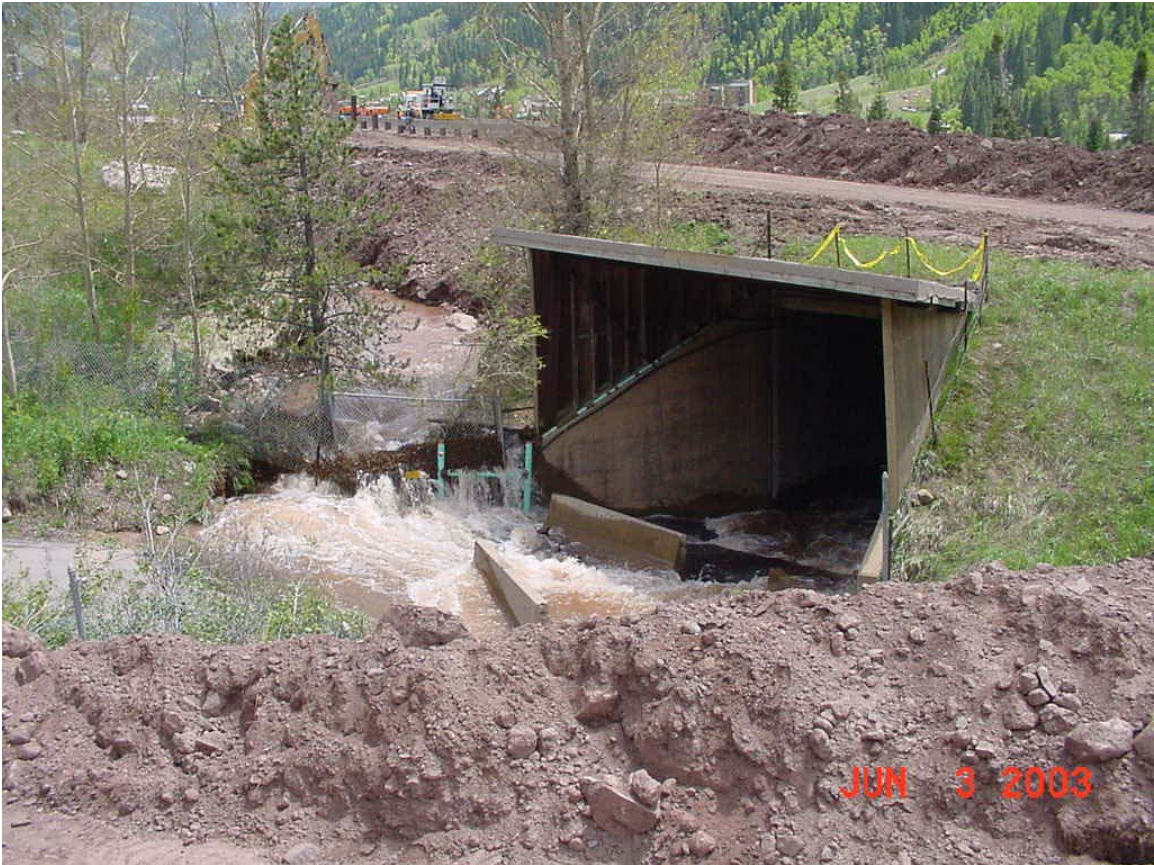
**Figure 1.26 –Picture of Culvert at Columbine Drive Underpass**  
Courtesy of Colorado Department of Transportation

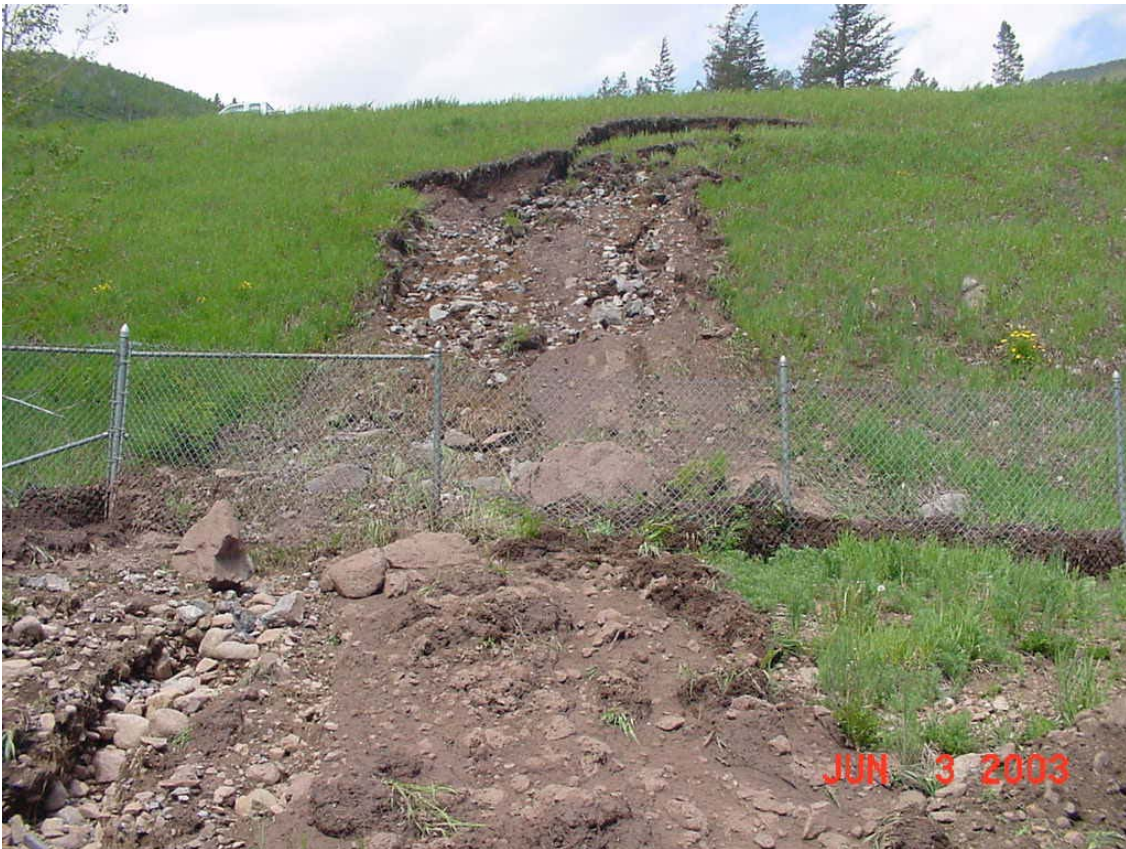
**Figure 1.27 –Picture of Hillside Erosion Along I-70 at Mile Marker 181**  
Courtesy of Colorado Department of Transportation

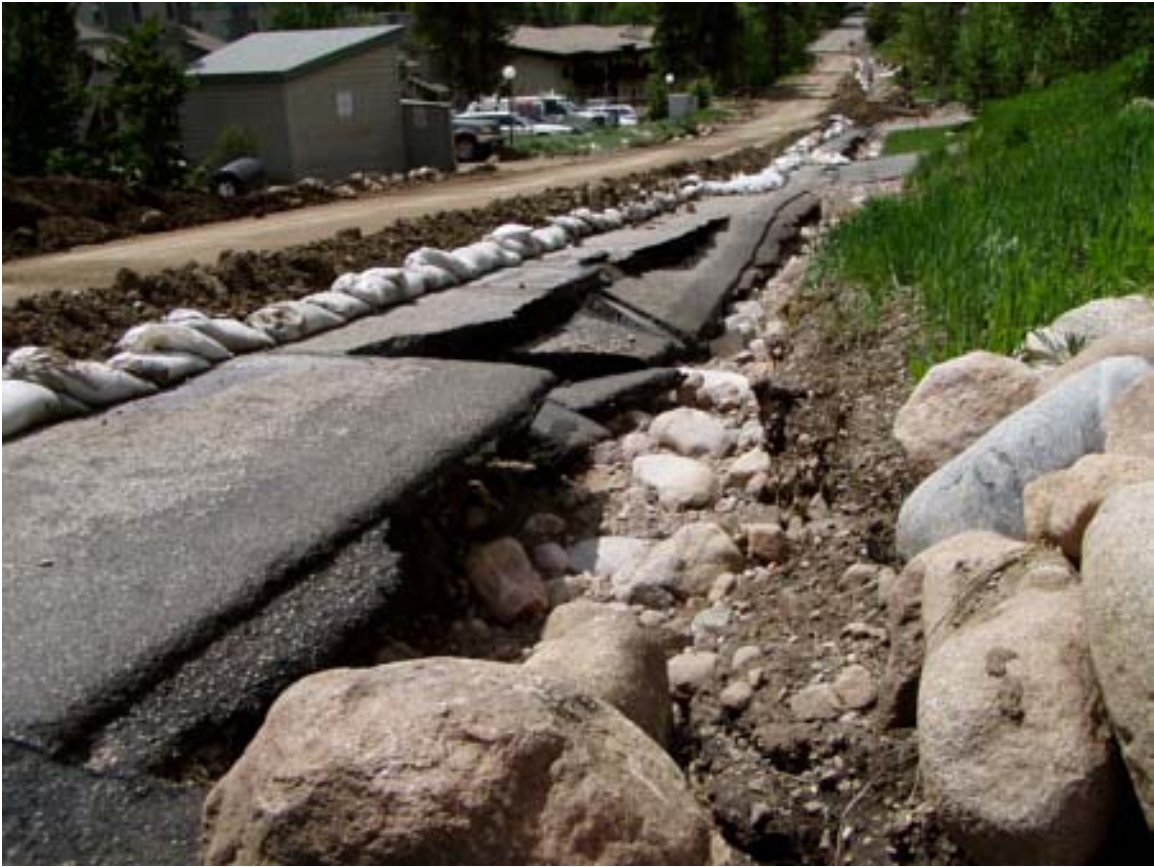
**Figure 1.27 –Picture of Spruce Way Looking West after the Storm**  
Courtesy of Town of Vail

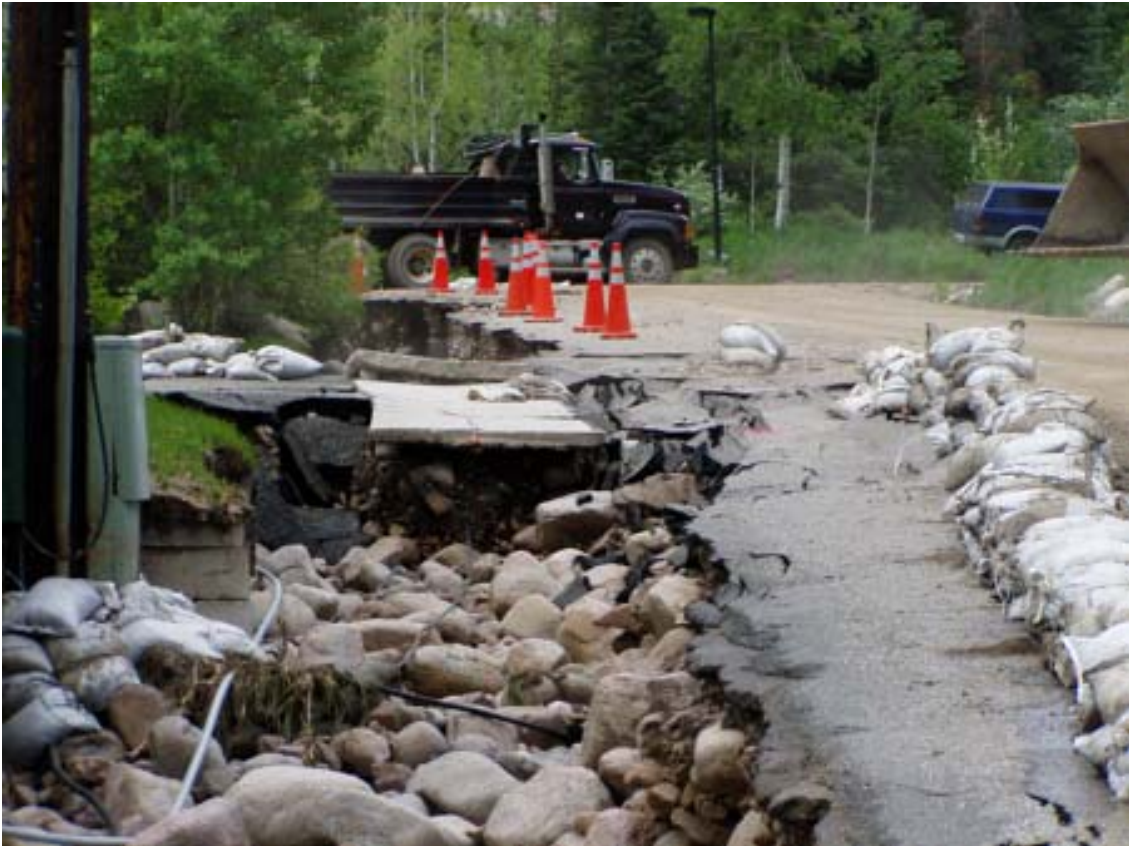
**Figure 1.28 –Picture of Damage to Columbine Drive**  
Courtesy of Town of Vail

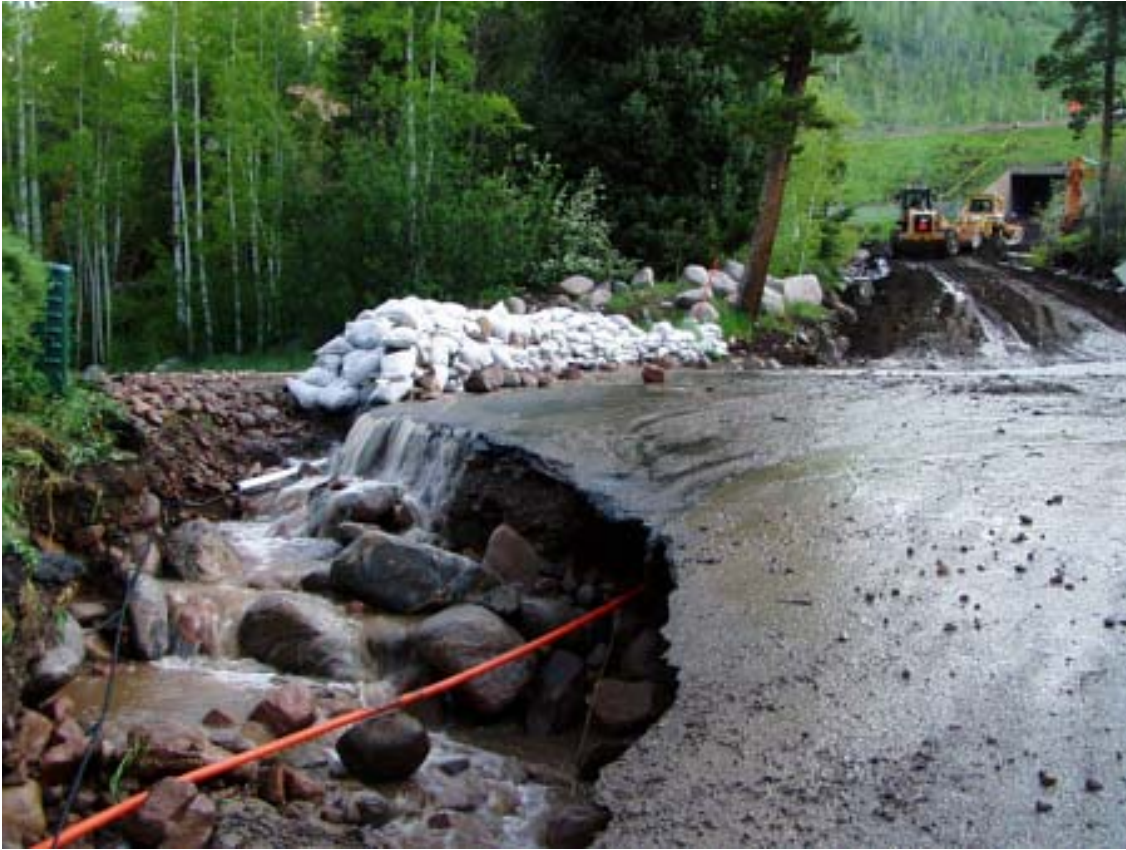
**Figure 1.29 –Picture of Damage to Columbine Drive below Interstate 70**  
Courtesy of Town of Vail

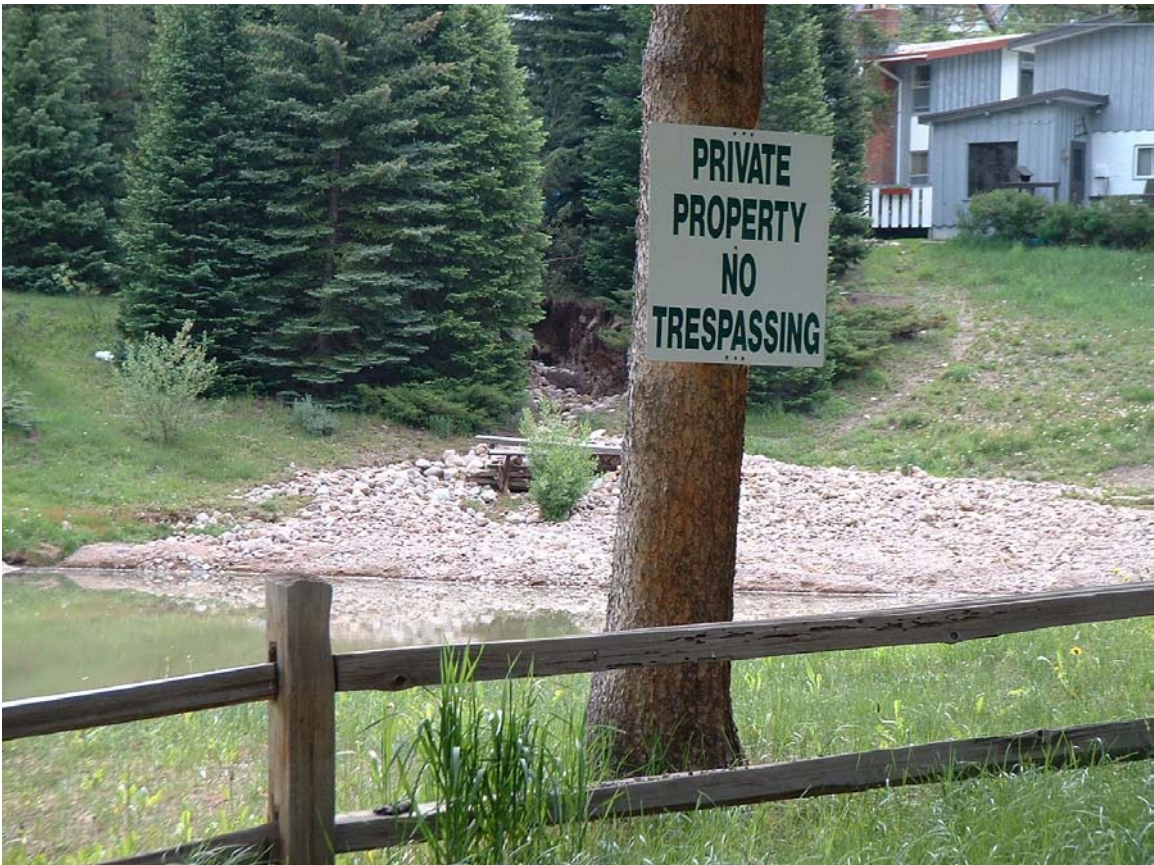
**Figure 1.30 –Picture of Debris Pile at Pond near Columbine Drive after the Storm**  
Courtesy of Site Visit by ICON Engineering, Inc.

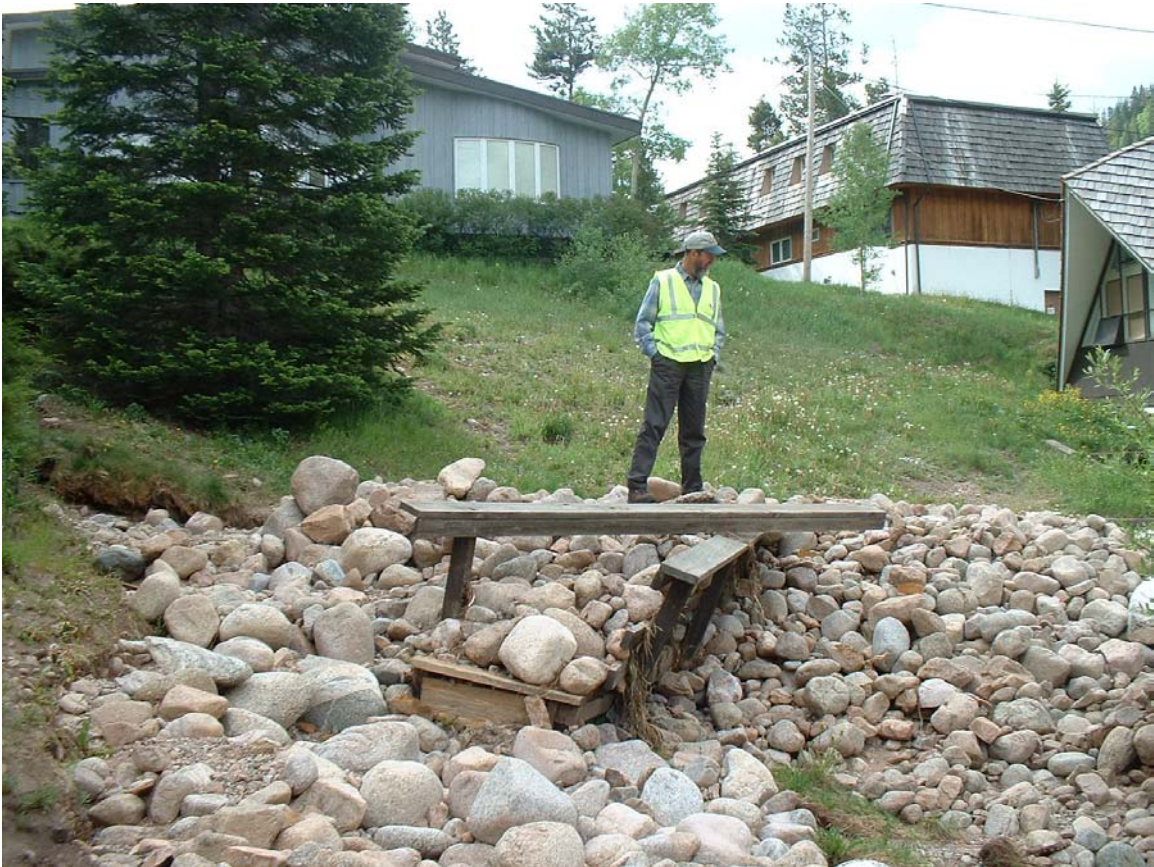
**Figure 1.31 –Close-up Picture of Debris Pile at Pond near Columbine Drive**  
Courtesy of Site Visit by ICON Engineering, Inc.

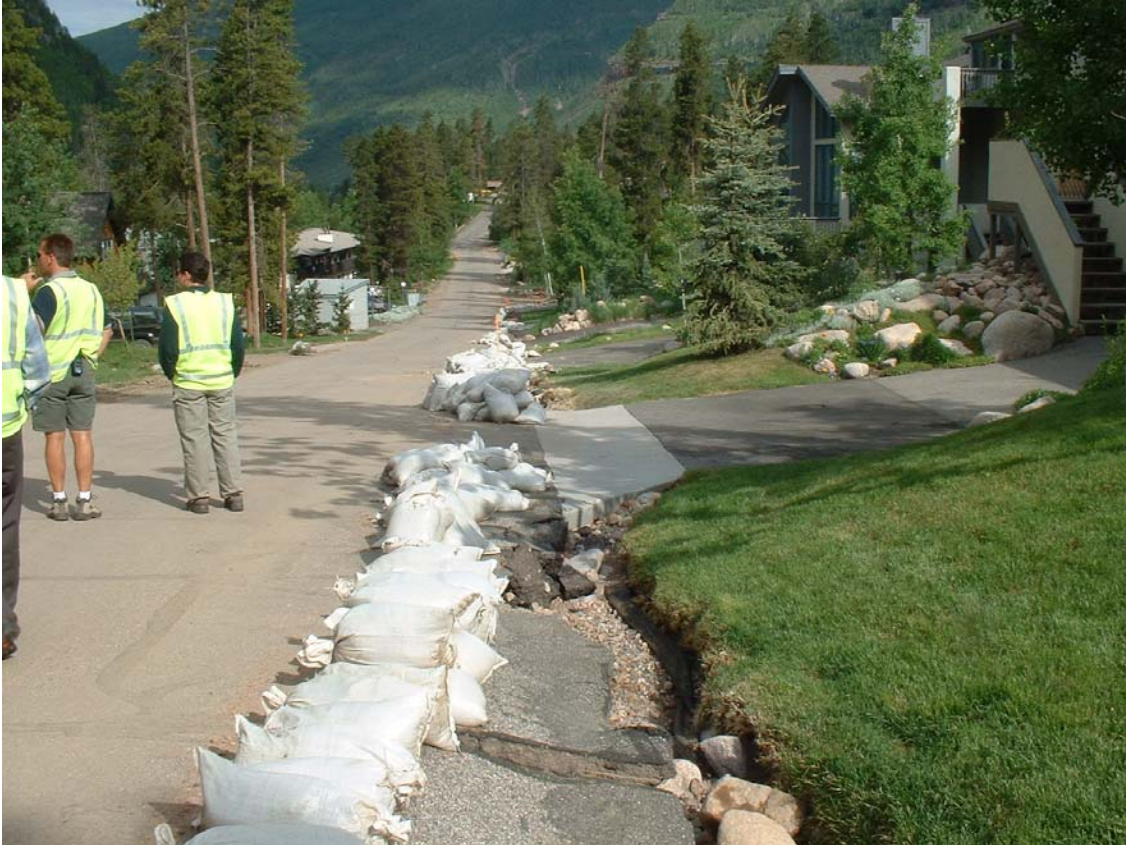
**Figure 1.31 – Picture of Erosion Damage to Spruce Way**  
Courtesy of Site Visit by ICON Engineering, Inc.

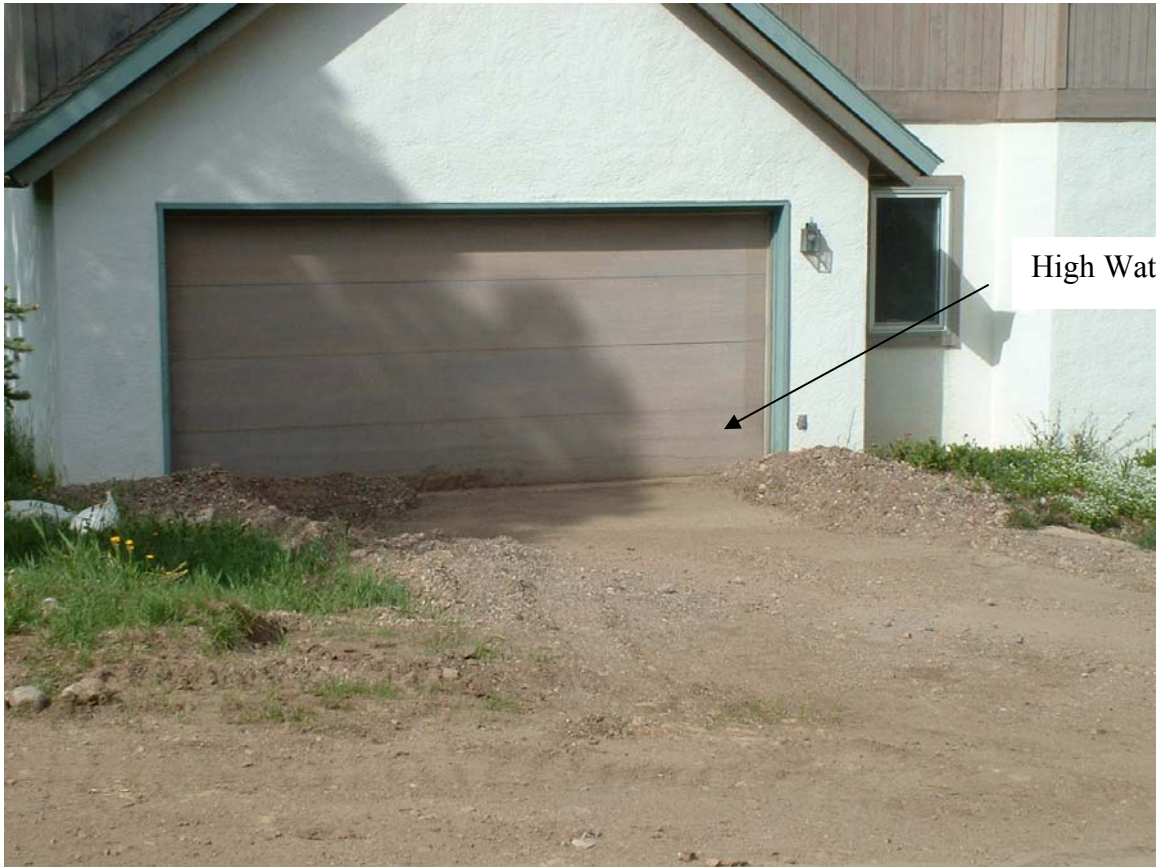
**Figure 1.31 – Picture of Debris Piles and High Water Mark on Residence along Spruce Way**  
Courtesy of Site Visit by ICON Engineering, Inc.
