**SUMMARY OF  
BUILDING EXCELLENT SCHOOLS TODAY (BEST)  
FY2012-13 GRANT APPLICATIONS  
RECEIVED ON MARCH 2, 2012**

DIVISION OF PUBLIC SCHOOL  
CAPITAL CONSTRUCTION ASSISTANCE

MAY 2012

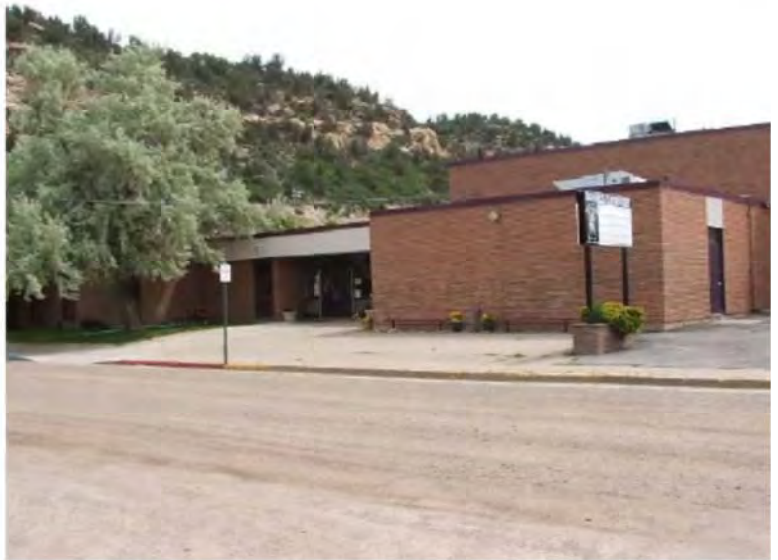
**School Name: Dolores ES**

Q#: 16.2 - Is the bus loading and unloading zone and parent drop-off - pickup area separated from other vehicle and pedestrian traffic? The AM drop off area is in the on street parking and parent drop off area. Score: 3

Q#: 17.4 - Is the parent drop off and pickup area separated from bus loading and unloading Parent drop off in front of ES is good, but bus unloading in AM is on a different street with MS and HS-related traffic. Score: 5

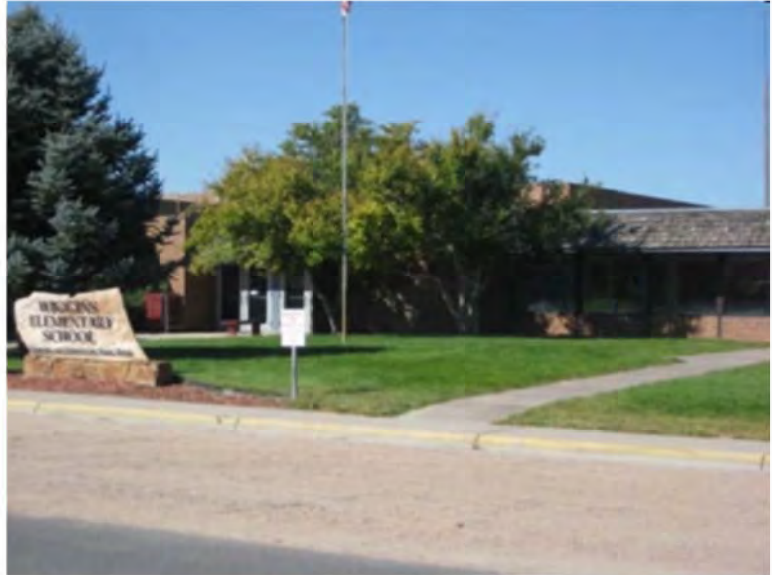
**School Name: Wiggins ES**

Q#: 110.4 - What is the condition of the roof covering? The roof is in poor condition. Score: 2

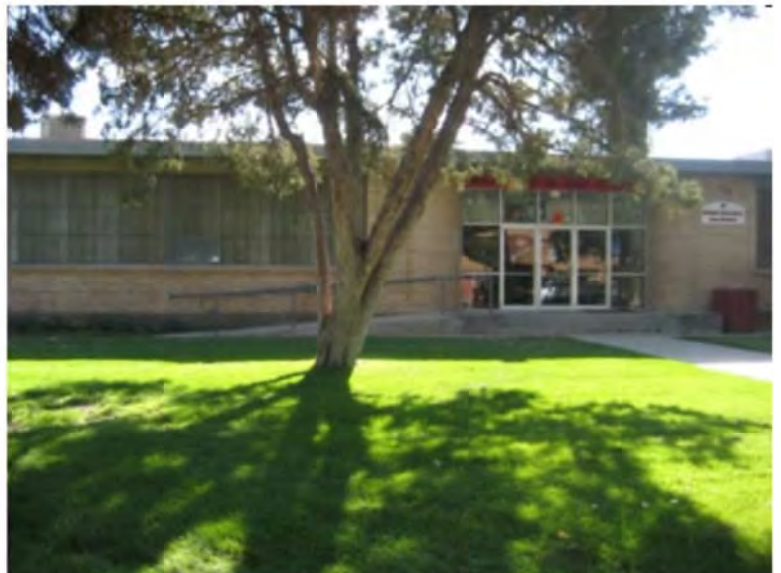
**School Name: Wiggins HS**

Q#: 110.4 - What is the condition of the roof covering? The roof is in poor condition and should be scheduled for complete replacement. Score: 1

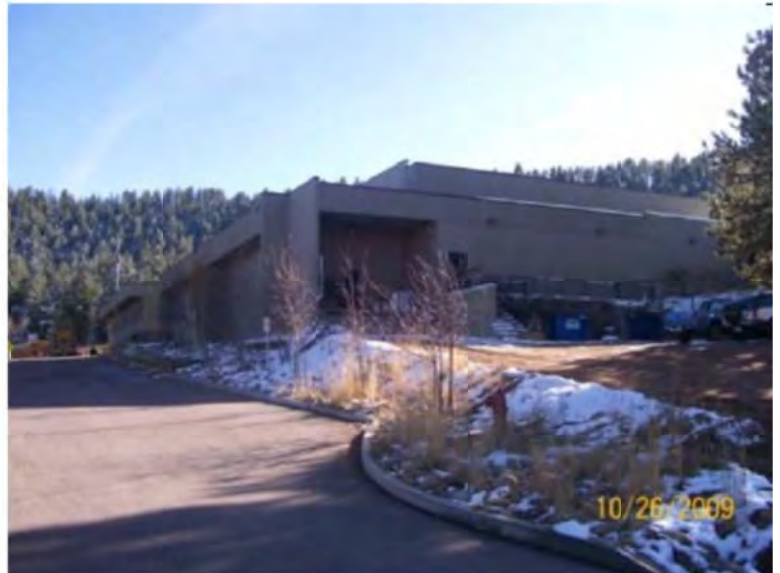
**School Name: Deer Creek ES**

Q#: 110.4 - What is the condition of the roof covering? The roof is in good condition. Score: 4
