# **STREAM HABITAT INVESTIGATIONS AND ASSISTANCE PROJECT SUMMARY**

2024 Progress Report

Colorado Parks & Wildlife

September 2024

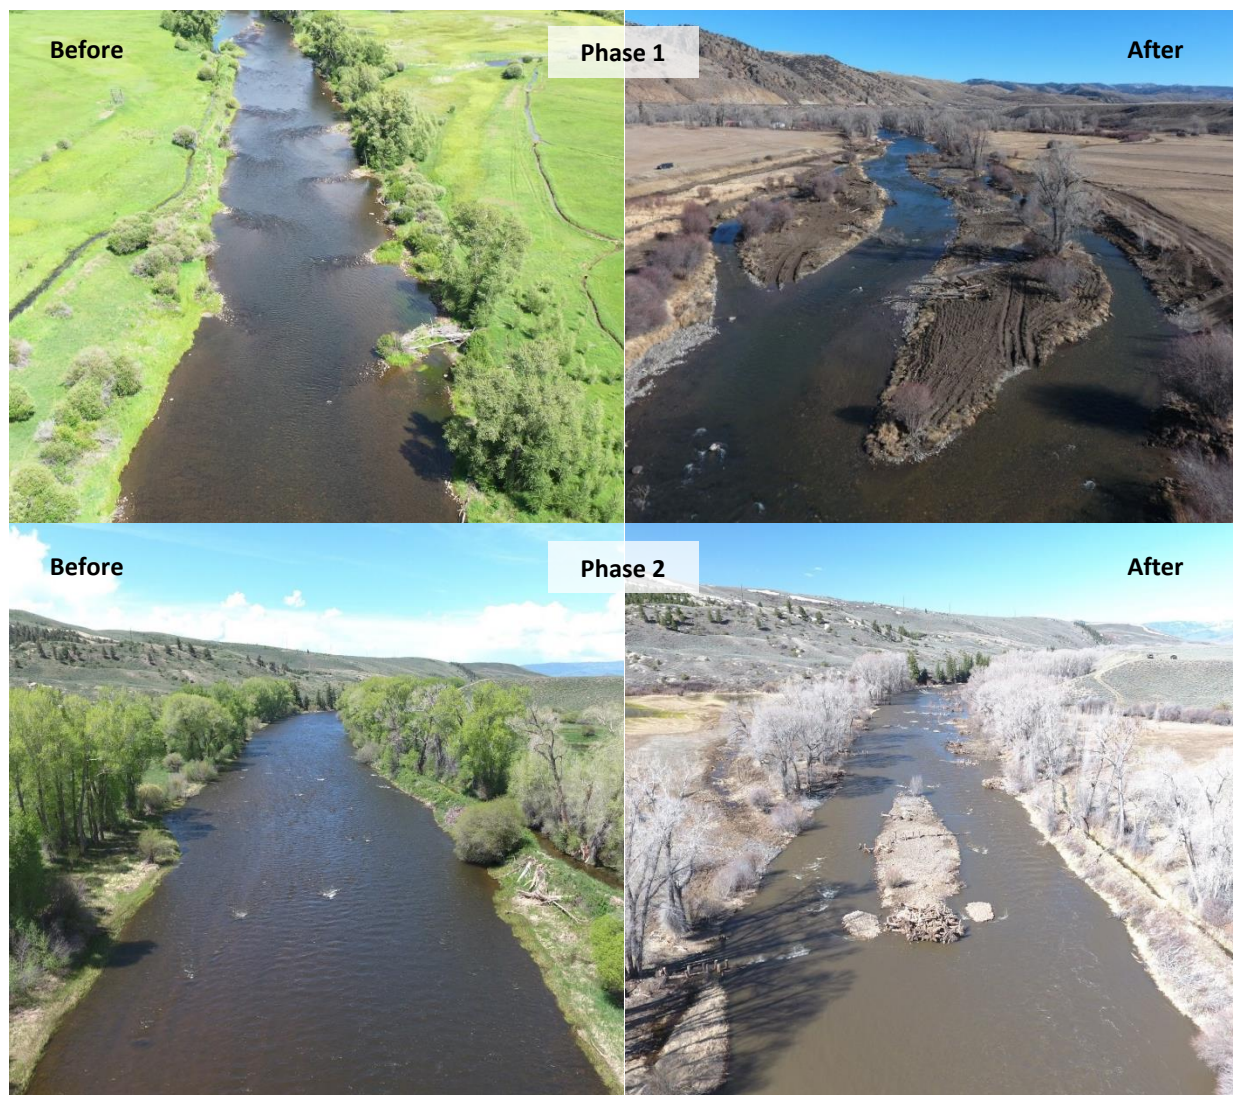
**Figure 1.** Before and after photographs for the Kemp-Breeze SWA Habitat Project on the Colorado River.

Phase 2 of the project was constructed during August-December 2023, focusing on the downstream half of project reach. Major activities included mass grading to narrow the channel and create a new floodplain bench, installation of log-jam structures, vegetation transplants, and gravel augmentation. Changes in channel and floodplain morphology are depicted in Figure 1. Although fill material had been stockpiled prior to construction, the amount of fill proved insufficient to meet design elevations for the large floodplain area on river right. As such, this new floodplain bench was left 1 ft lower than design elevations in many locations. Floodplain jams, vegetation transplants, brush trenches, and topographic complexity were utilized to provide stability and induce sediment deposition. Similar to Phase 1, the use of piles to anchor the log jams proved challenging, as the depth to bedrock was shallower than anticipated. All of the in-channel jams had to be relocated to the stream bank or floodplain, and alluvial sediment was used to provide

additional ballast for floodplain and bank jams. Willow staking and restoration of access roads were completed in the spring of 2024 prior to snowmelt runoff. Planting, seeding, and mulching were then conducted after runoff in summer and fall of 2024.

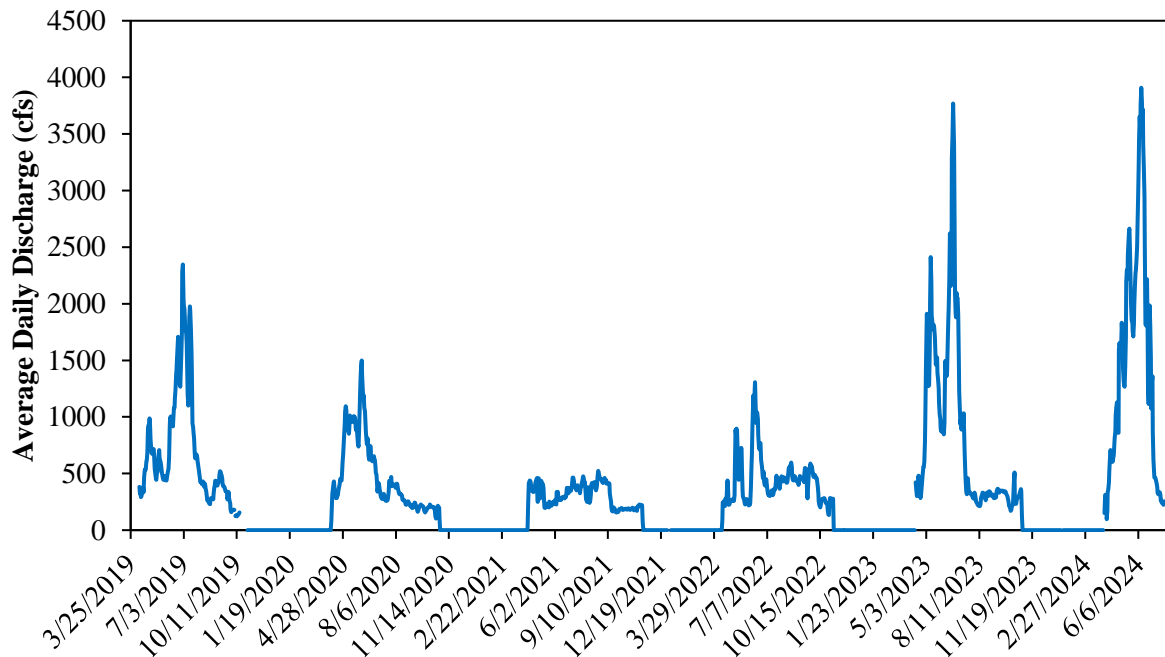
**Figure 2.** Average daily discharge (cfs) at the Kemp-Breeze SWA project site on the Colorado River, 2019-2024.

logs without rootwads, 173 logs with rootwads, and 21 cottonwood trees were used in construction of the log jams. All but one of the structures was considered stable and intact during the as-built assessments. Flows were higher than average in 2023, peaking around 3,800 cfs (Figure 2) and inundating the newly constructed islands and floodplains (Figure 3). Some bank erosion was evident after the 6.5-year flood event, and 15% of the structures in the Phase 1 reach were damaged during runoff in 2023. However, all structures were still considered functional and only one structure was identified for maintenance. Additional piles were installed at the damaged bar-apex jam in the fall of 2023 to address the maintenance concerns.

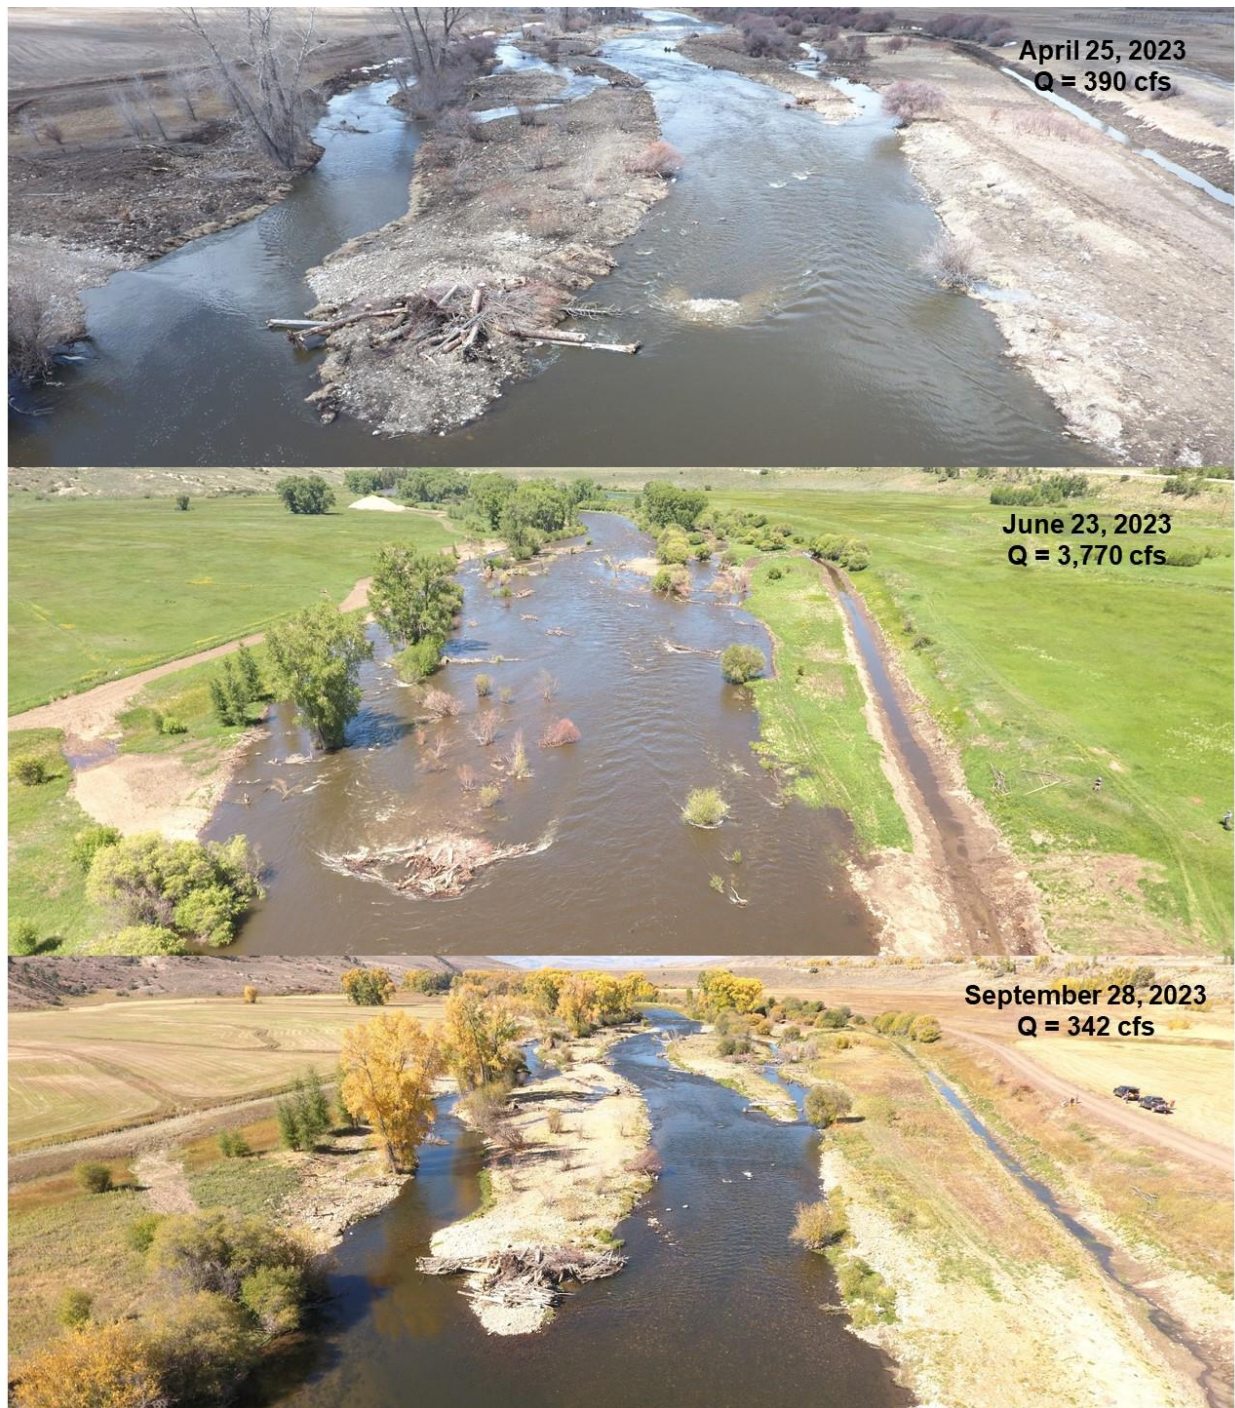
**Figure 3.** Time series of photos from the Kemp-Breeze SWA Habitat Project on the Colorado River showing flooding of newly constructed islands and side channels in 2023.

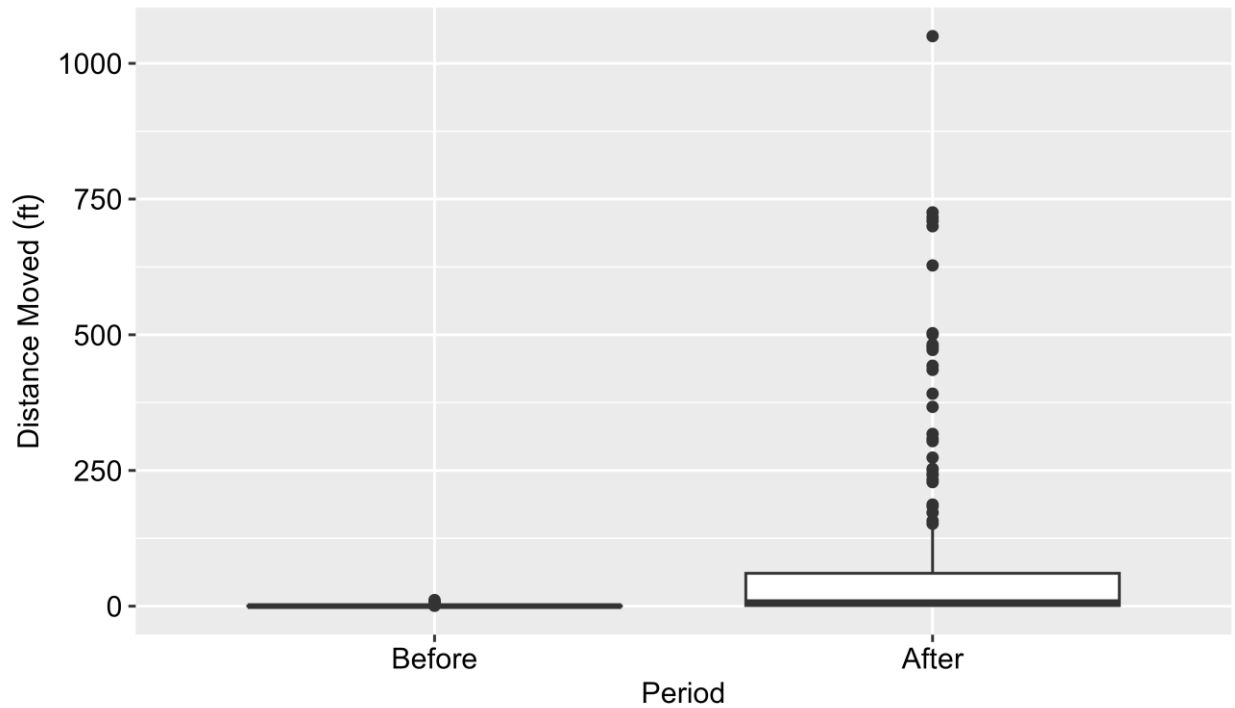
**Figure 4.** Boxplots for distance moved by tracer rocks during the before (2019-2021) and after periods (2023).

The relocation rate for tracer rocks during the before period was very high (99%), but we were only able to relocate 70% of the tracer rocks in 2023 due the greater distances moved. We utilized a raft-based antenna to survey the entire river channel and then investigated each detection with backpack antennas. The revised relocation methods increased the number of tags we detected but also the amount of effort. Results from pebble counts, longitudinal profiles, and tracer rocks all indicate that bedload transport occurred within the Phase 1 reach during 2023, which redistributed tracer rocks through the study sites (Figures 8 and 9). Tracer rocks will be relocated the fall of 2024 and additional rocks will be deployed at riffle 3 in the Phase 2 reach to support further analysis. At least three years of post-construction tracer rock surveys are planned to investigate sediment transport in the restored reaches over a range of flows. Final analyses will be performed following completion of the post-restoration monitoring period.

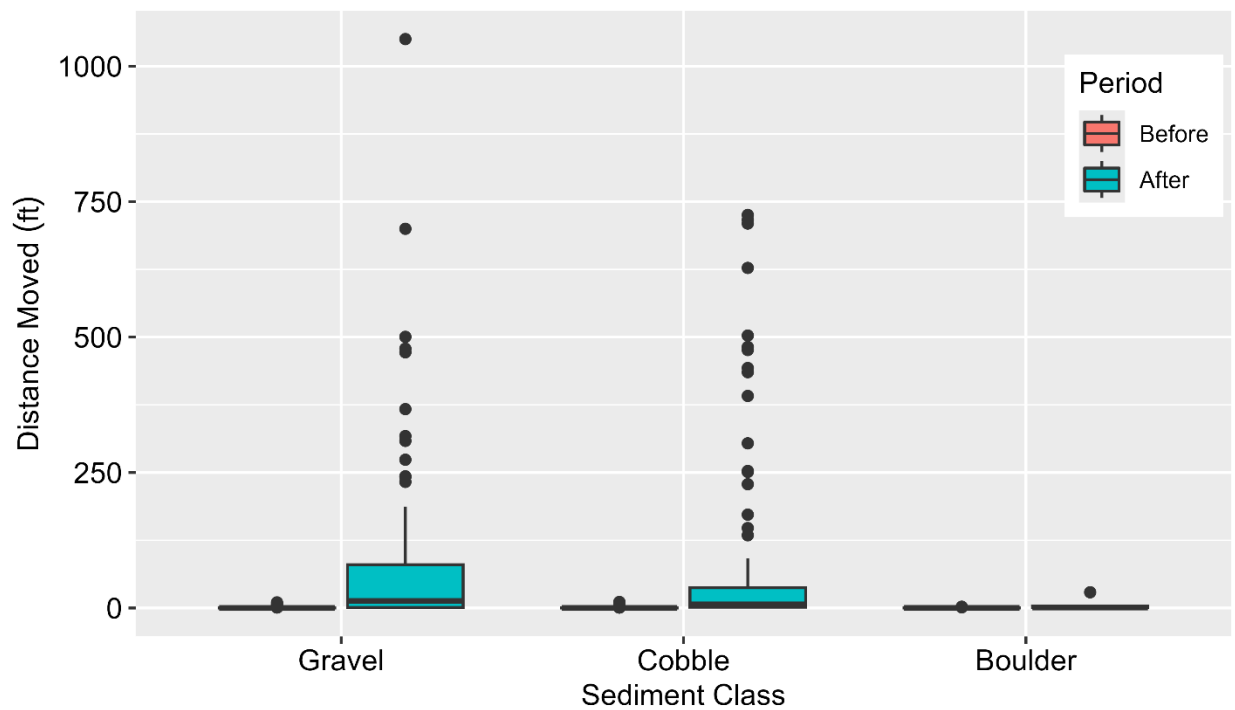
**Figure 5.** Boxplots by sediment size class for distance moved by tracer rocks during the before (2019-2021) and after periods (2023).

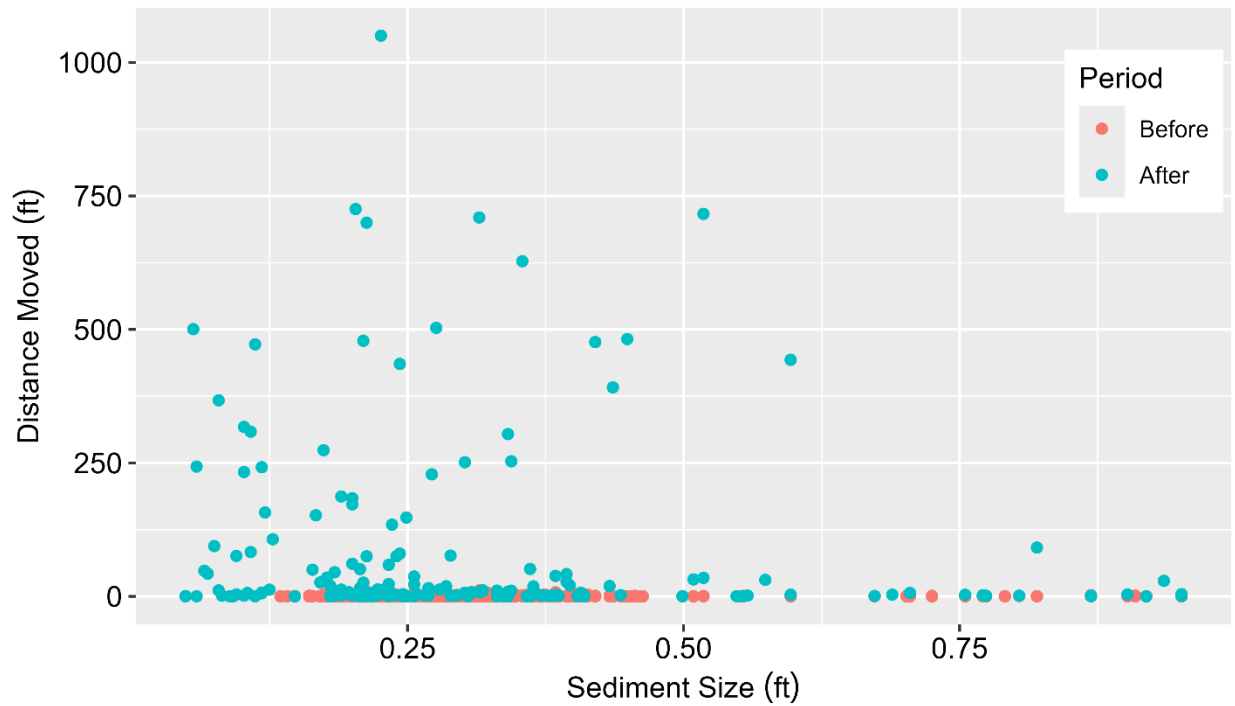
**Figure 6.** Comparison of sediment size and distance moved for tracer rocks that were relocated during the before (2019-2021) and after (2023) periods.

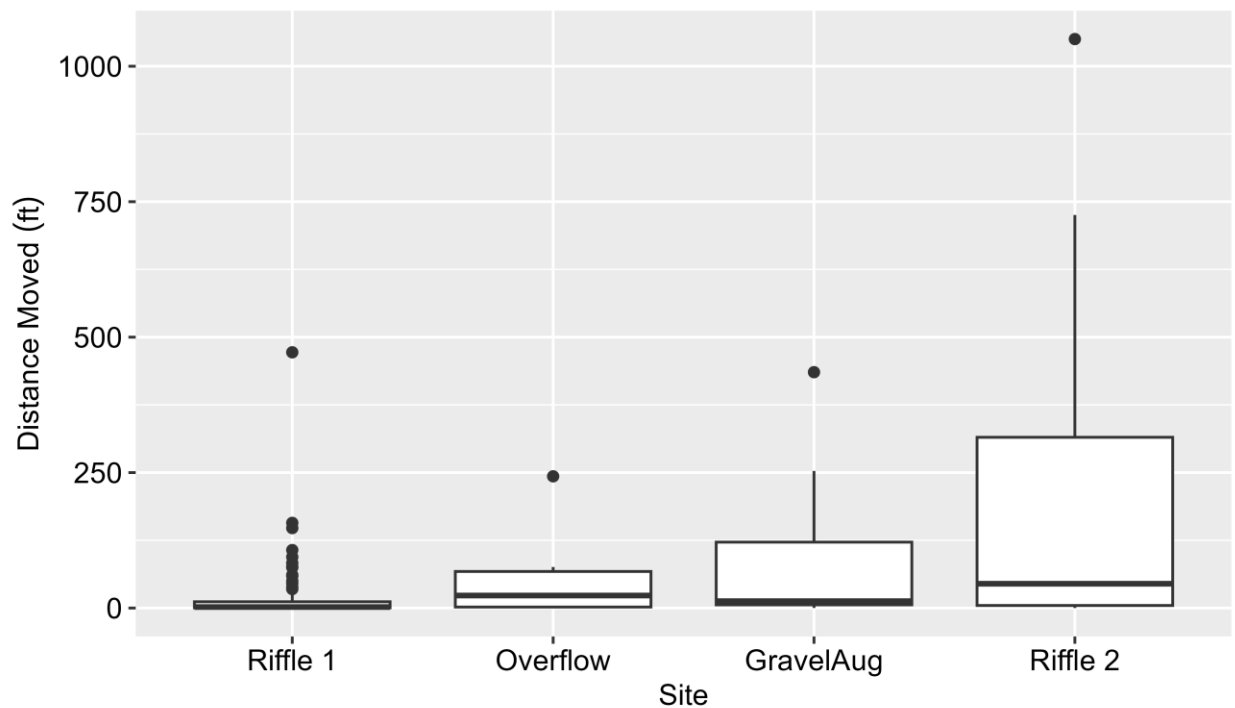
**Figure 7.** Distance moved by study site for tracer rocks that were relocated in 2023. Note that riffle 2 includes data from both riffles 2A and 2B.

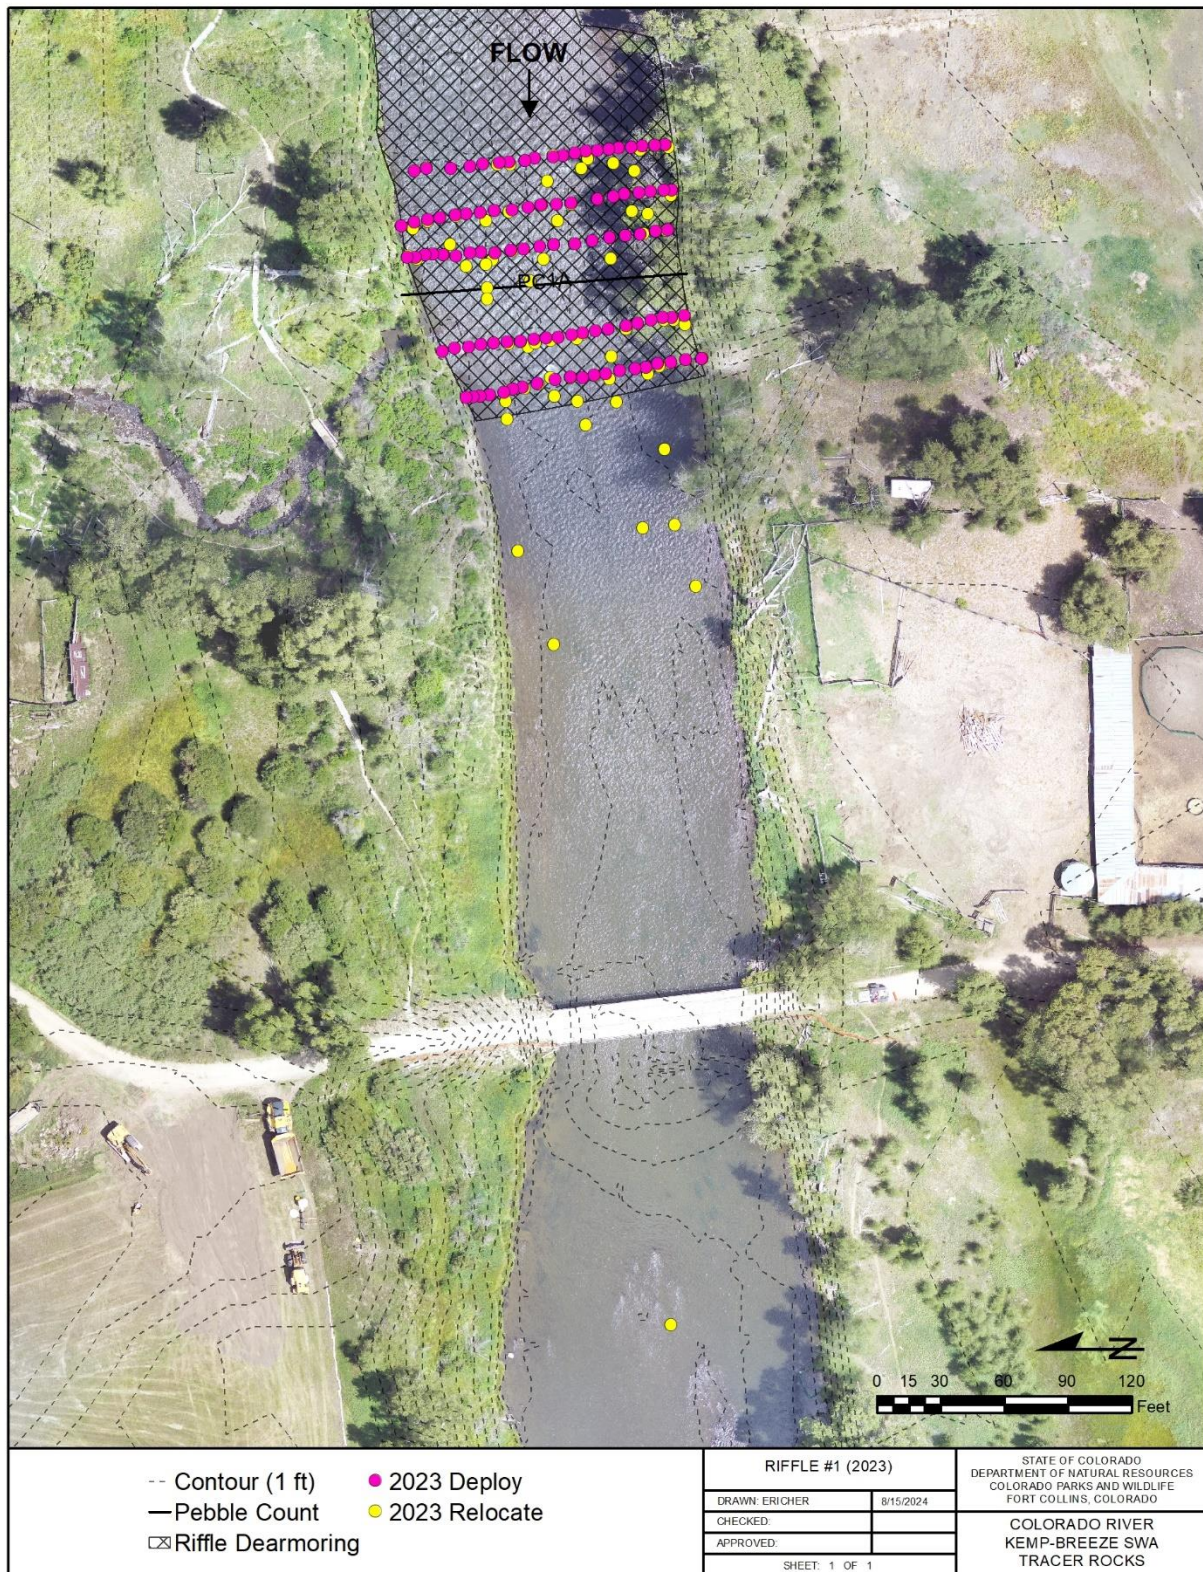
**Figure 8.** Tracer rock locations following deployment in April 2023 and relocation in October 2023 at an experimental location that was treated with riffle dearmoring (riffle 1).

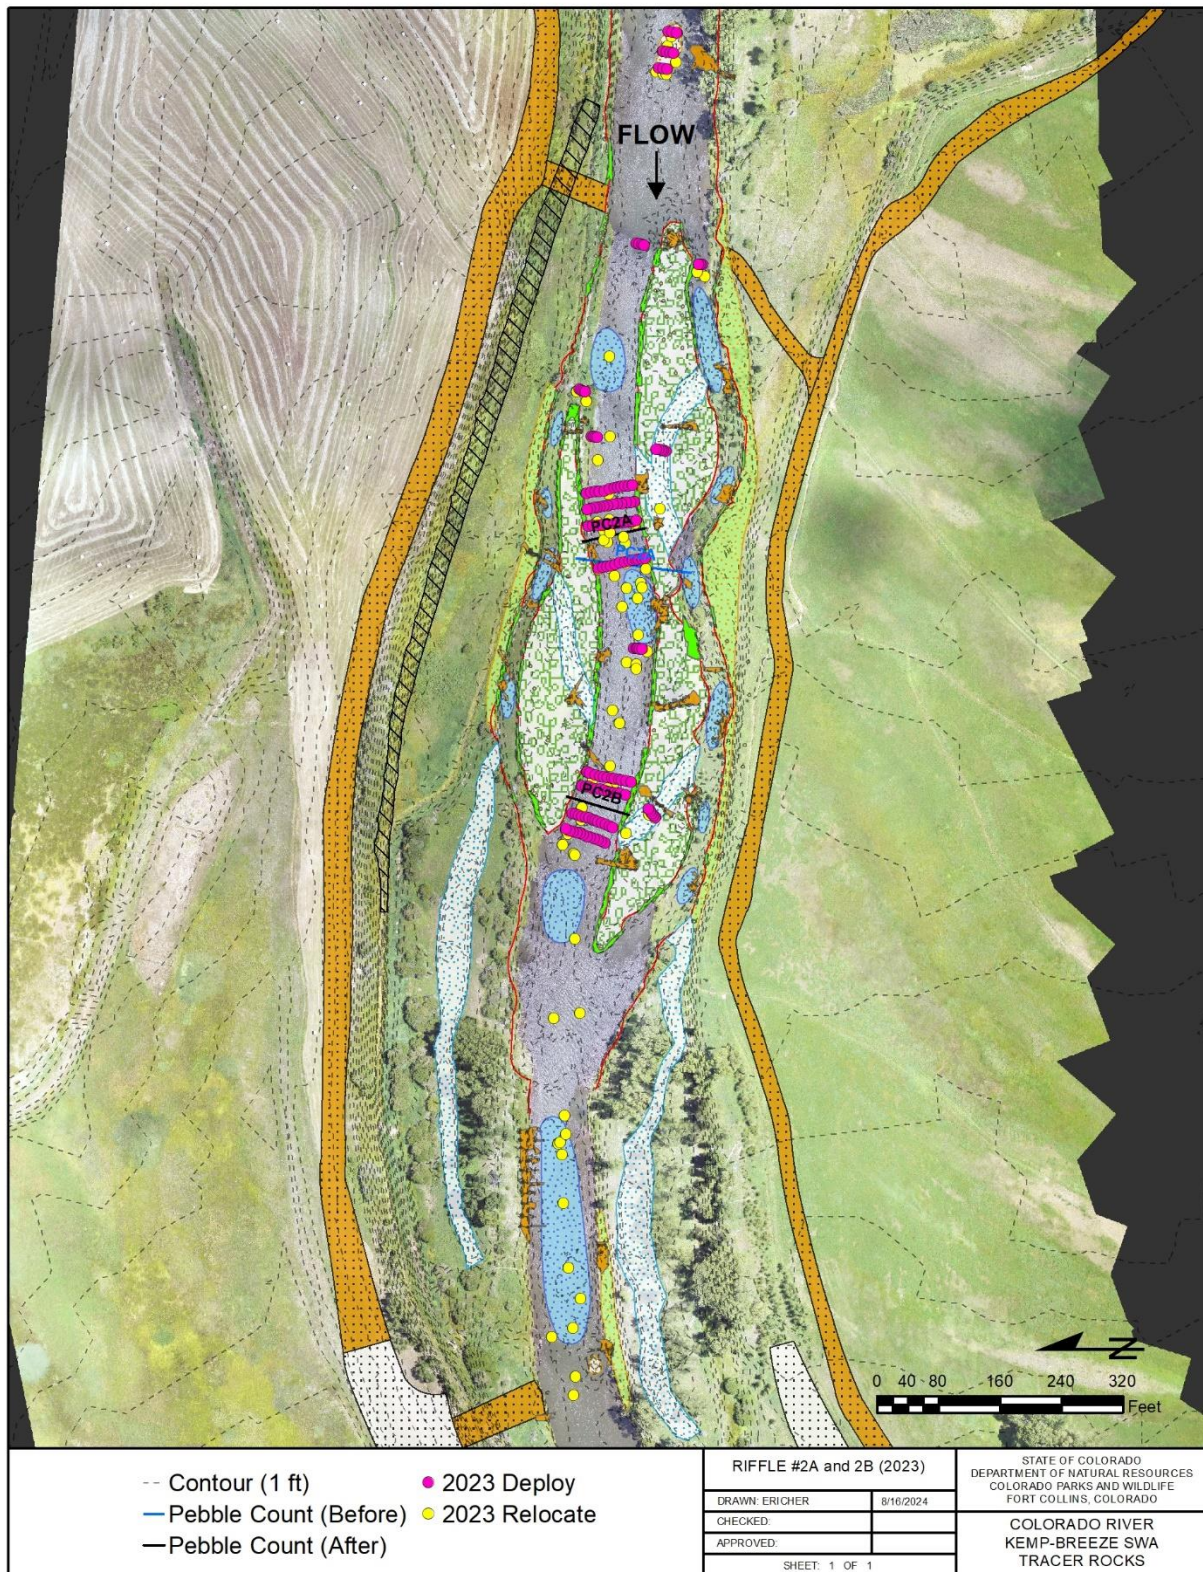
**Figure 9.** Tracer rock locations following deployment in April 2023 and relocation in October 2023 within the Phase 1 reach, including riffle, gravel augmentation, and overflow sites.

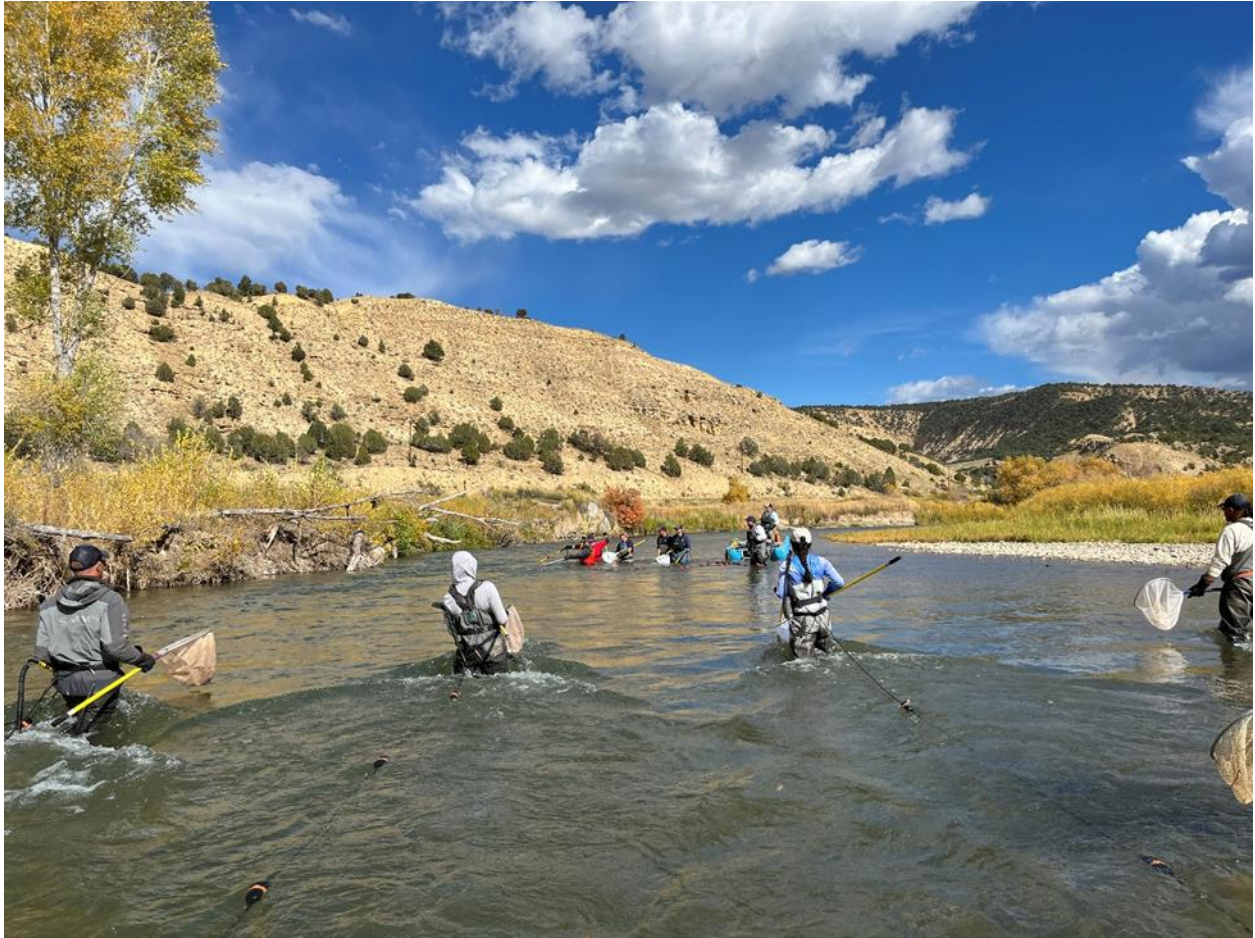
**Figure 13.** Collecting baseline fish population data in October 2023.

Baseline fish population (Figure 13), hydraulic, and geomorphic (Figure 14) monitoring of the treatment site and control site began in October 2023. We will conduct another round of baseline sampling during the fall of 2024. Upon completion of construction we plan to conduct the same sampling 1 year, 3 years, 5 years, and 10 years after construction is complete to monitor the fish community and geomorphic response through time.

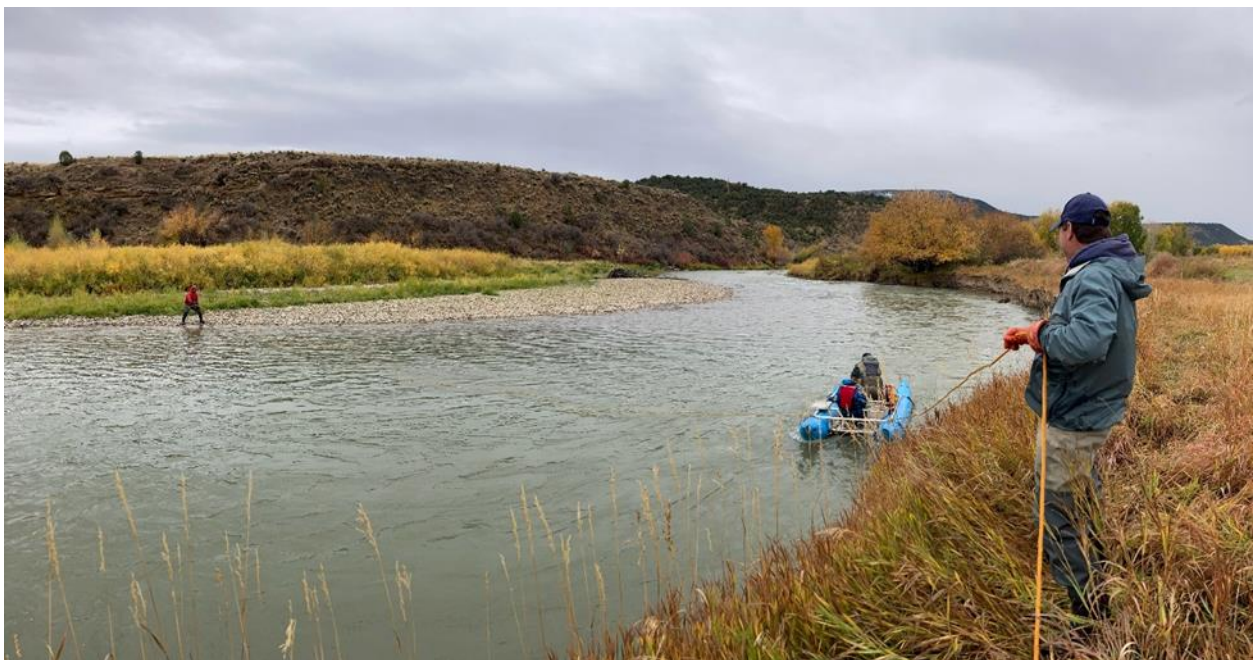
**Figure 14.** Collecting baseline geomorphic data in October 2023.

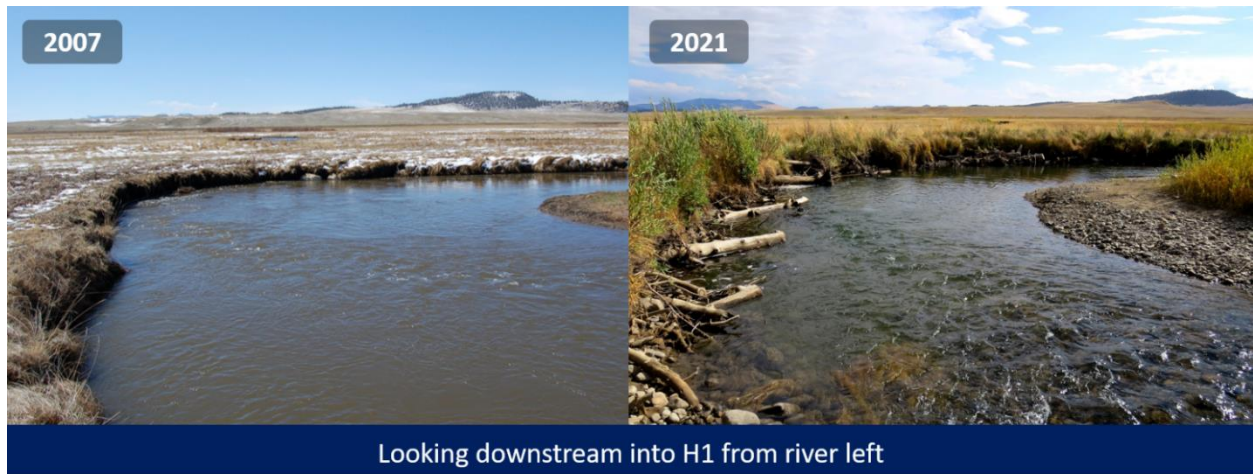
**Figure 15.** Photos showing riparian vegetation and bank conditions before (2007) and after (2021) construction at a haphazard toe wood-treated pool site. Note differences in deep-rooted willow abundance, large wood presence, and coarseness of sediments composing the streambed and point bar in before versus after photos.

Thousands of deep-rooted willows that were planted in the treatment reach have grown significantly and improved streamside shading by reducing the effect of solar radiation, thereby potentially decreasing stream temperatures (Figure 15).

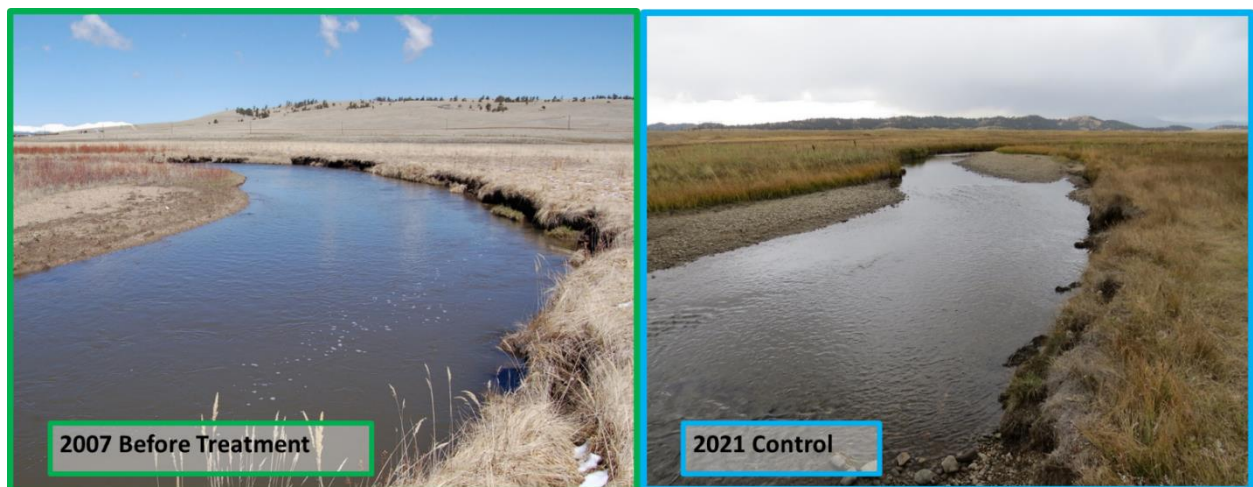
**Figure 16.** Representative photos from the before treatment project reach (left photo) and control reach (right photo) showing impaired stream and riparian habitat conditions. The control reach had many characteristics similar to before treatment (pretreatment) conditions found in the project reach including over-wide stream banks, active livestock grazing, accelerated bank erosion along outside bends, and a shallow-rooted, grass-dominated riparian community.

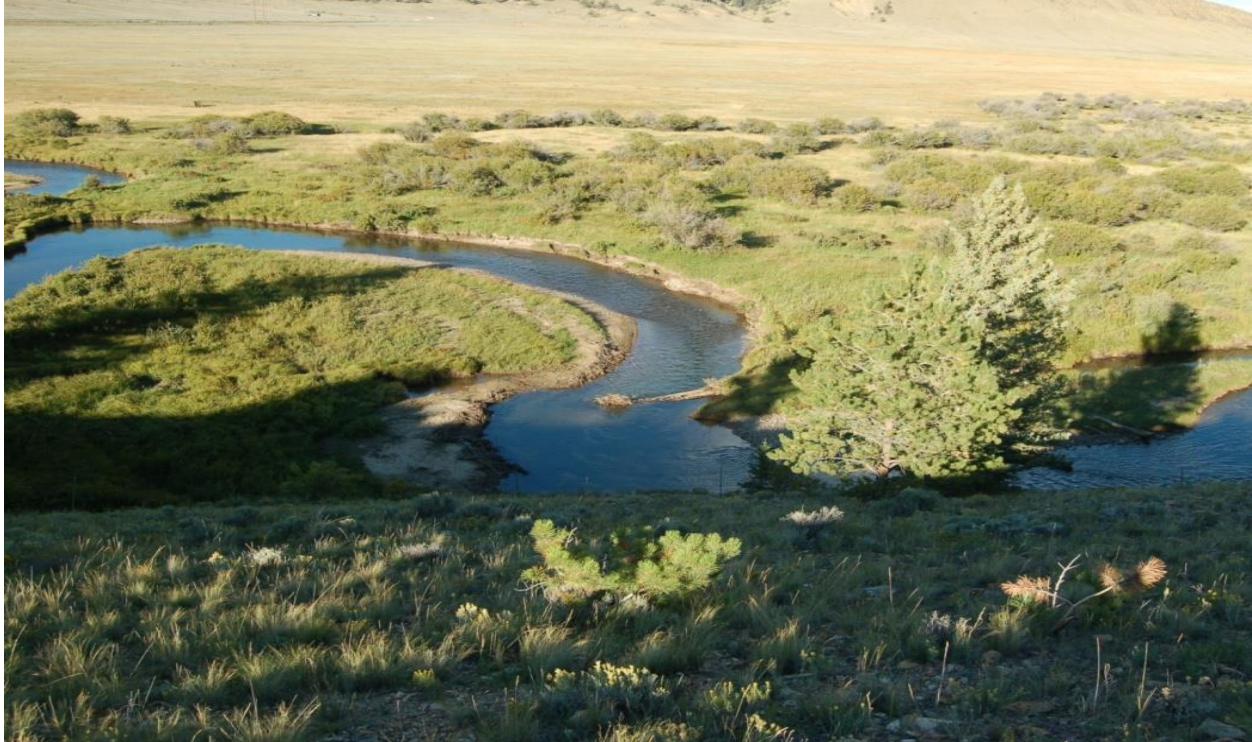
**Figure 17.** A representative photo from the reference reach showing the high-quality stream and riparian habitat conditions.

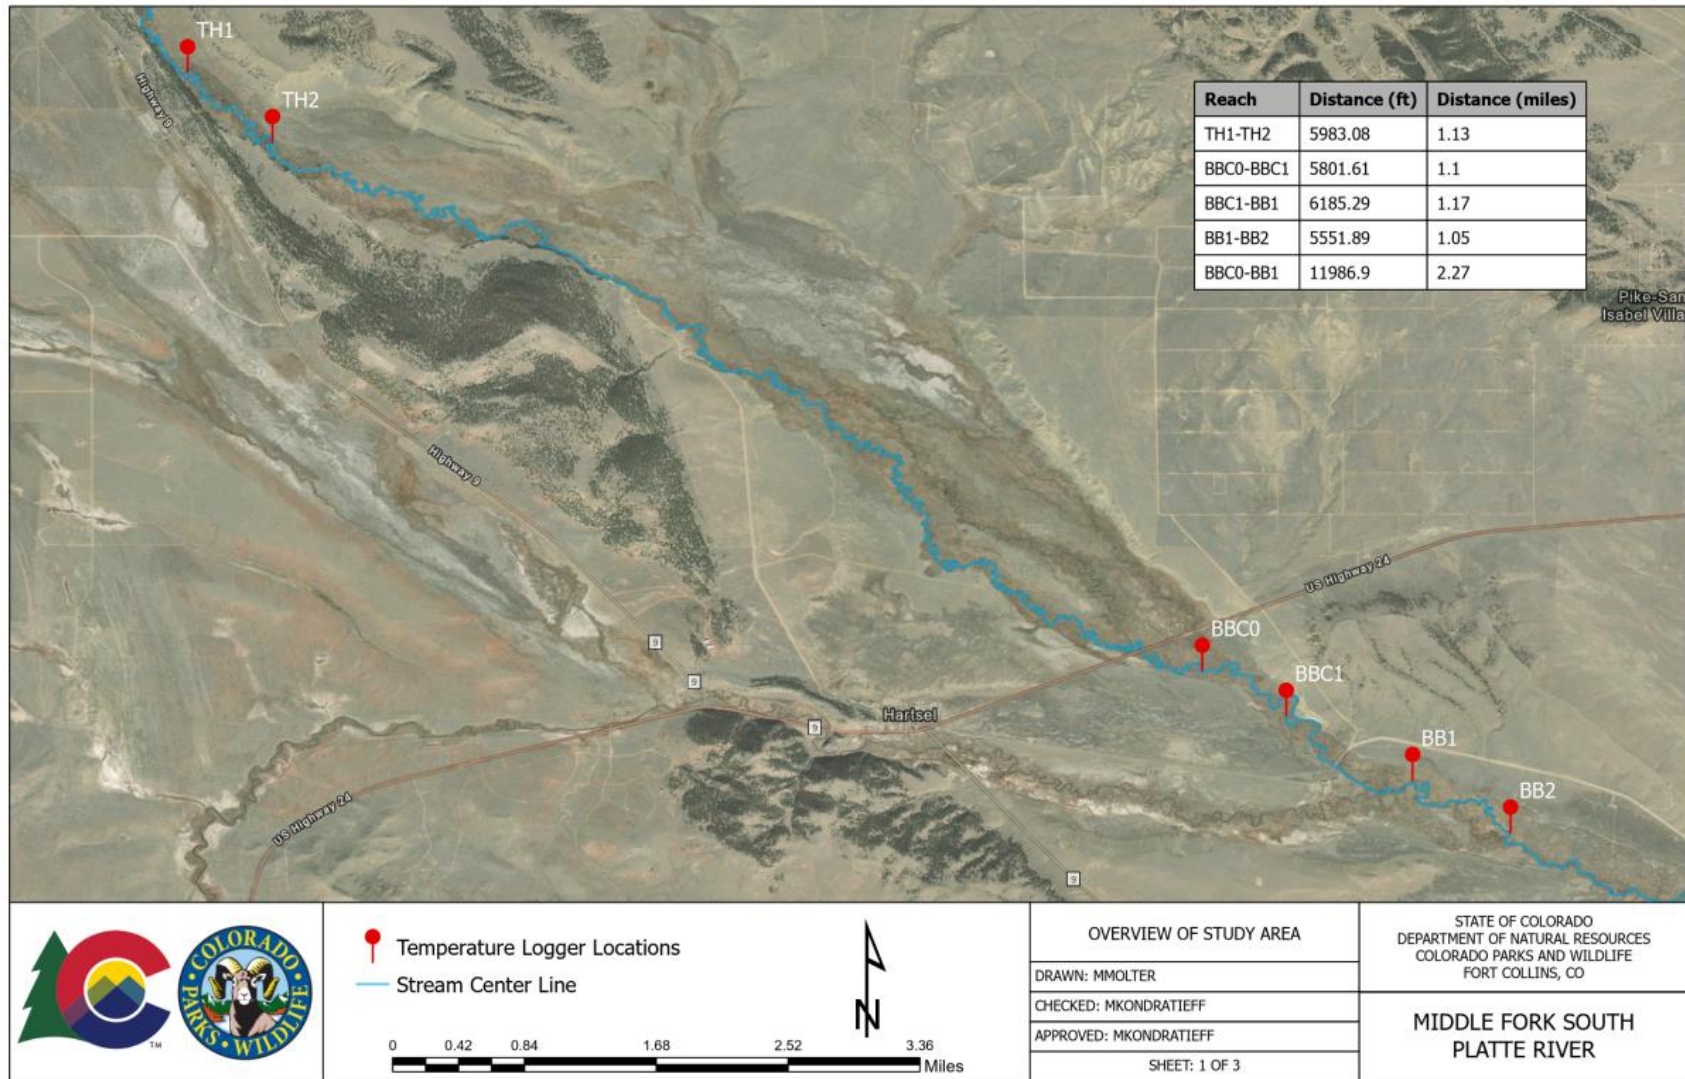
**Figure 18.** Locations of temperature sensors across reference, control, and treatment reaches for the temperature study on the Middle Fork South Platte River. Streamflow runs from top-left to bottom-right.

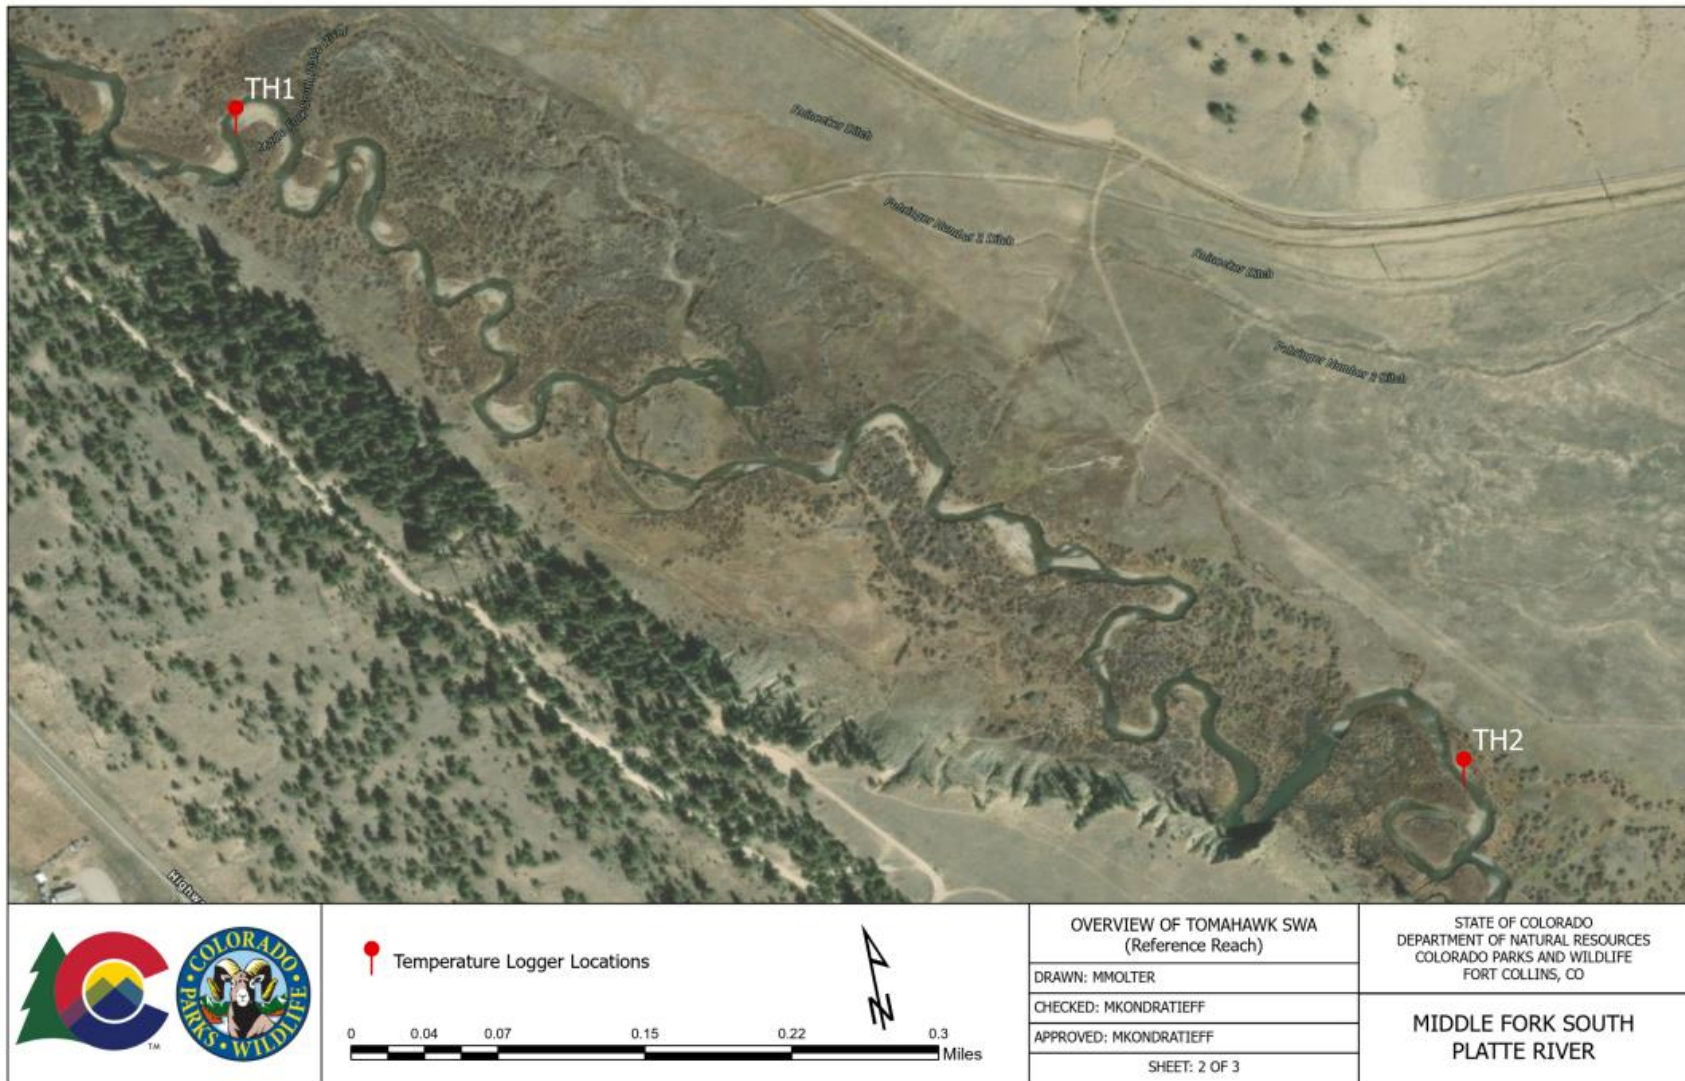
**Figure 19.** Locations of the two temperature sensors in the reference reach located on the Middle Fork of the South Platte River, Tomahawk SWA. Streamflow runs from top-left to bottom-right.

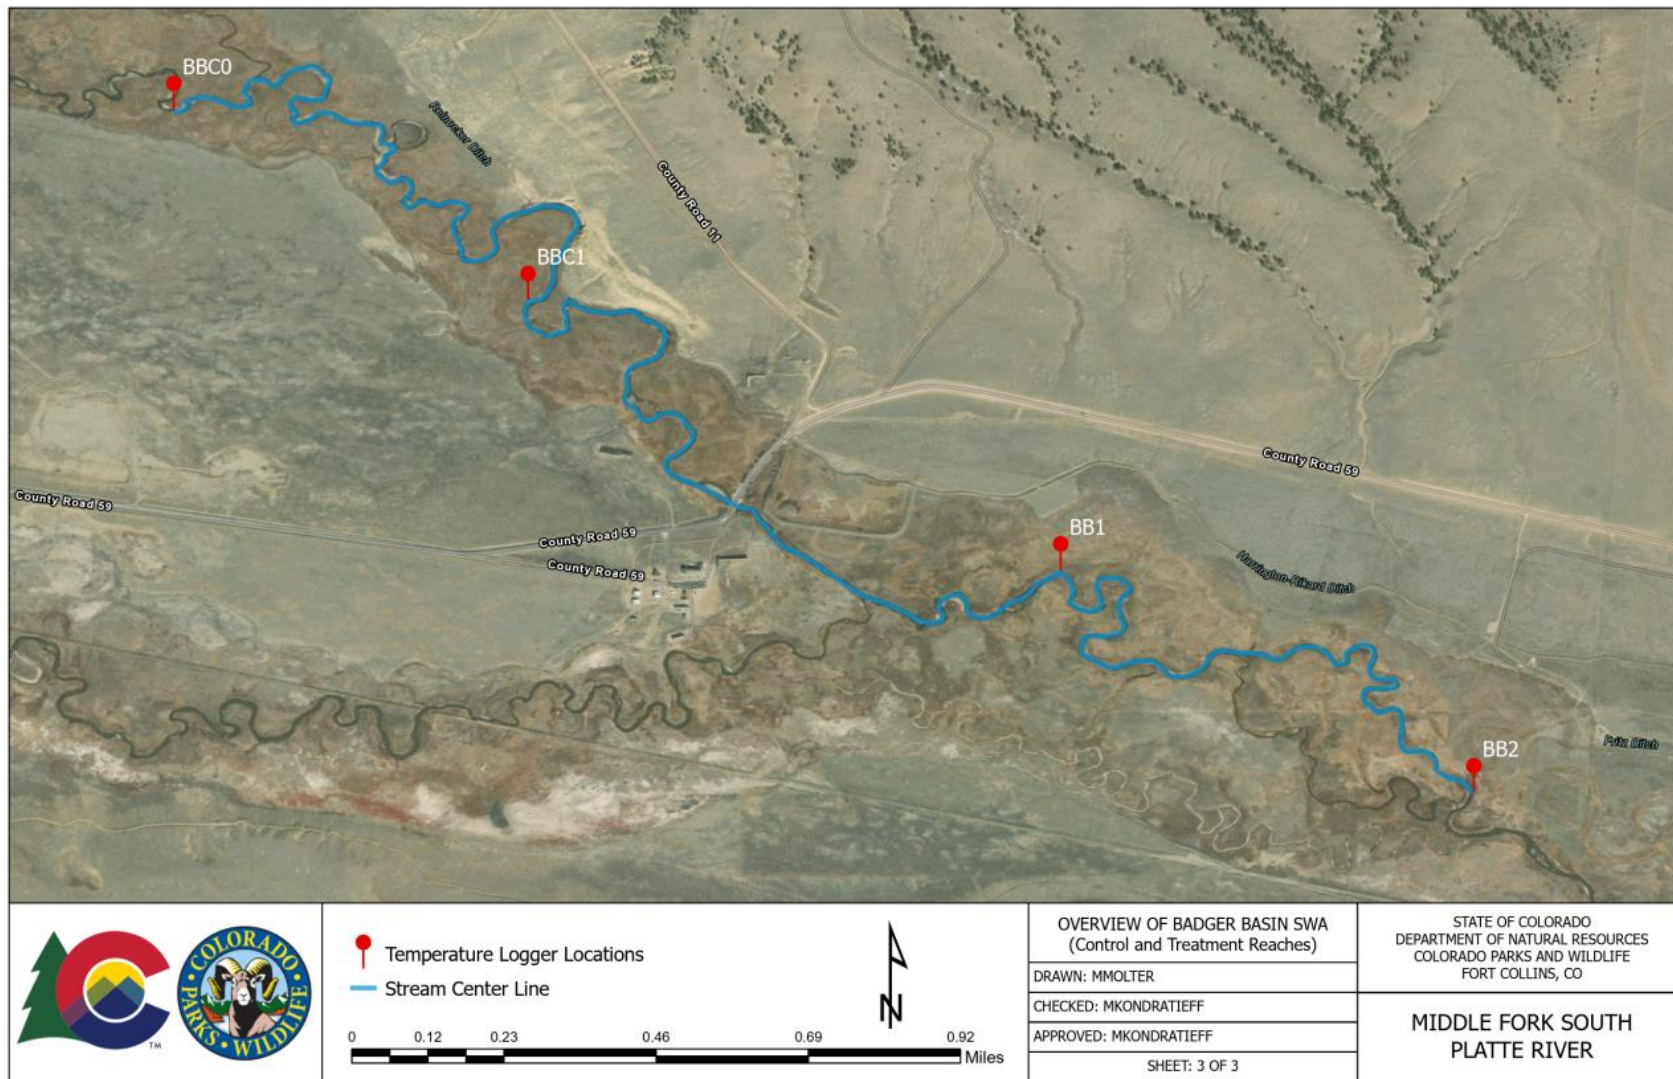
**Figure 20.** Locations of the four temperature sensors on the Middle Fork of the South Platte River on Badger Basin SWA, used as our control (upstream; BBC0 or BBC1 to BB1) and treatment (downstream; BB1 to BB2) reaches. Streamflow runs from top-left to bottom-right
