# **STREAM HABITAT INVESTIGATIONS AND ASSISTANCE PROJECT SUMMARY**

2024 Progress Report

Colorado Parks & Wildlife

September 2024

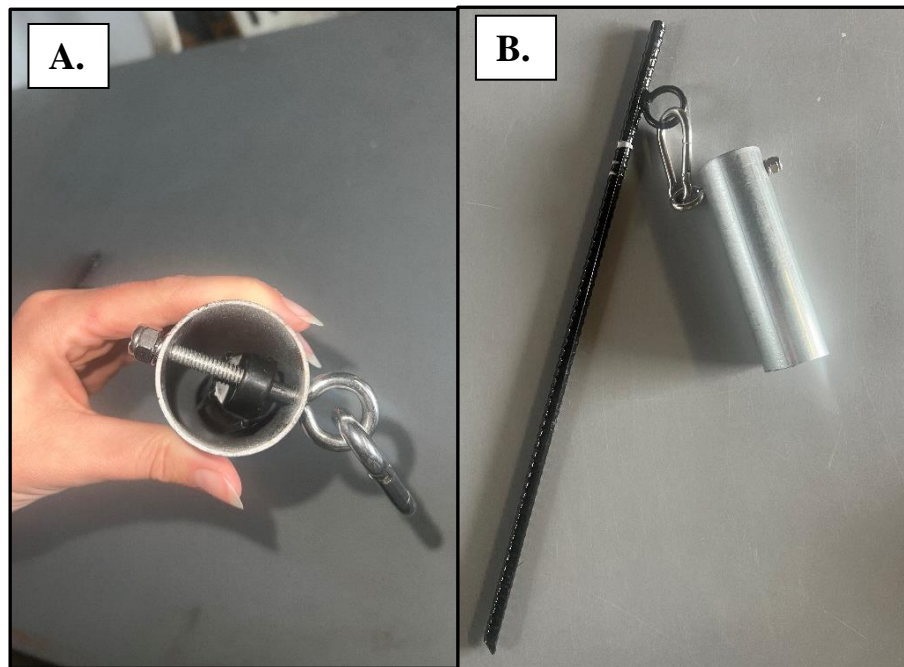
**Figure 21.** Photo showing (A) temperature logger inside metal housing and (B) temperature housing, carabiner, and rebar stake used to deploy temperature loggers in the field.

Water temperatures were monitored continuously by using six Onset Hobo™ Water Temperature Pro v2 Data Loggers deployed in each of the three study reaches. Figure 21 demonstrates how the loggers were installed, including a metal pipe to protect them from damage and shield them from direct sunlight. This housing was then clipped to rebar with a carabiner and anchored in the streambed with a rebar stake.

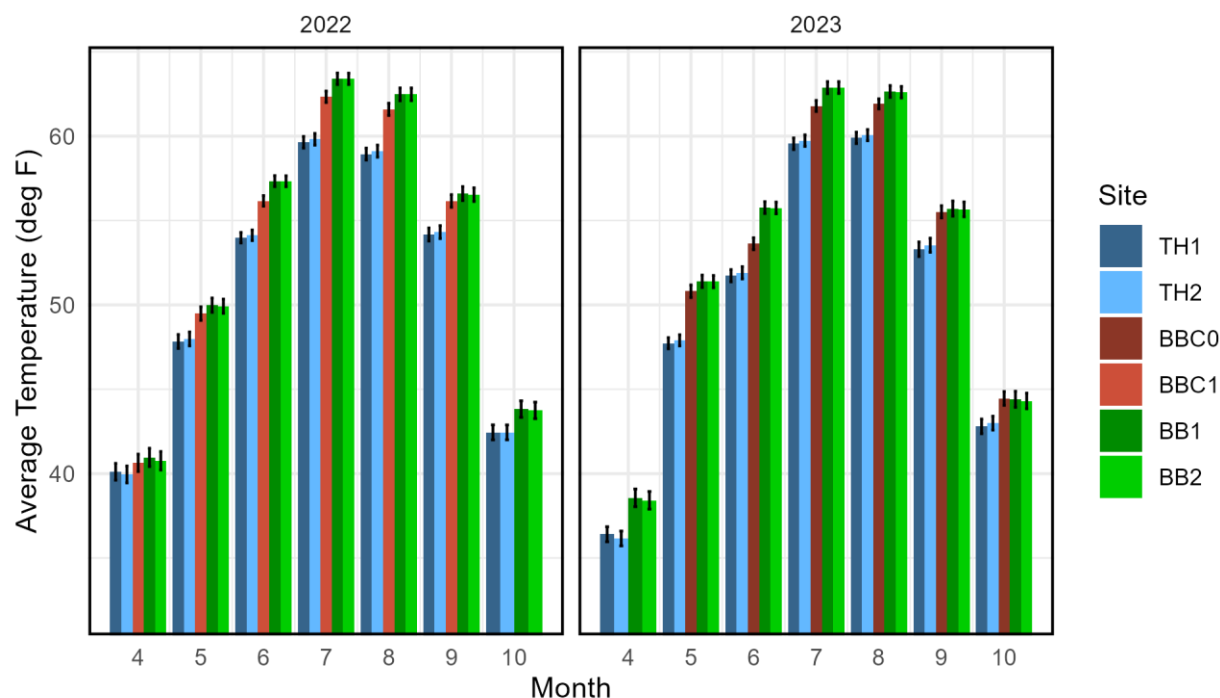
**Figure 22.** Average monthly water temperatures with 95% confidence intervals during 2022 and 2023 for all sites. Sites are listed from upstream to downstream: upstream Tomahawk (TH1), downstream Tomahawk (TH2), upstream Badger Basin Control (BBC0), downstream Badger Basin Control (BBC1), upstream Badger Basin treatment (BB1), and downstream Badger Basin (BB2).

Average monthly water temperature exhibited the expected trend of increasing as water flows downstream (Figure 22). The large increase in water temperature from the Tomahawk/reference sites (TH1 and TH2) to the control sites (BBC0, BBC1, and BB1) is mainly due to the distance between the two reaches (approximately 10 miles), which is much greater than the distance between control and treatment reaches (0 miles; Figure 18). The farther water travels downstream, the more it heats up, which makes sense especially considering the large impaired section of river that the water must flow through which lacks shading from vegetation and exhibits shallow pools depths with over-wide channel dimensions, all of which results in higher temperatures. Though we see the general trend of temperatures increasing downstream, this is not the case for the treatment reach between BB1 and BB2 sites. Instead, there is a cooling effect in the treatment reach which is explained later in the ANOVA and pairwise comparisons for standardized changes in water temperature (deltas).

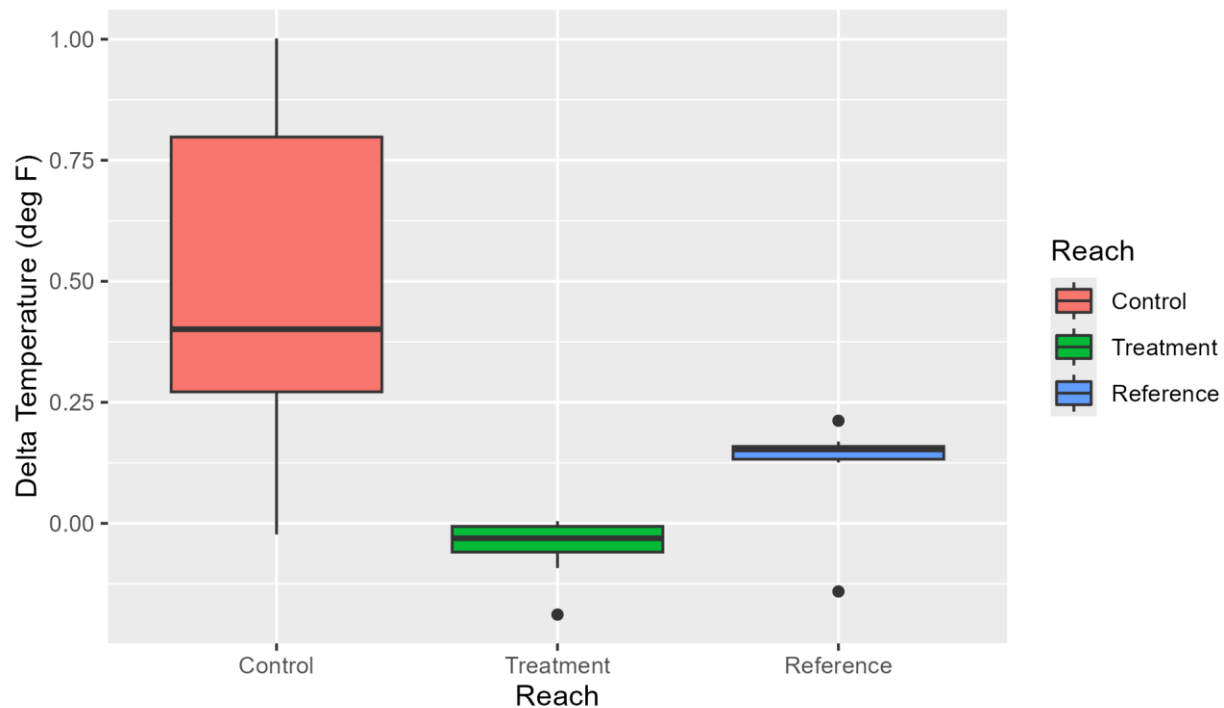
**Figure 23.** Change in water temperature by reach across months and years. Boxplots display median, 25%, and 75% interquartile ranges.

The observed changes in temperature (deltas) were presented by reach (Figure 23) and month (Figure 24). By observing the change in temperature (delta) for reach alone averaged across time (month and year), we see a median increase of  $+0.4$  °F/mile for the control reach (Figure 23). The control reach also exhibits a much higher degree of variability in the deltas with more widely dispersed interquartile ranges. In contrast, results from the reference and treatment reaches are much more stable with extremely low interquartile ranges. This is likely the result of temperature fluctuations being buffered by improved floodplain connectivity (ground water return) and shading from vegetation which is present in both of these reaches and not present in the control (Figures 15-17). However, the treatment reach consistently experiences a cooling effect through the reach (median =  $-0.03$  °F/mile), whereas temperatures are slightly increasing (median =  $+0.15$  °F/mile) through the reference reach. By examining the effect of month on the change in temperature (delta) it becomes clear that more extreme temperature fluctuations are seen in the control reach during the summer months where solar exposure and increased air temperature are more likely to have a larger effect on water temperature (Figure 24). The shoulder months of April and October are more stable as air temperatures start to drop and the river may begin thaw or freeze (resulting in a stable water temperature of  $\sim 32$  °F). Within the control reach, water temperatures are more variable and usually increasing anywhere from  $0.08$  to  $1.0$  °F/mile (Figure 24). Only in October 2023 did we see a decrease in temperature of  $0.02$  °F/mile within the control reach. Interestingly, reference and treatment reaches still have much more stable temperatures during the summer, again likely a result of floodplain connectivity and vegetation to dampen the effects of temperature fluctuations.

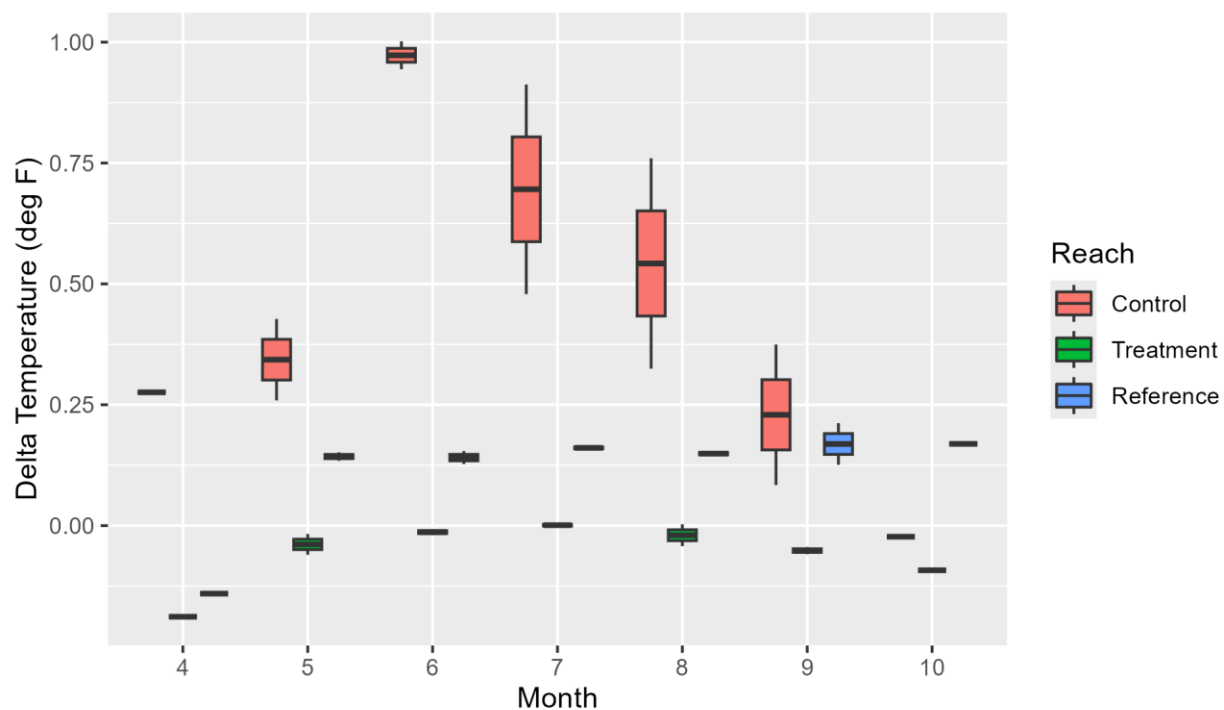
**Figure 24.** The change in water temperature by month and reach. Boxplots display median, 25%, and 75% interquartile ranges.

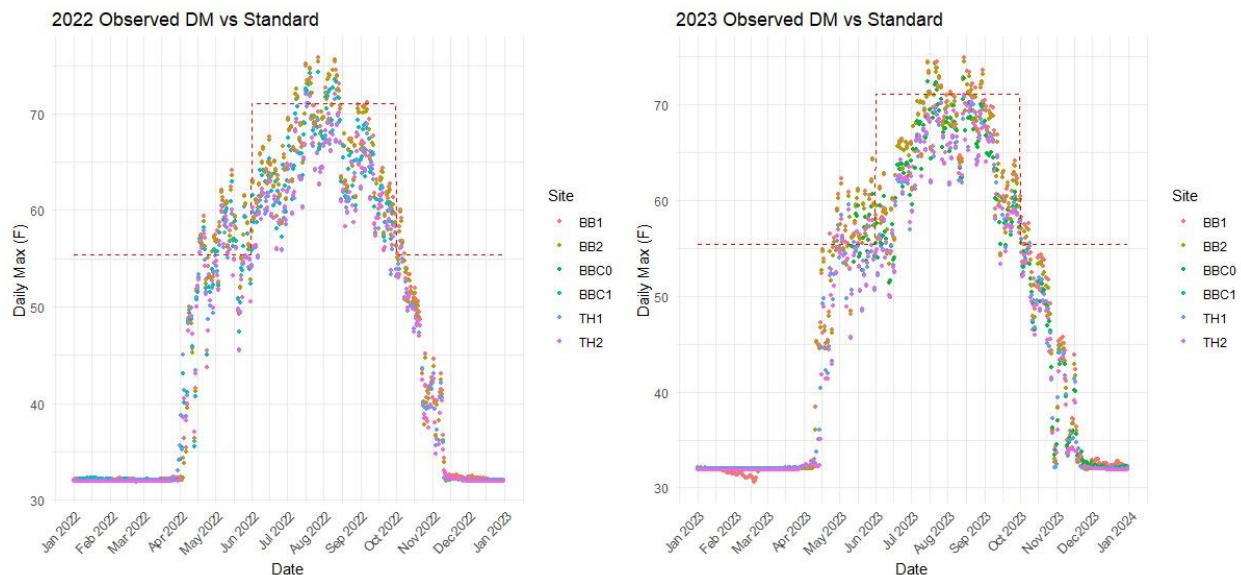
**Figure 25.** Observed daily maximum temperatures (DM) at each site in 2022 and 2023 compared to the Colorado Water Quality Temperature Standard for cold water Tier 1 (trout) depicted by the dashed red line.

months (May and October) as well as peak summer months (July and August) are particularly problematic (Figures 25 and 26).

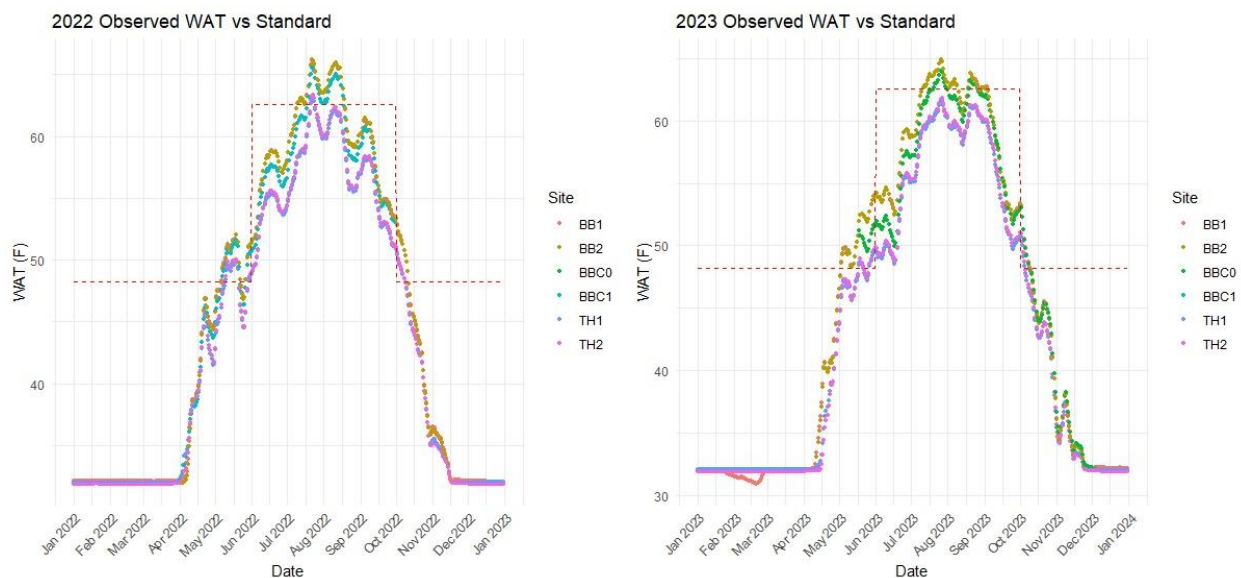
**Figure 26.** Observed weekly average temperature (WAT) at each site in 2022 and 2023 compared to the Colorado Water Quality Temperature Standard for cold water Tier 1 (trout) depicted by the dashed red line.

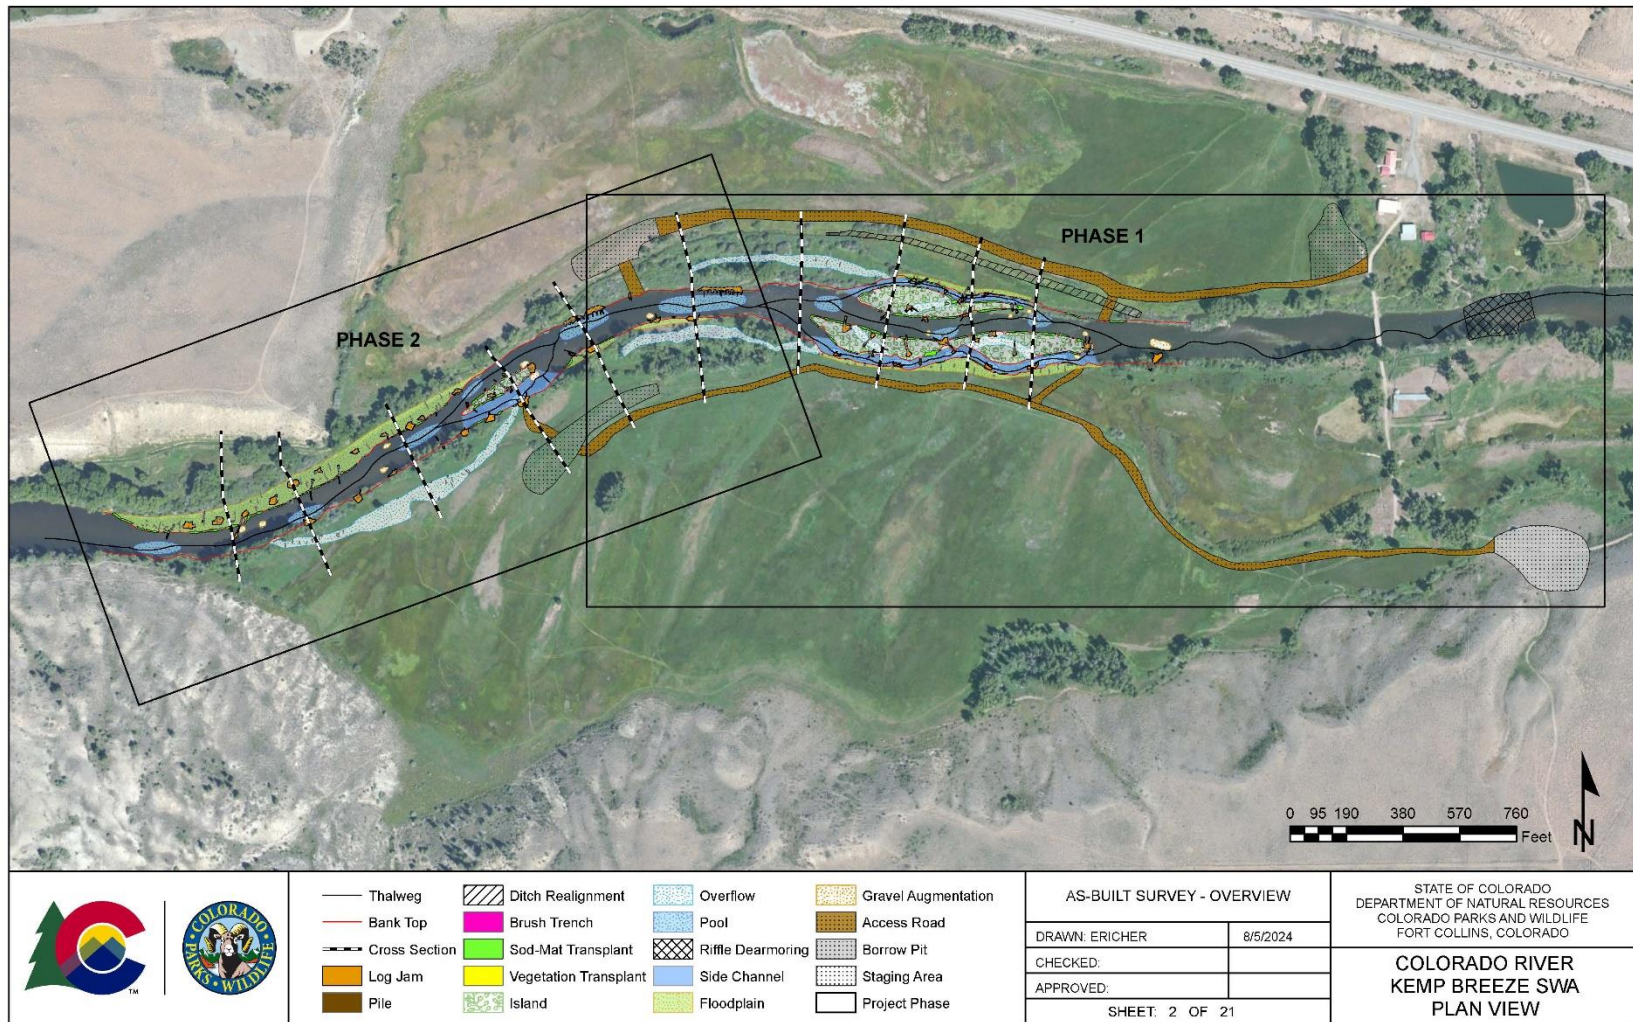
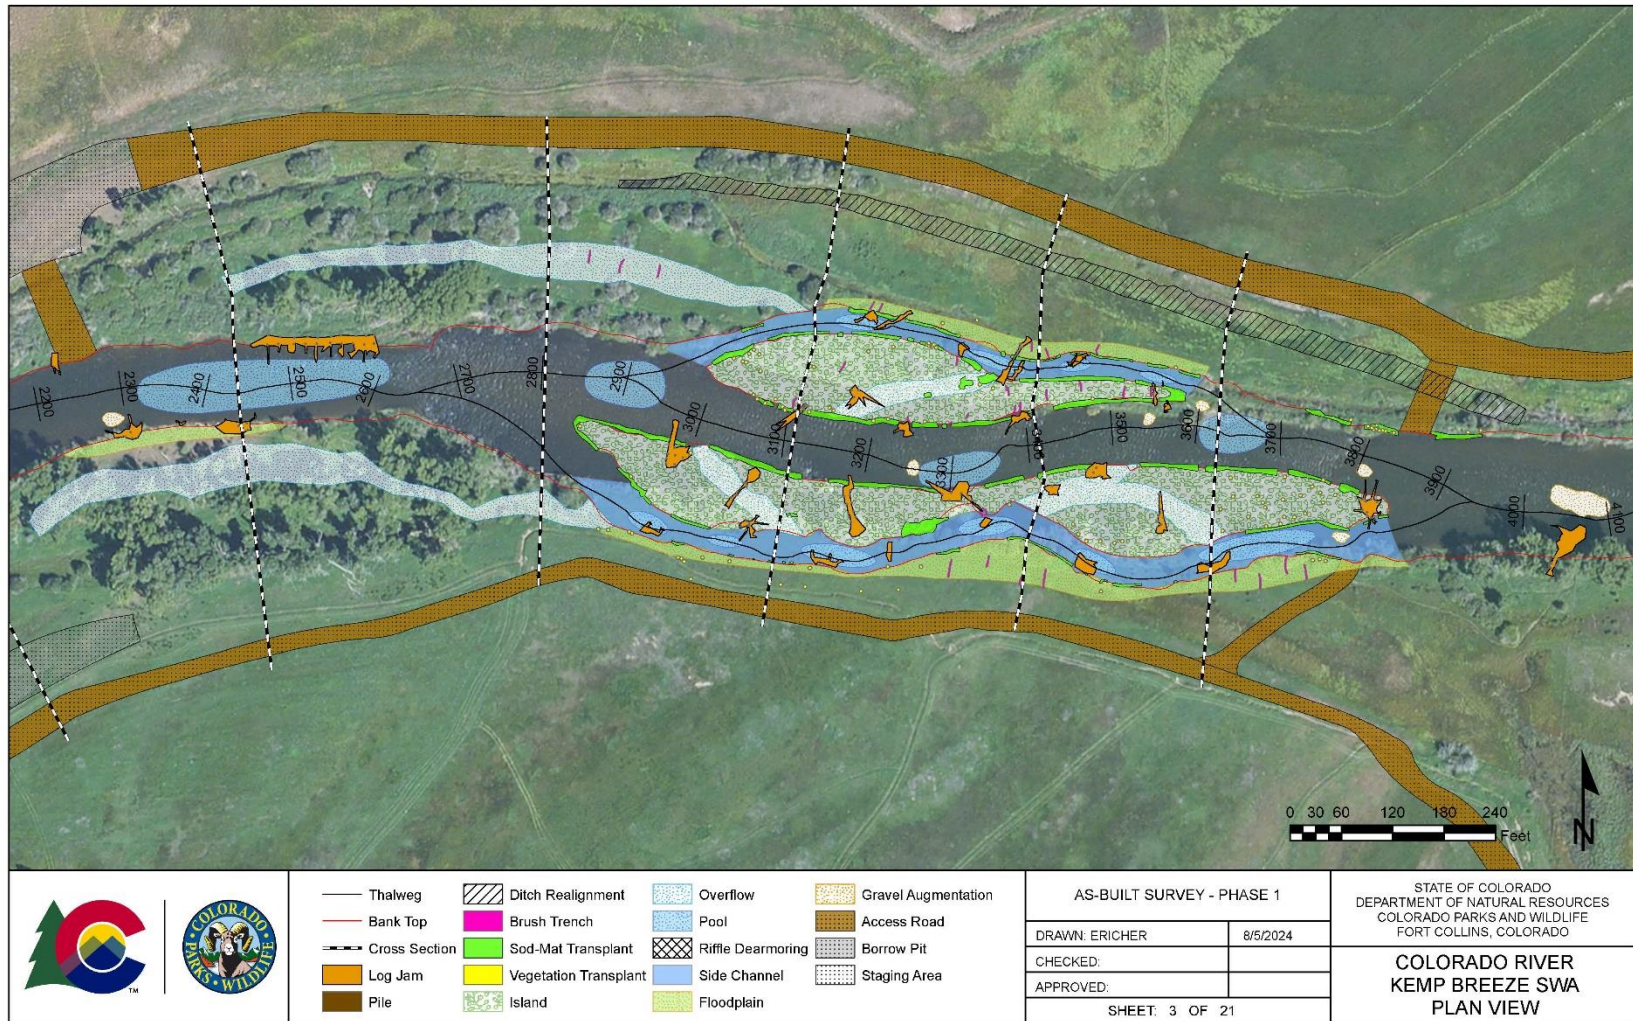
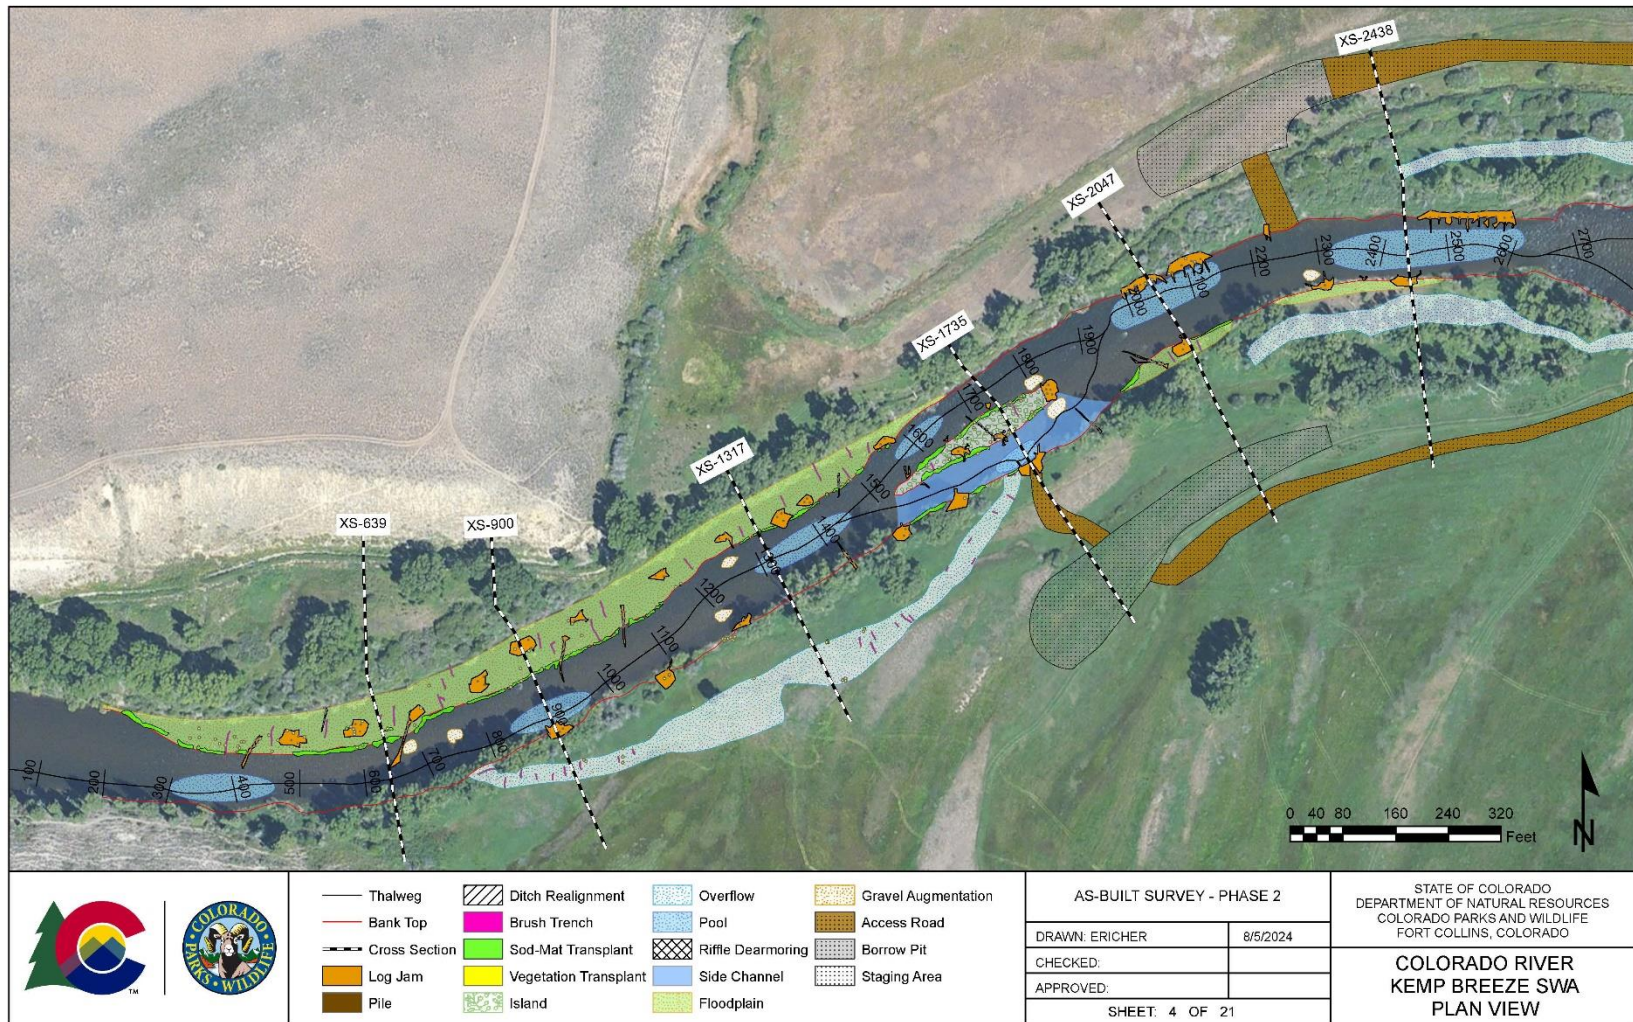
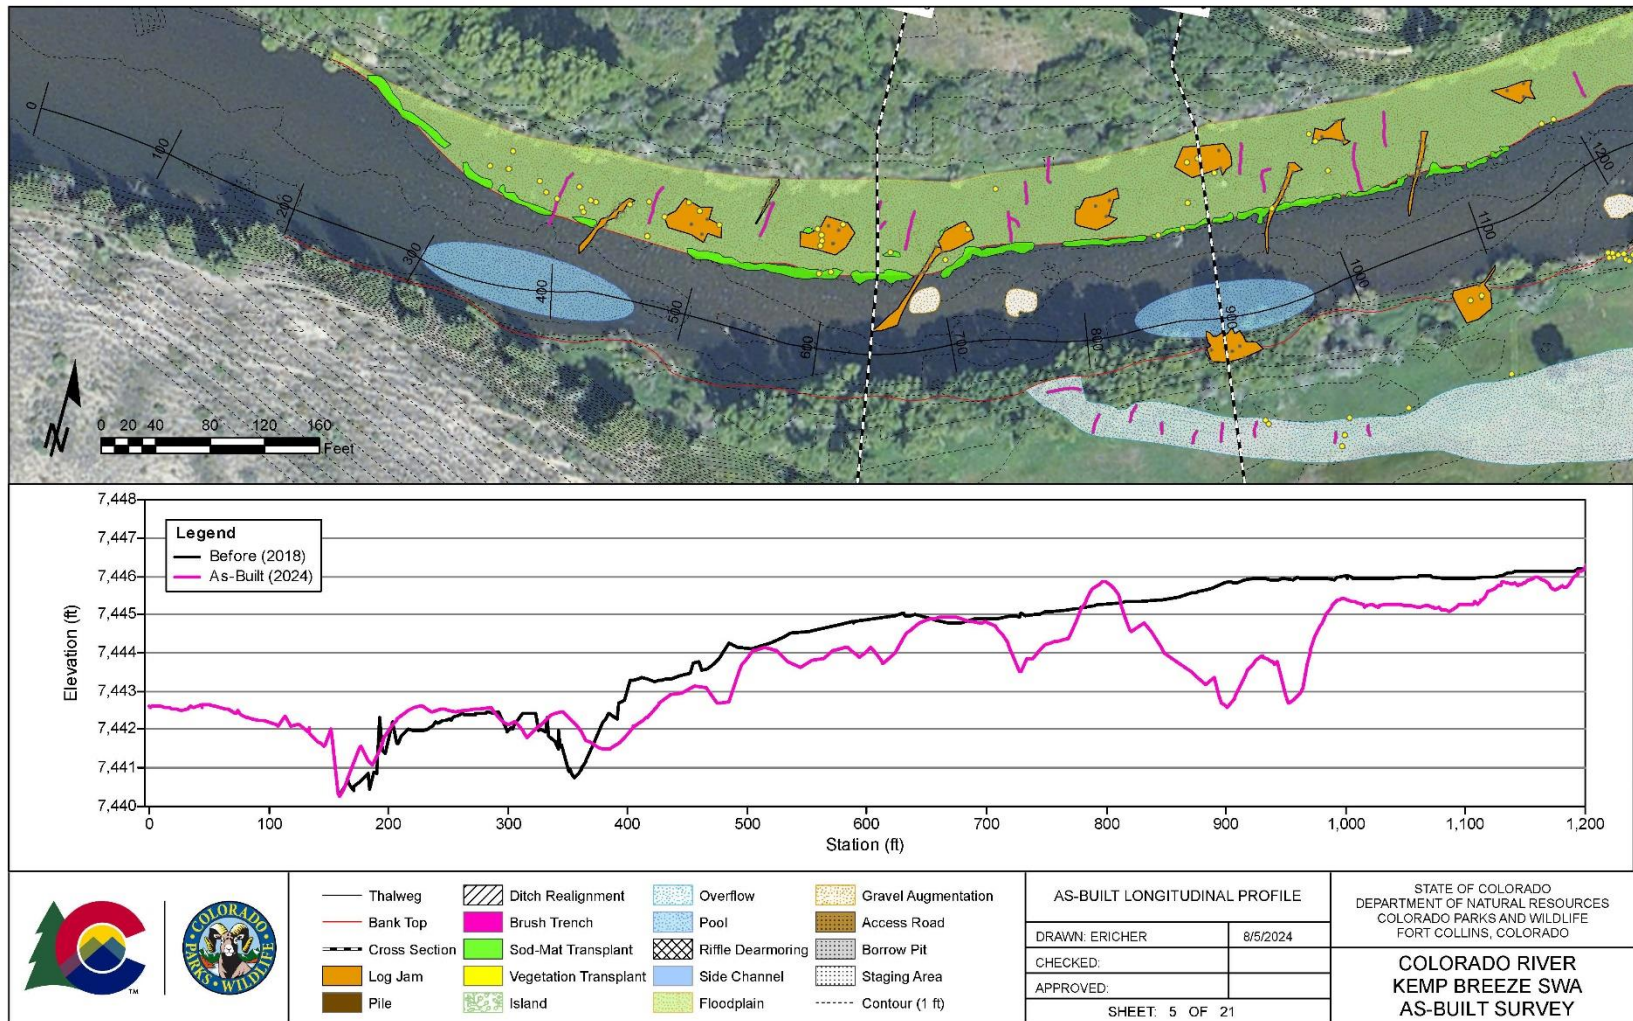
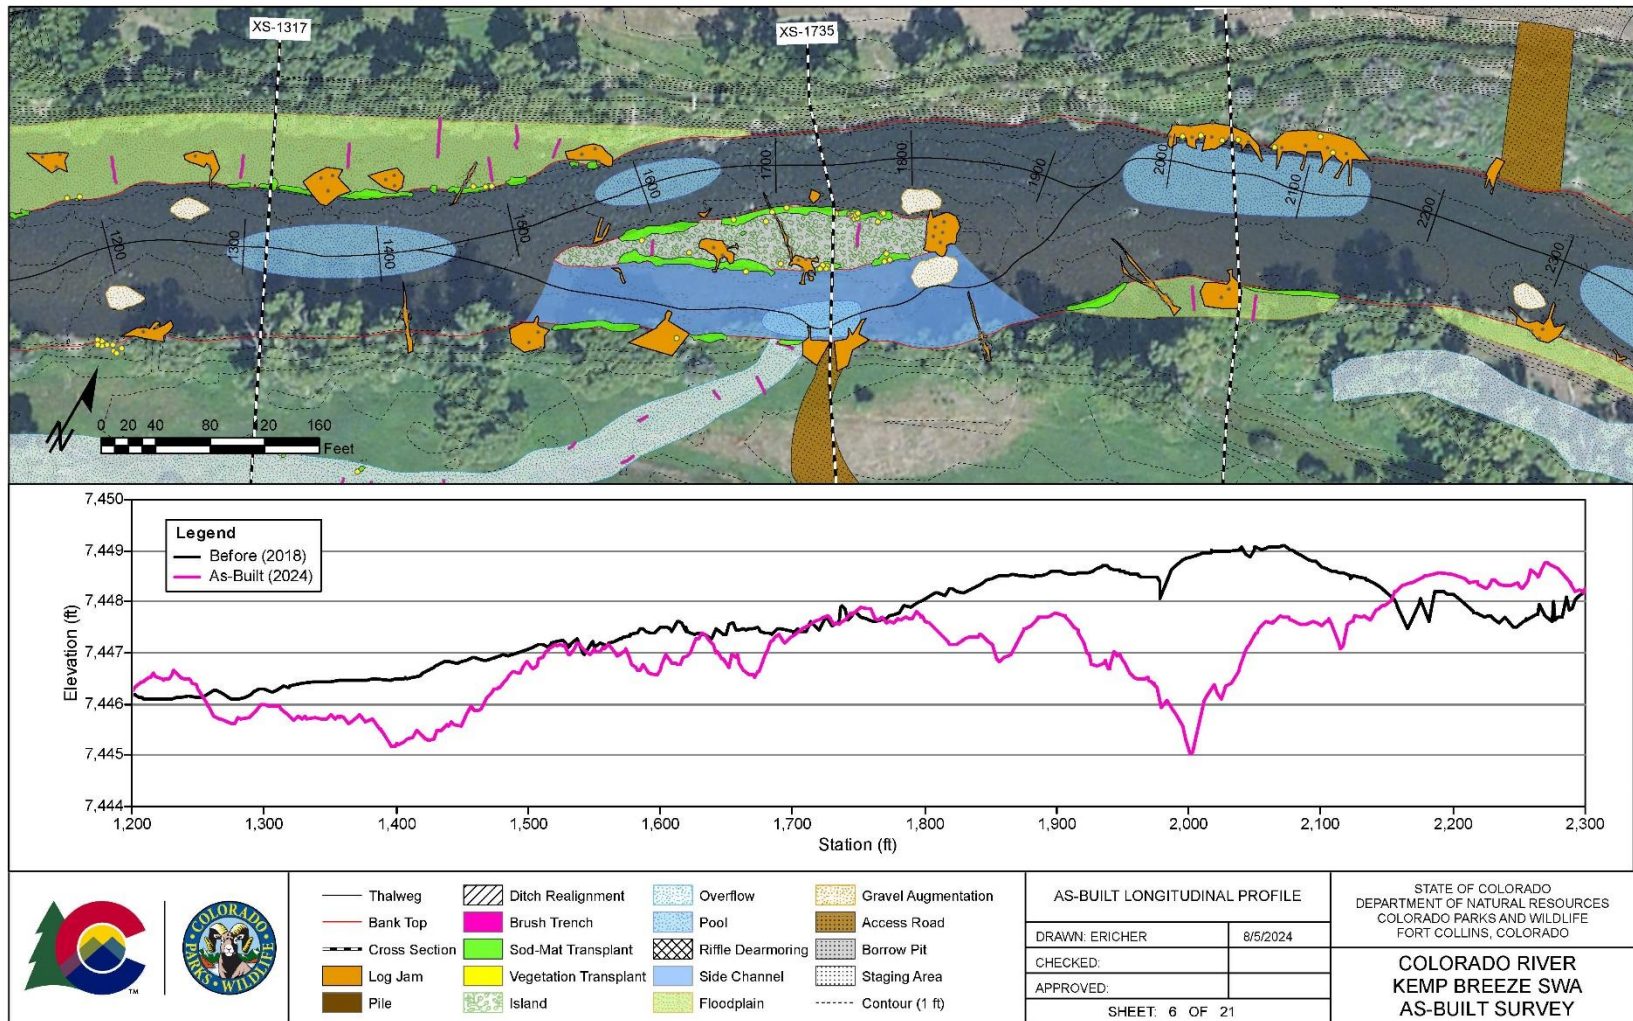
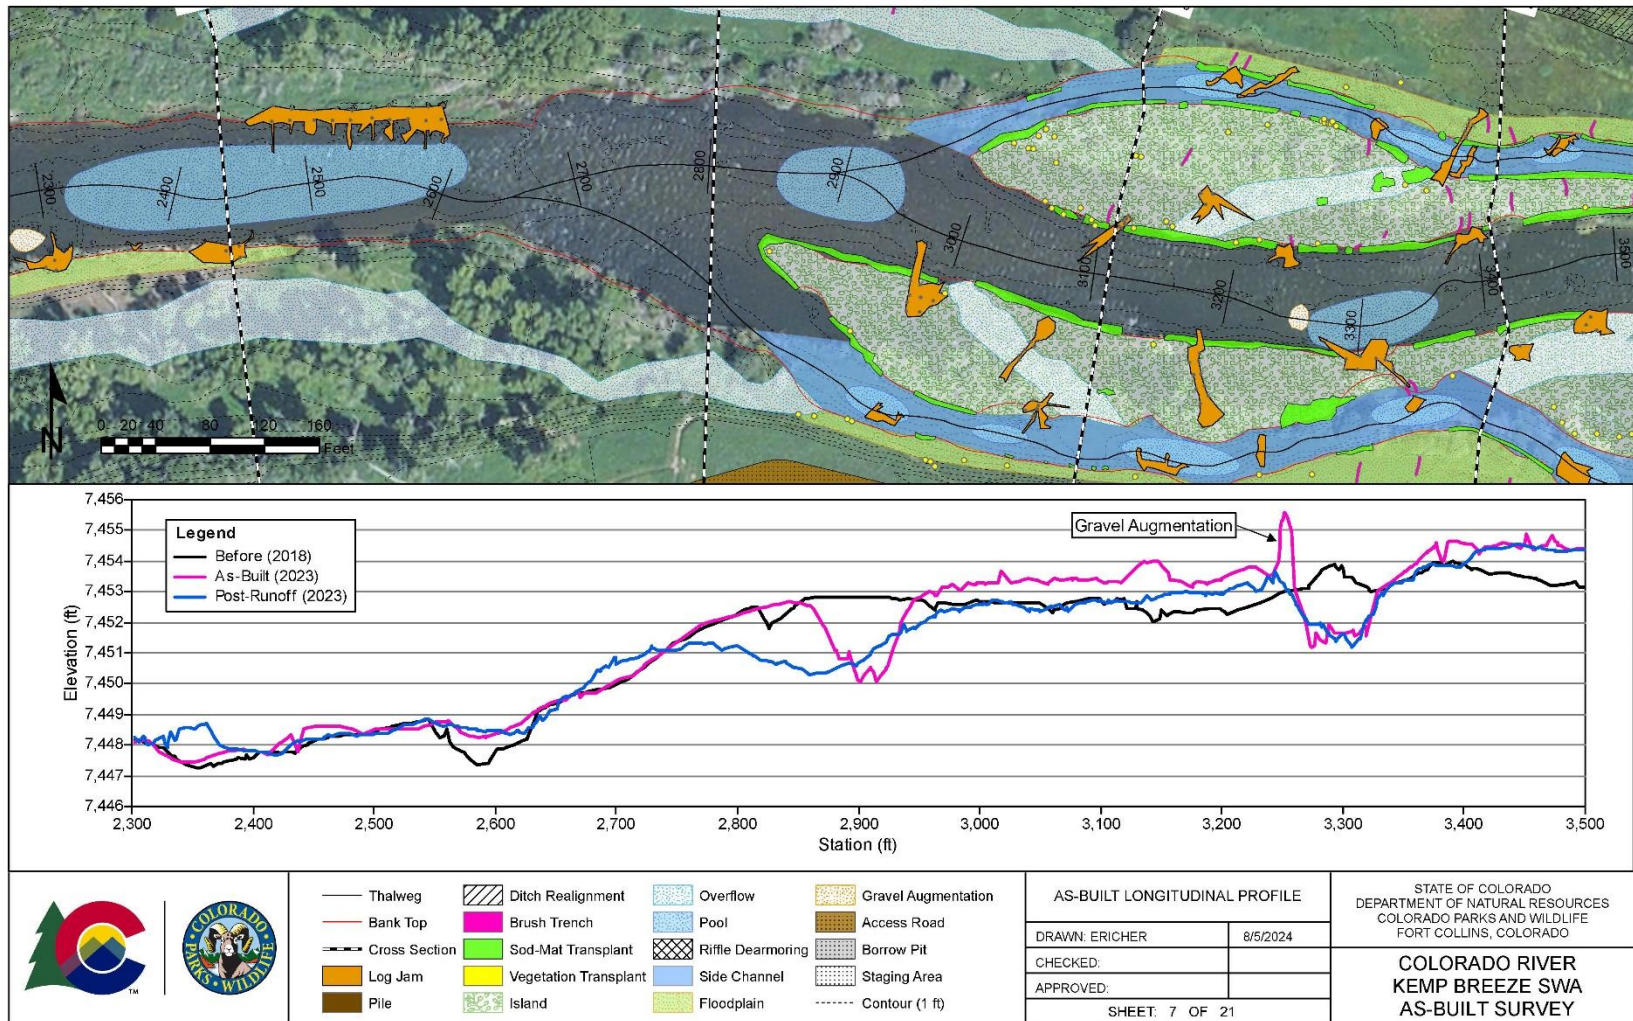
COLORADO RIVER  
KEMP-BREEZE SWA  
AS-BUILT SURVEY

Survey data were collected in October 2018 to represent preexisting conditions at the project site (Before 2018).

As-built conditions for the Phase 1 reach were surveyed in April 2023 (As-Built 2023).

Post-runoff conditions for the Phase 1 reach were surveyed in October 2023 and as-built conditions for the Phase 2 reach were surveyed in April 2024. Survey data from the October 2023 and April 2024 surveys were combined to create a single surface for analysis (Post-Runoff 2023 for Phase 1 and As-Built 2024 for Phase 2)

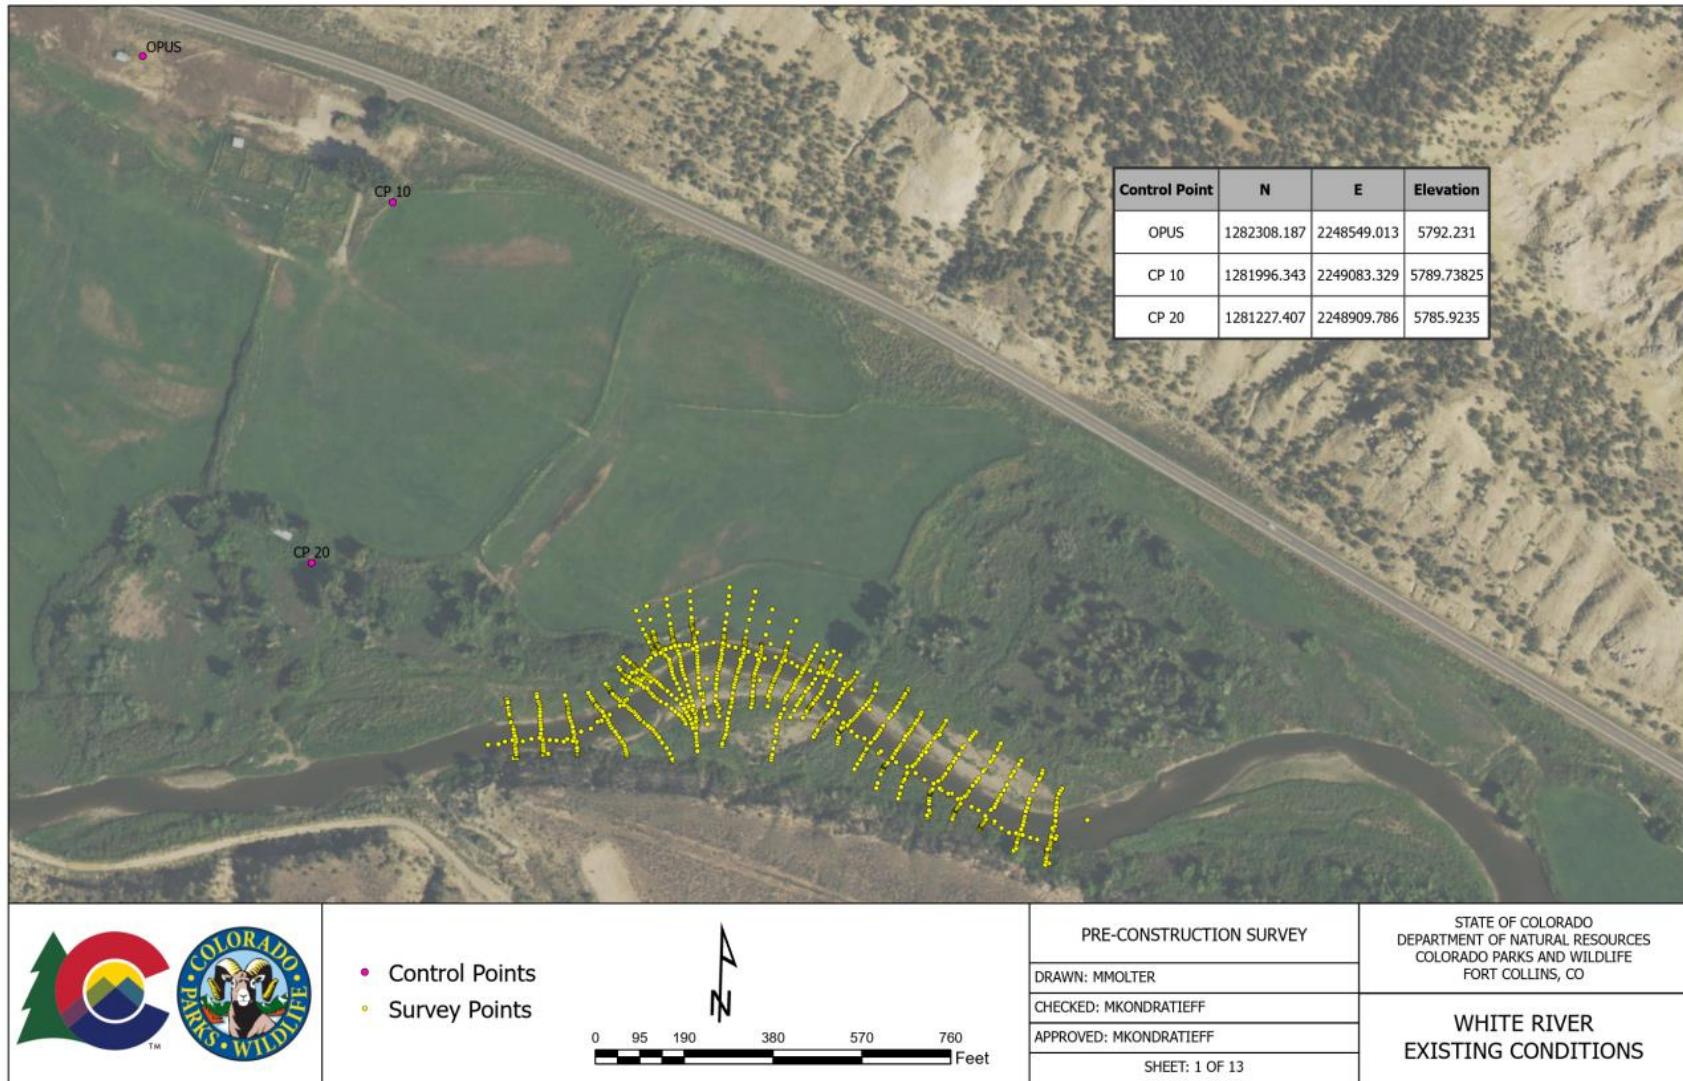
**Figure B1.** Locations of survey data points and control points at the project site on the White River.

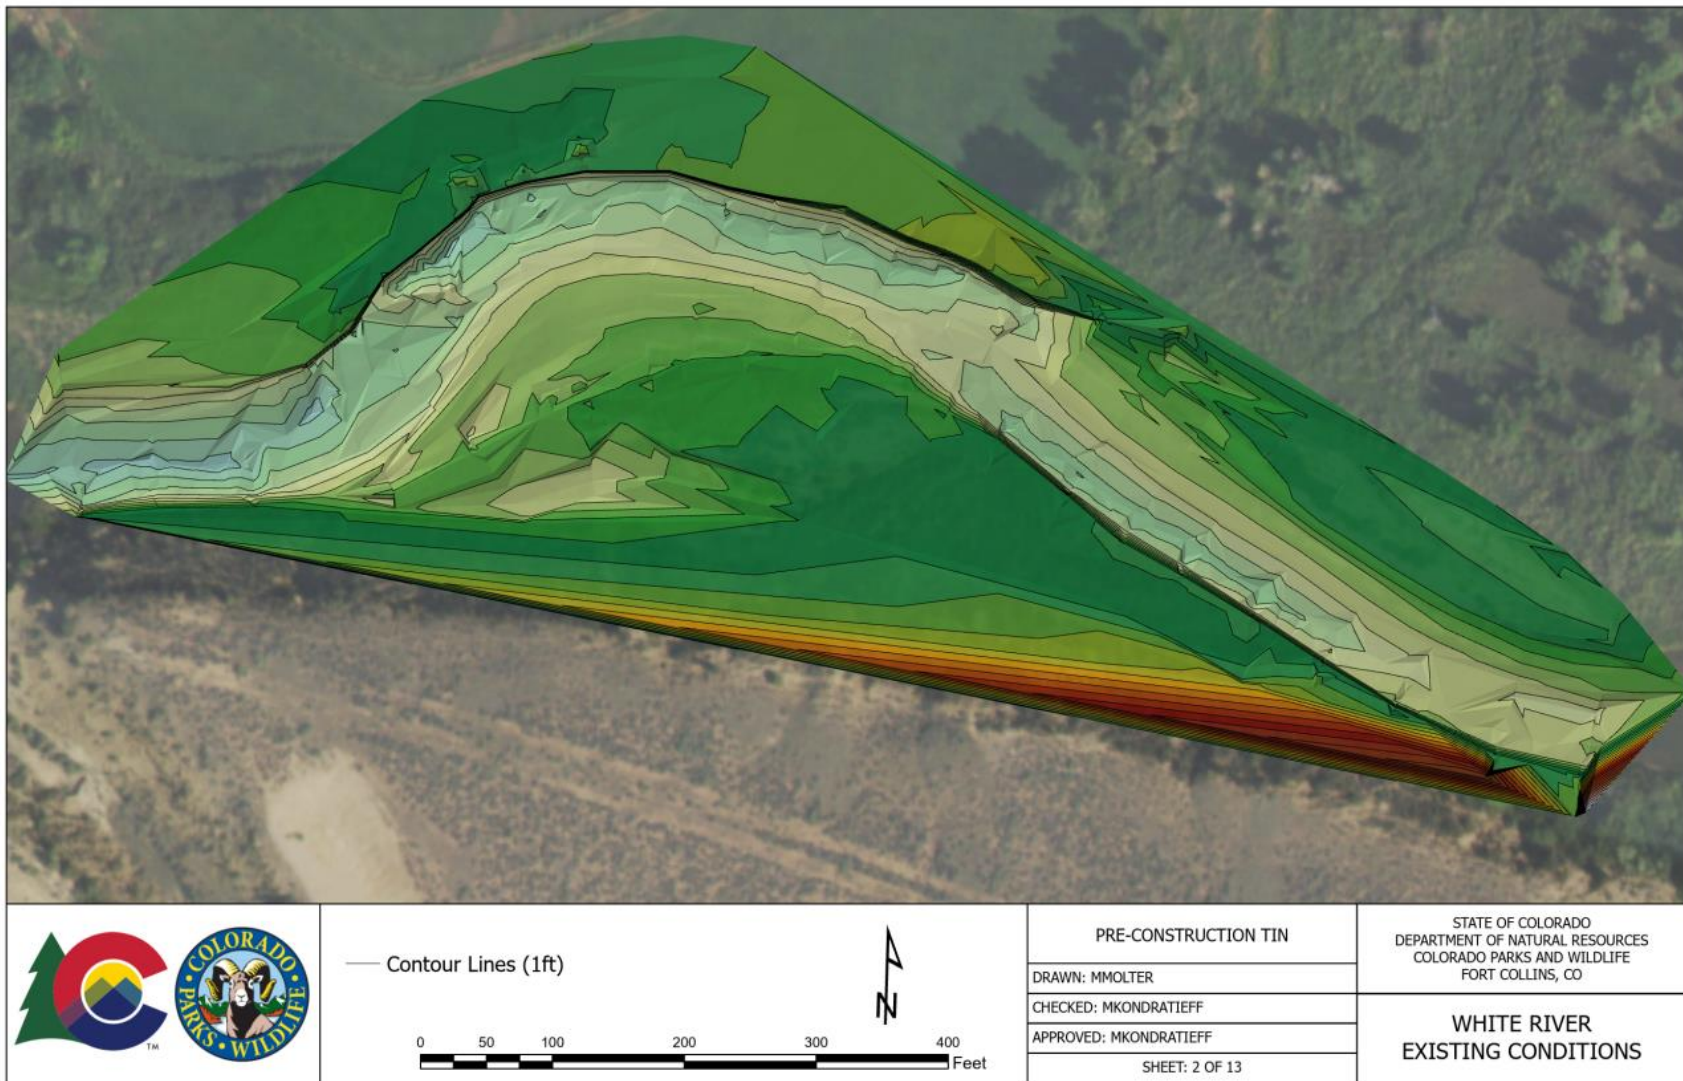
**Figure B2.** Triangulated irregular network (TIN) showing existing conditions of the channel through the project reach.

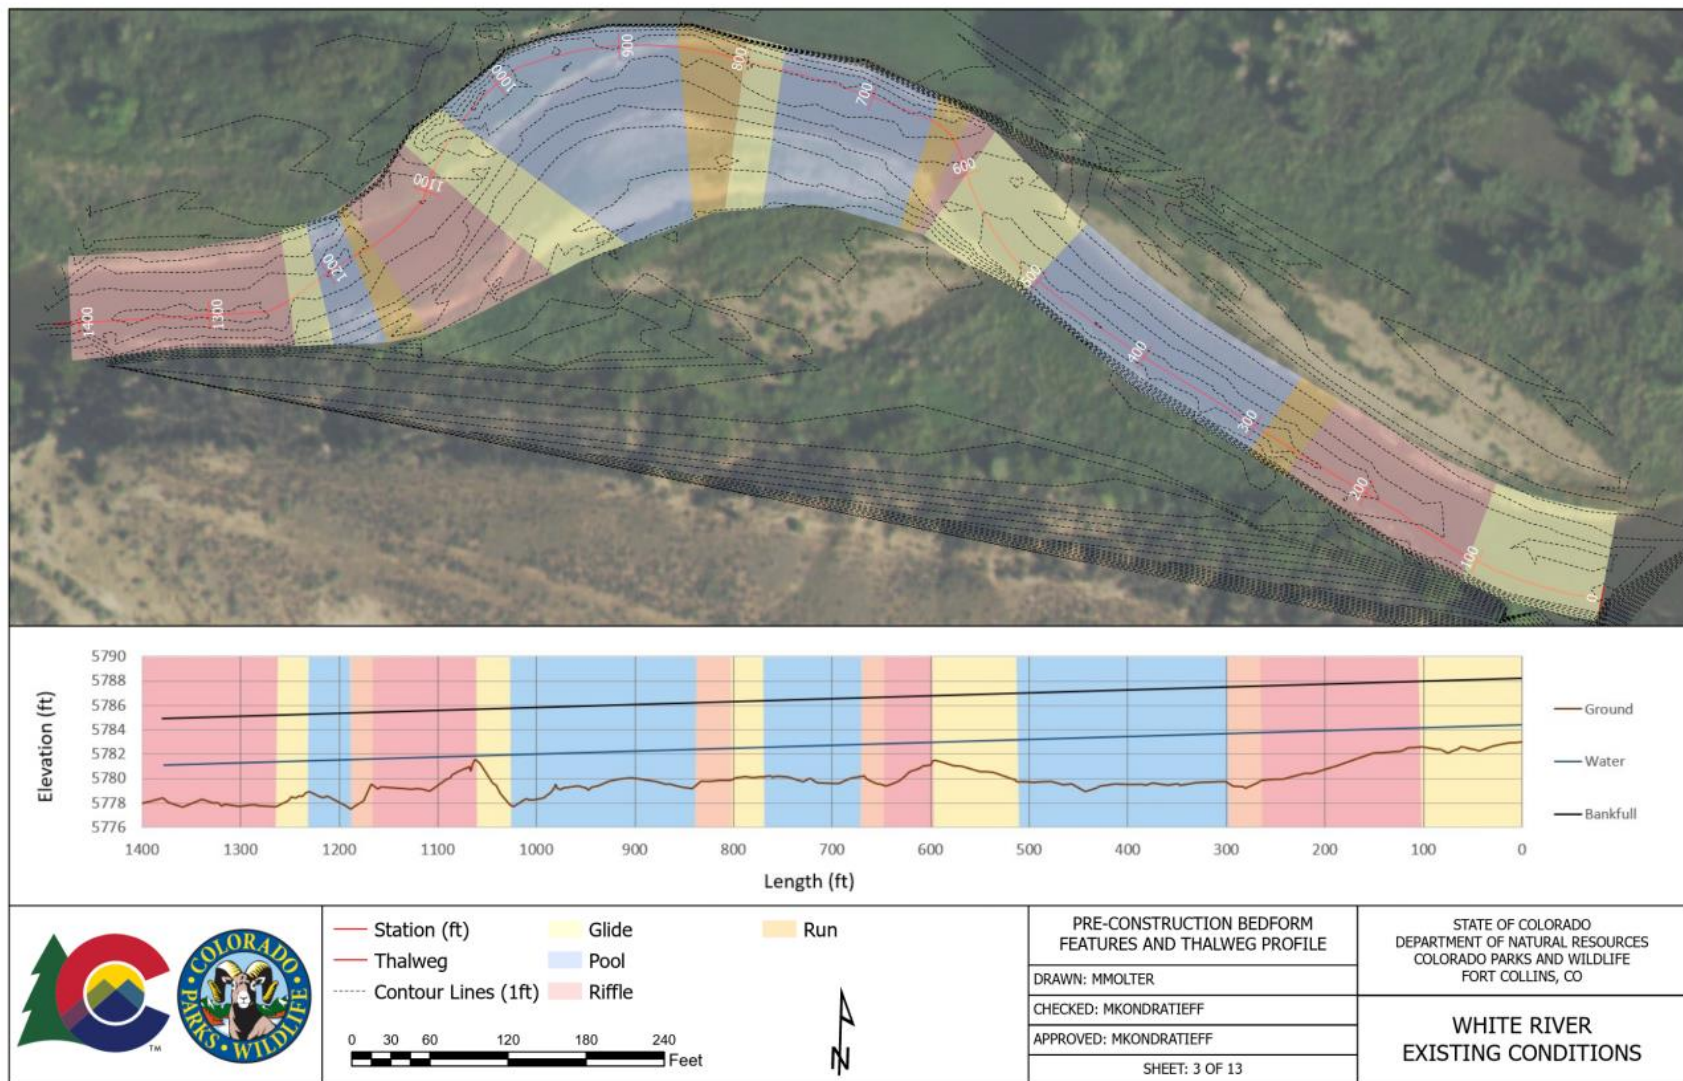
**Figure B3.** Channel bedforms and longitudinal profile graph with bankfull, water surface, and streambed (ground) elevations.
