# **STREAM HABITAT INVESTIGATIONS AND ASSISTANCE PROJECT SUMMARY**

2024 Progress Report

Colorado Parks & Wildlife

September 2024

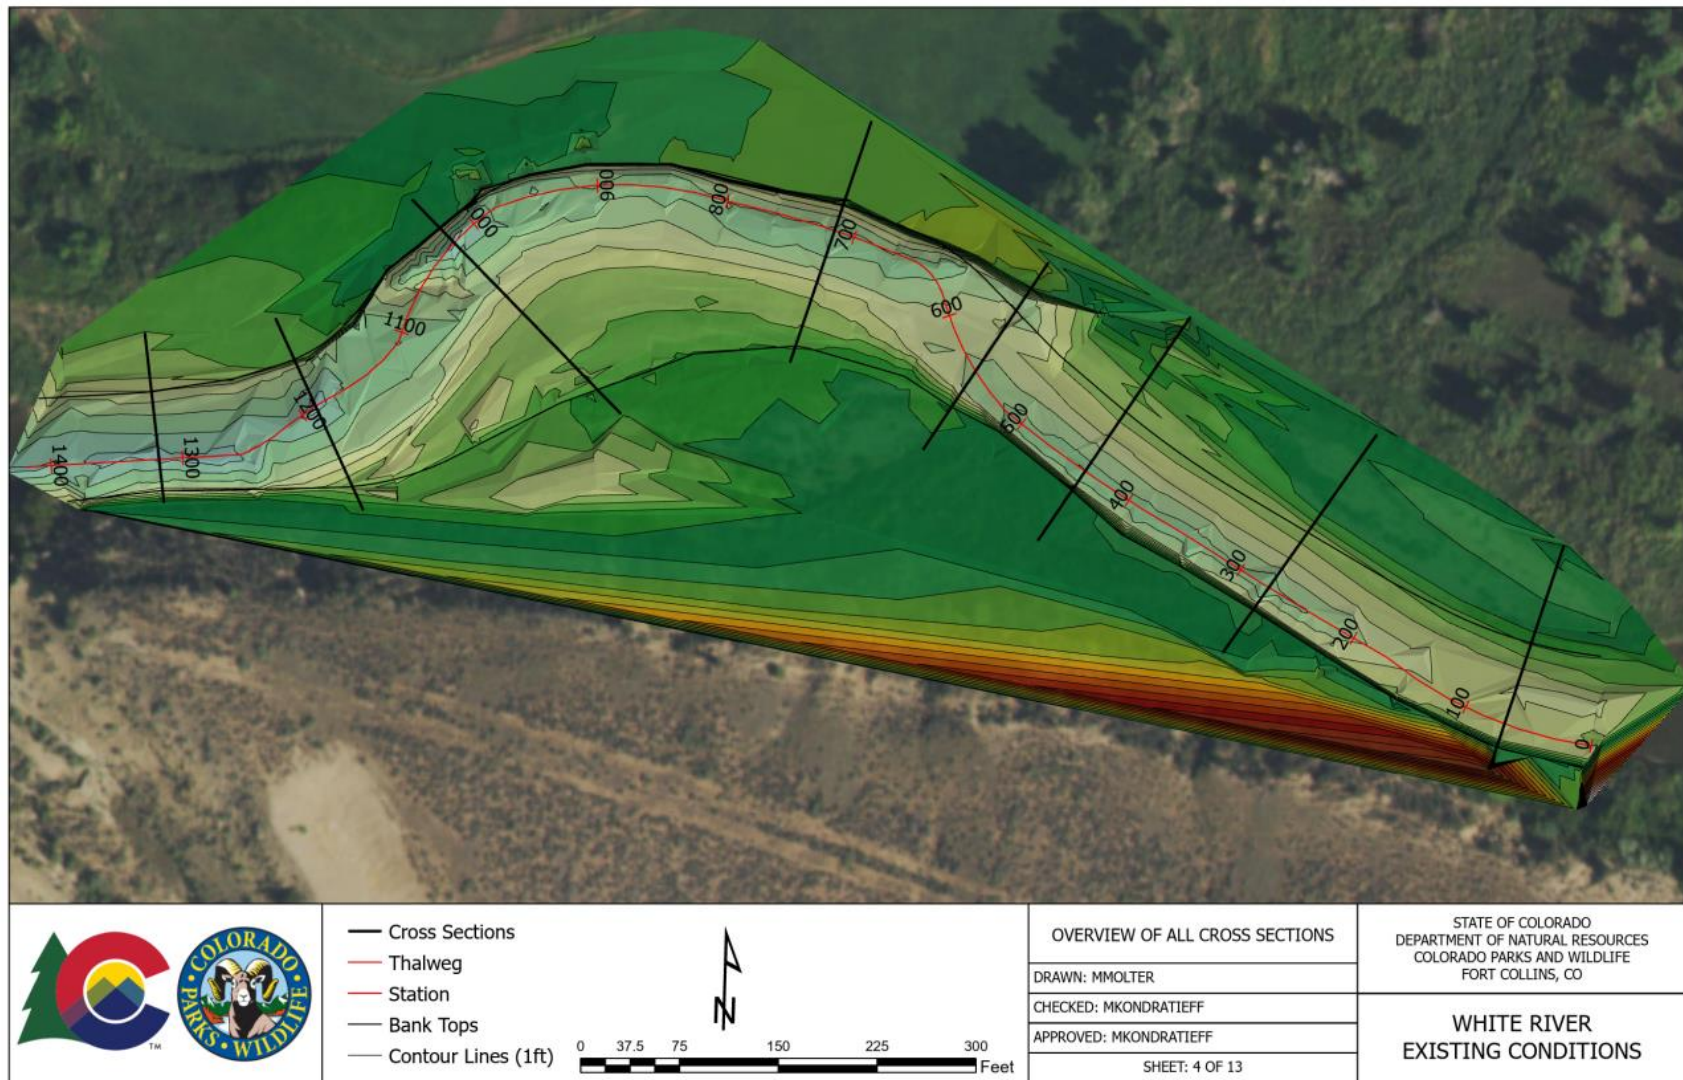
**Figure B4.** Cross section locations at the project site on the White River.

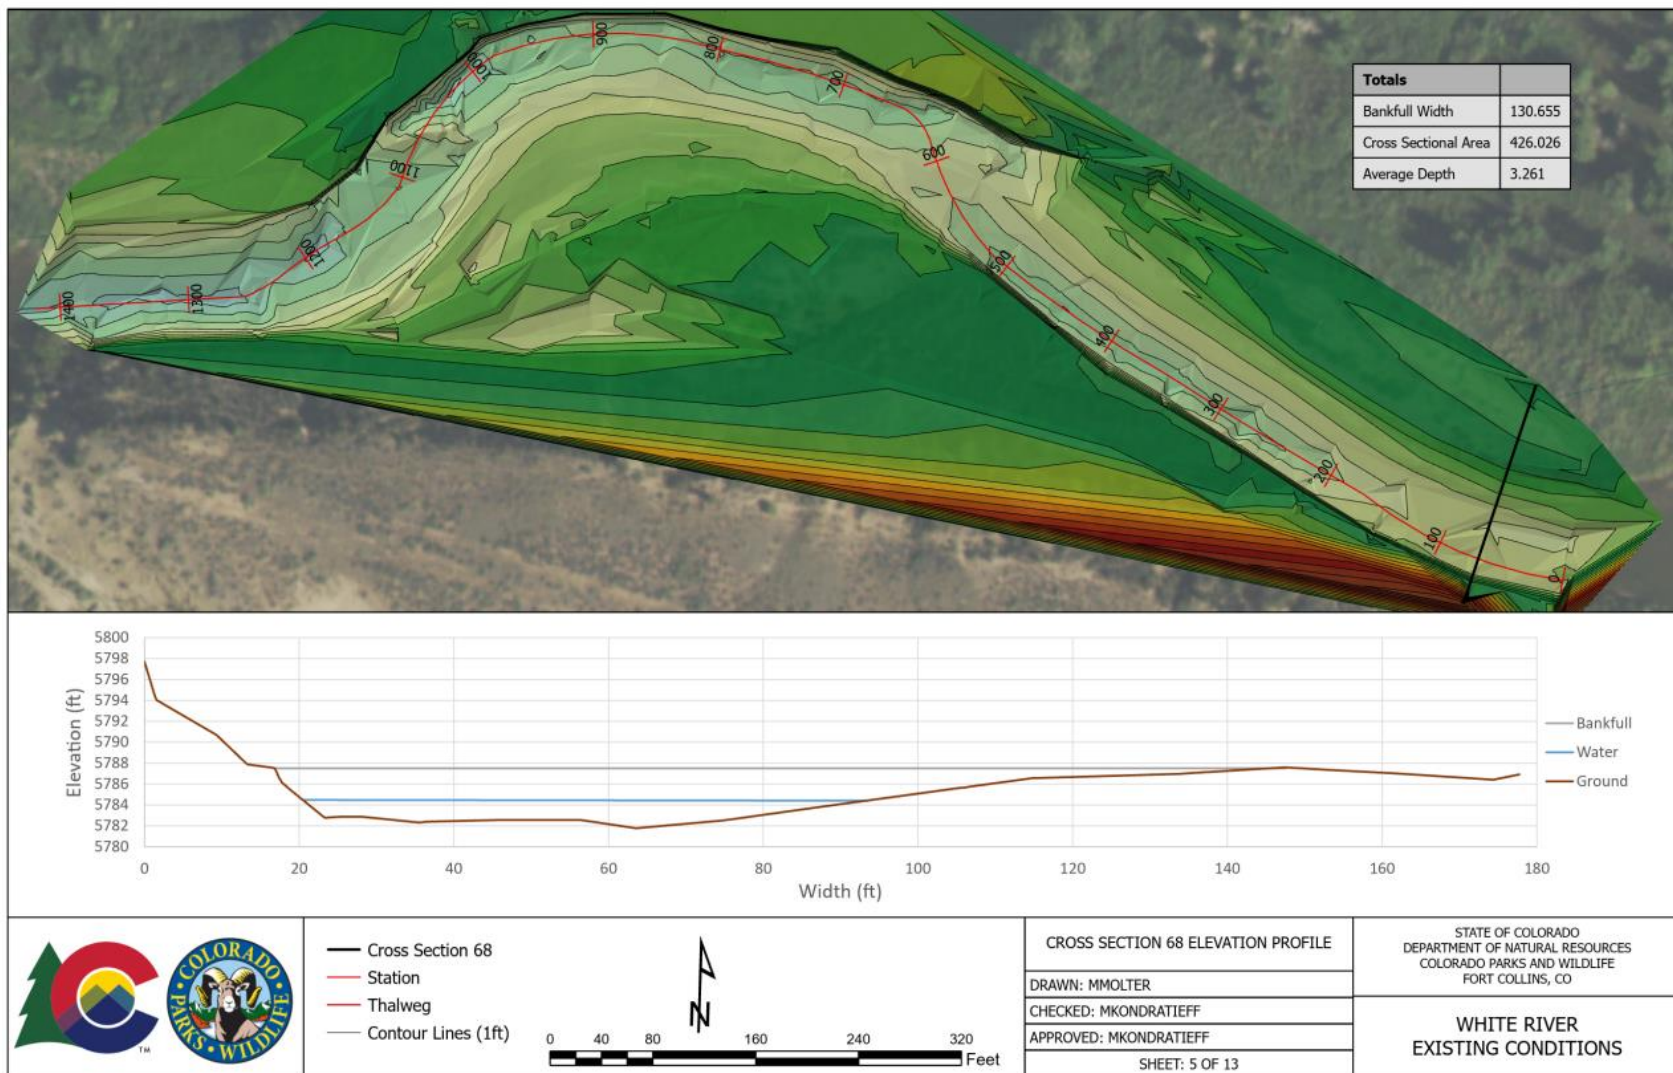
**Figure B5.** Location and profile graph for the cross section at station 68.

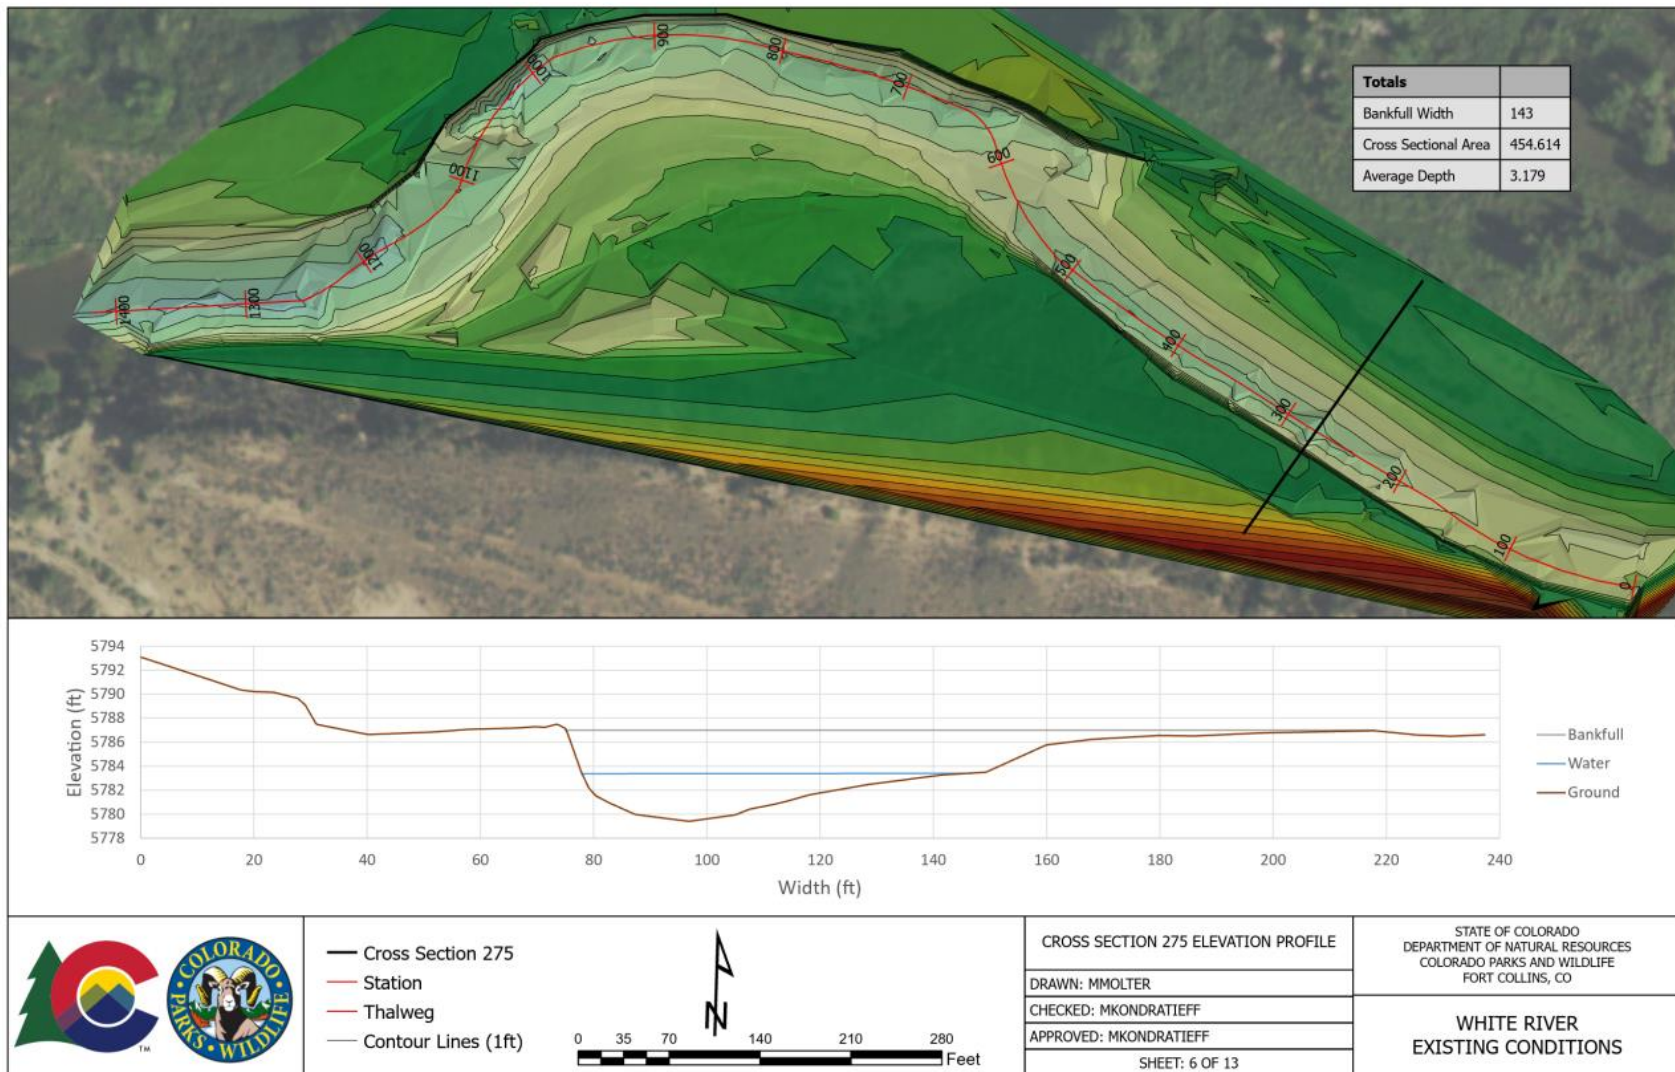
**Figure B6.** Location and profile graph for the cross section at station 275.

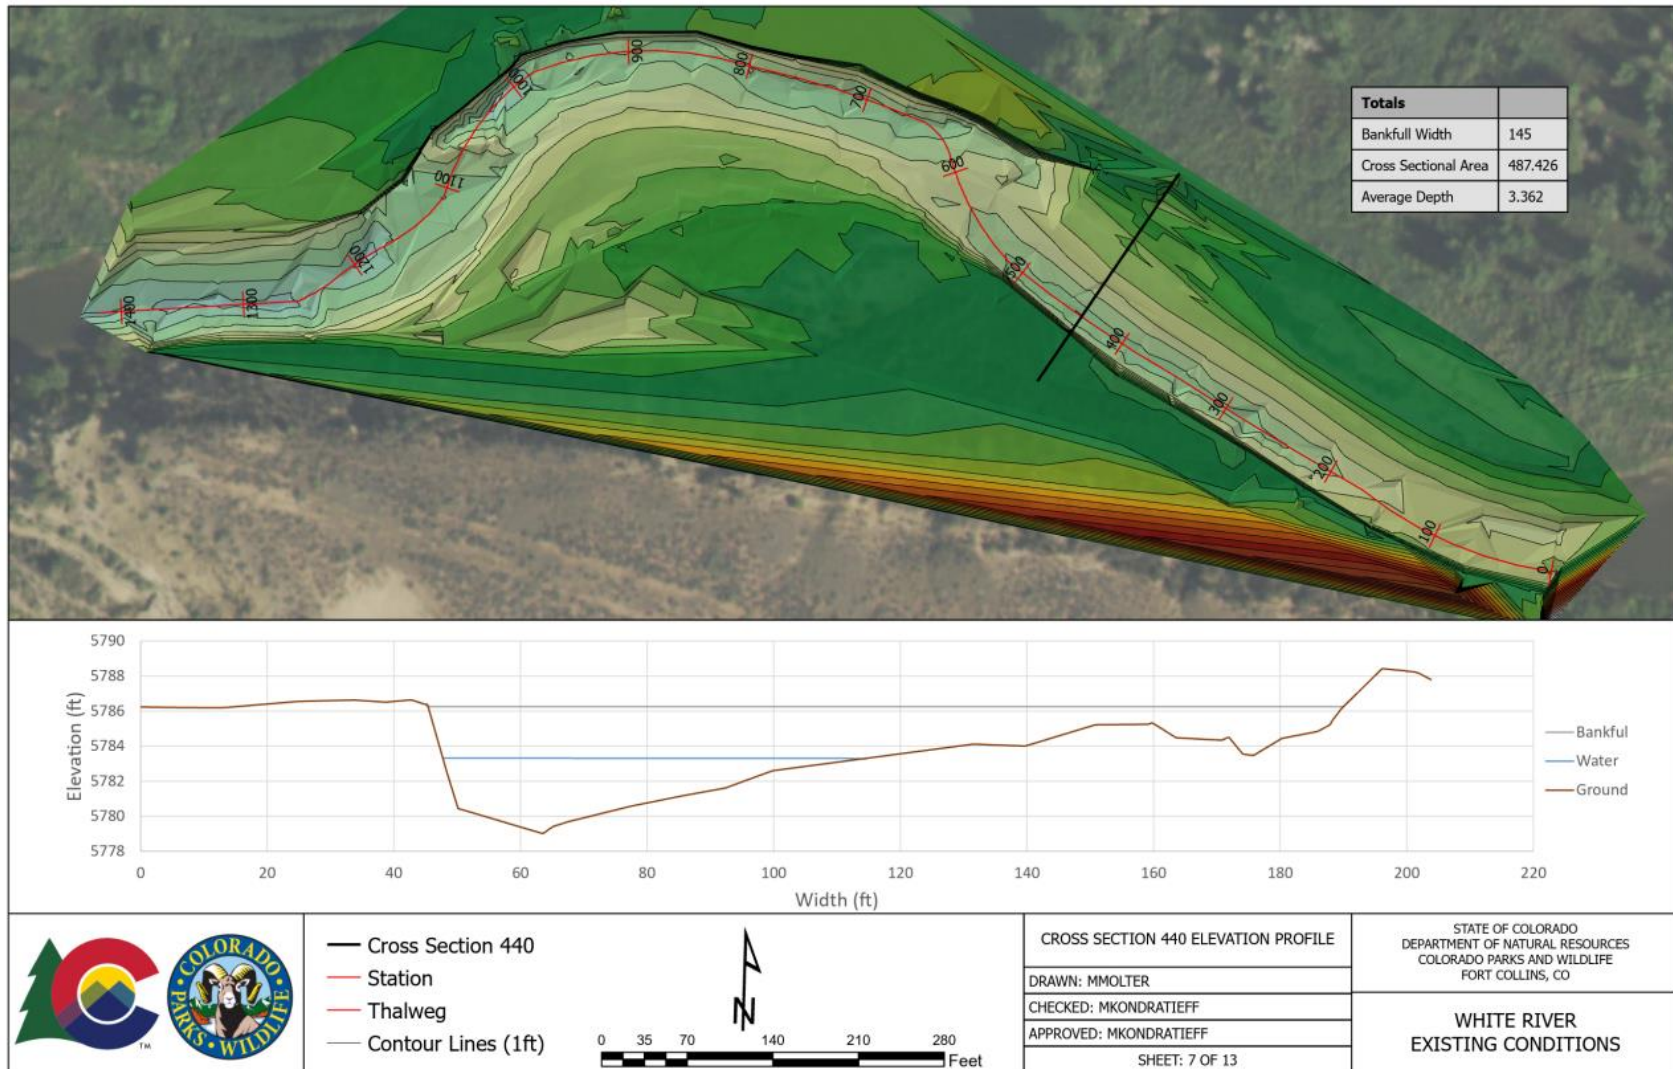
**Figure B7.** Location and profile graph for the cross section at station 440.

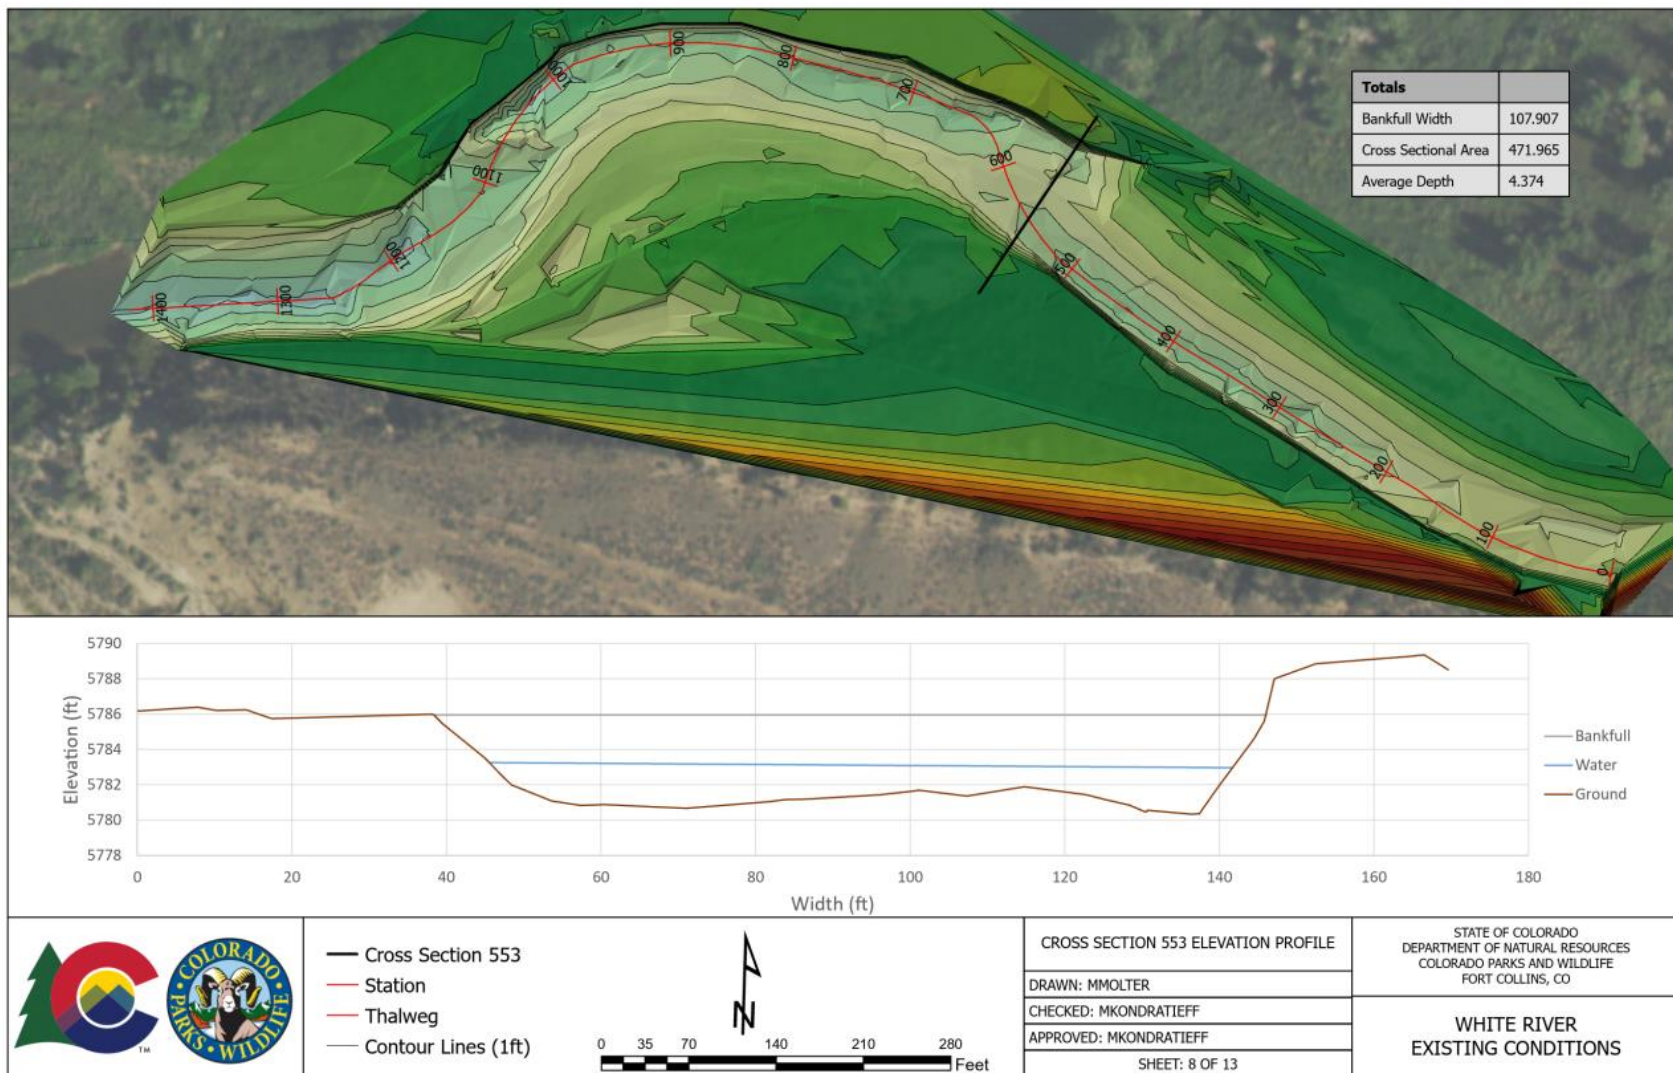
**Figure B8.** Location and profile graph for the cross section at station 553.

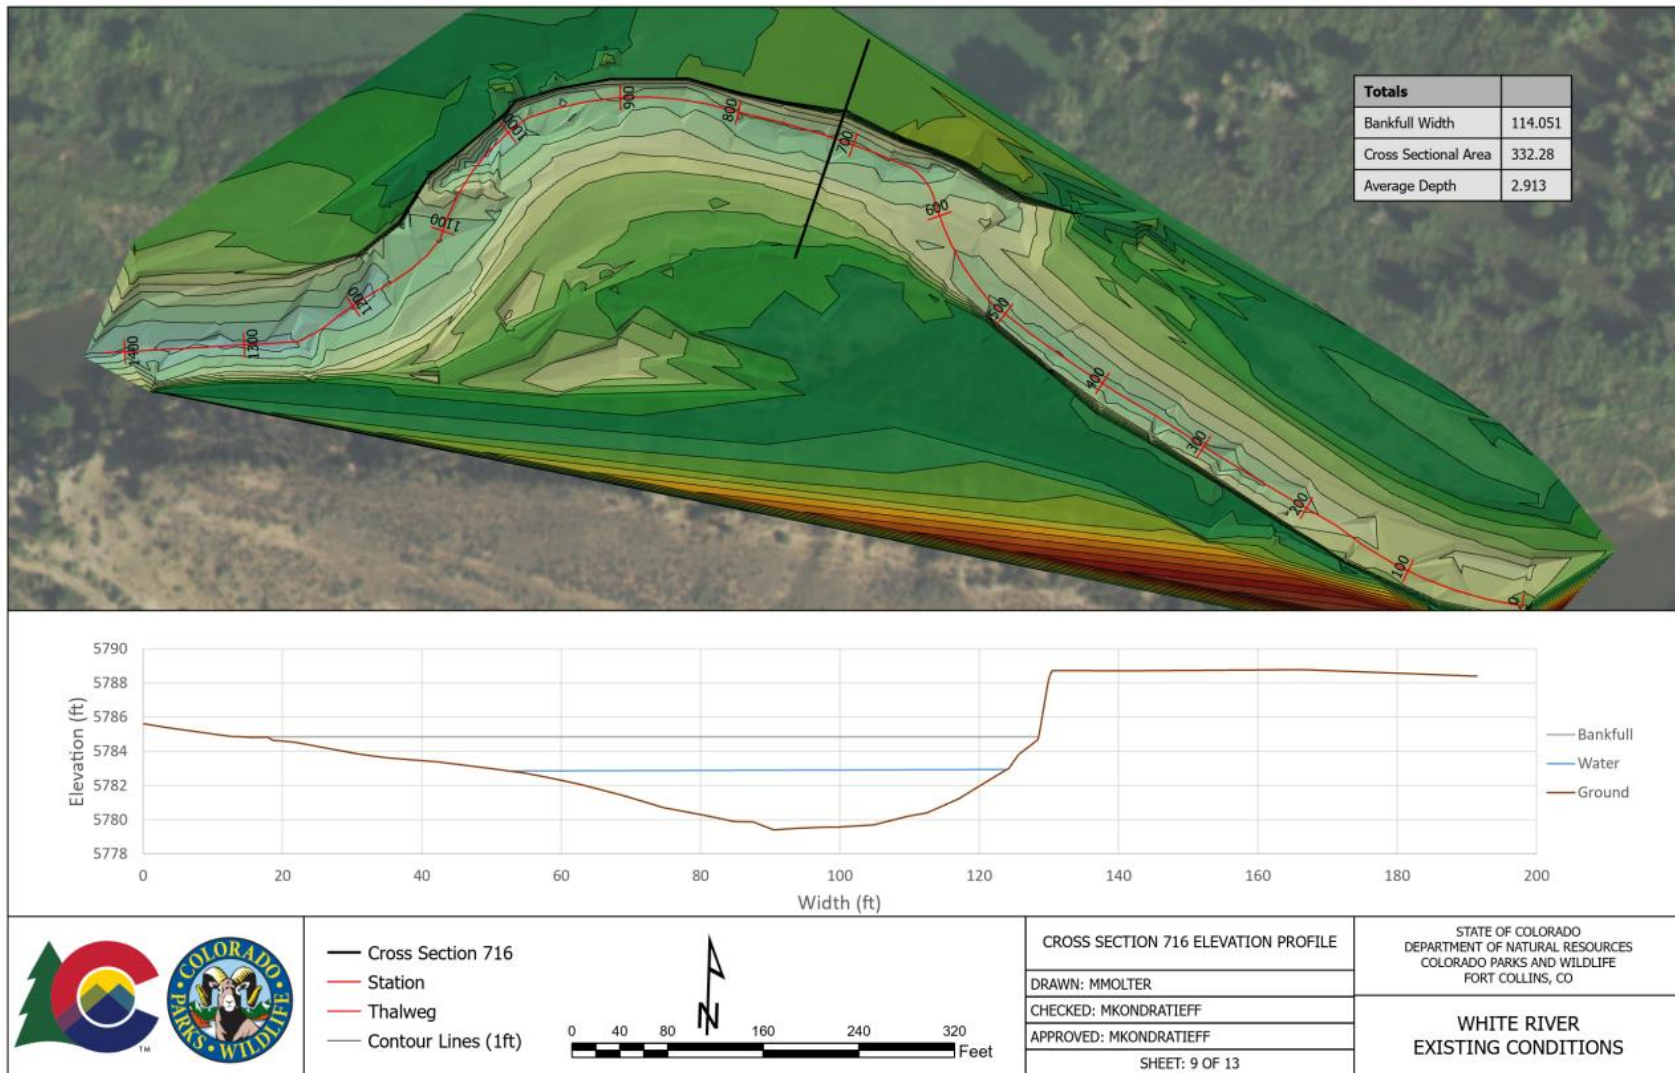
**Figure B9.** Location and profile graph for the cross section at station 716.

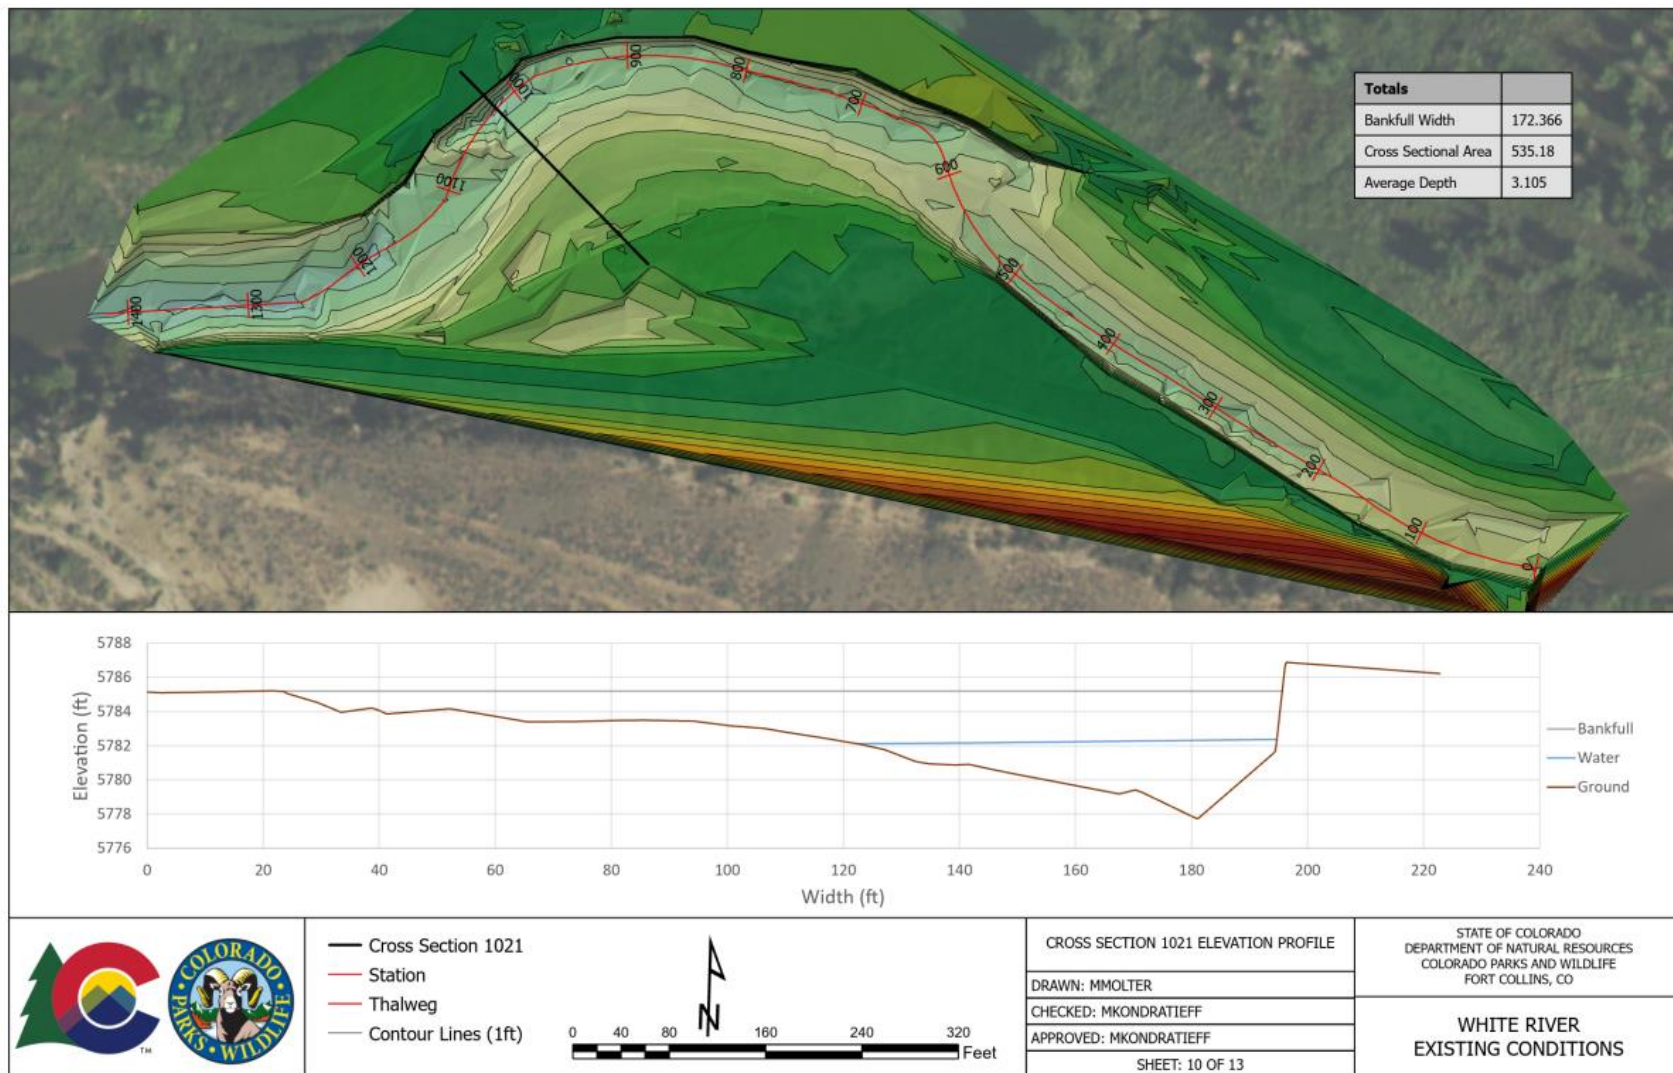
**Figure B10.** Location and profile graph for the cross section at station 1021.

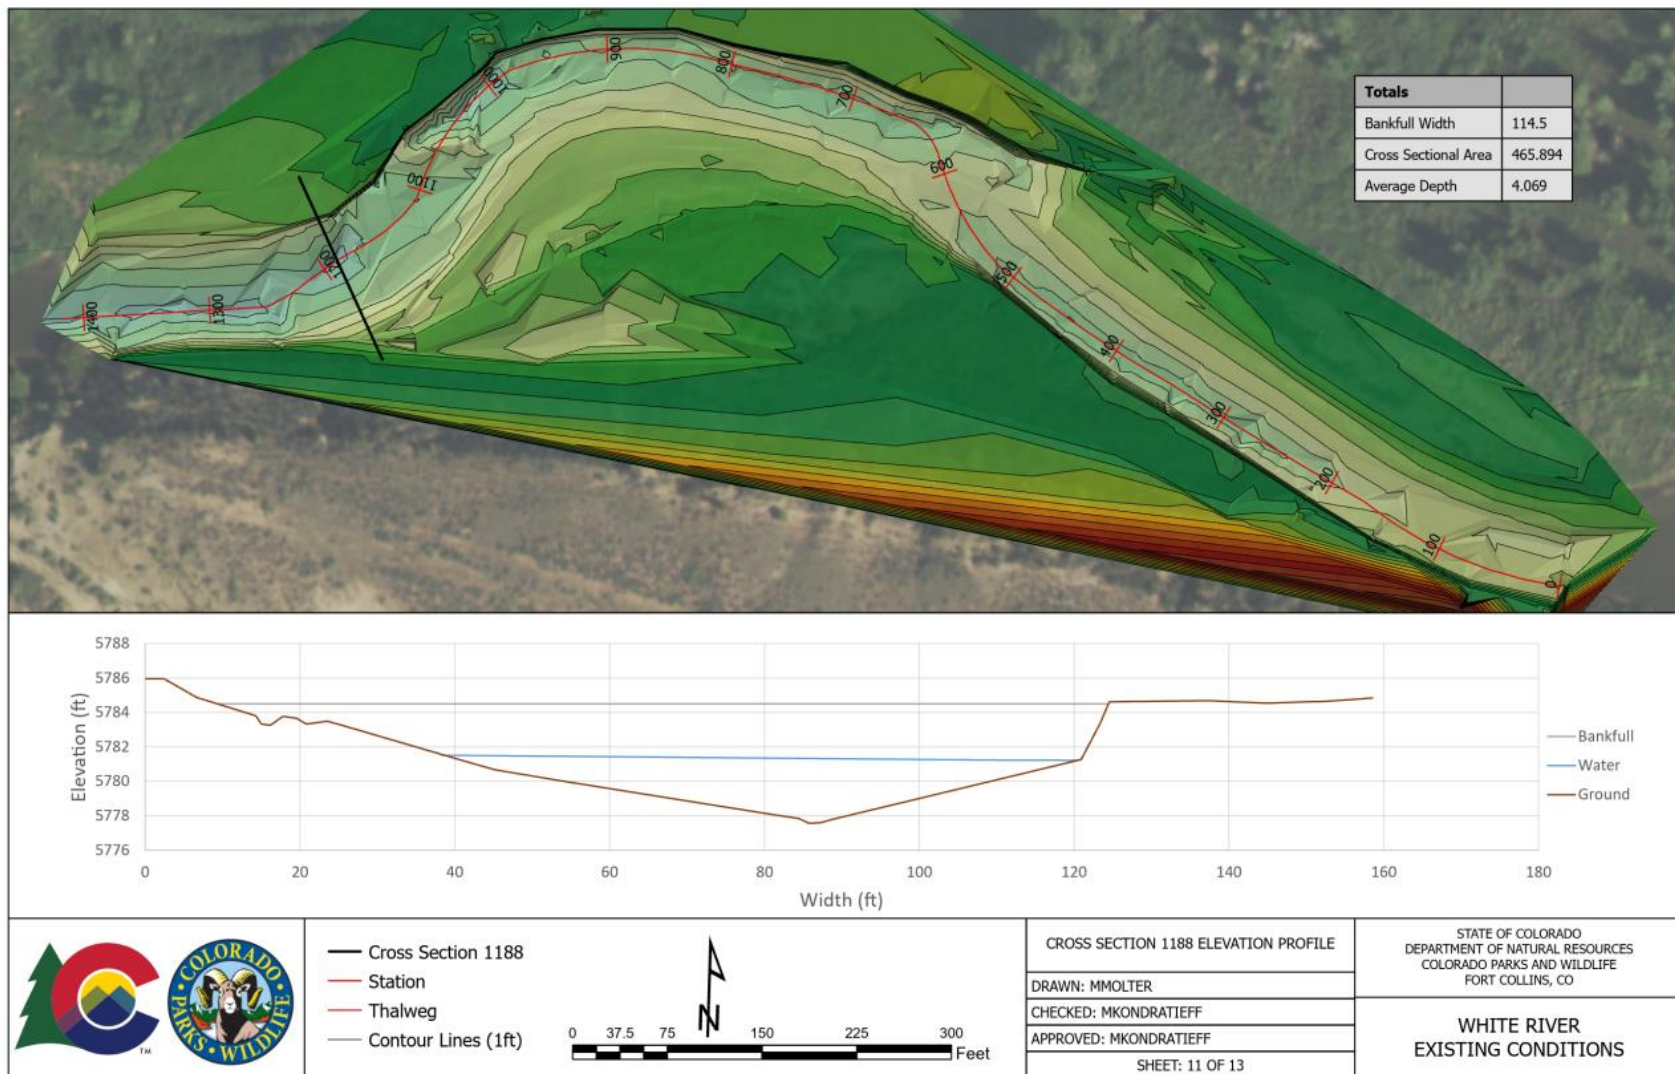
**Figure B11.** Location and profile graph for the cross section at station 1188.

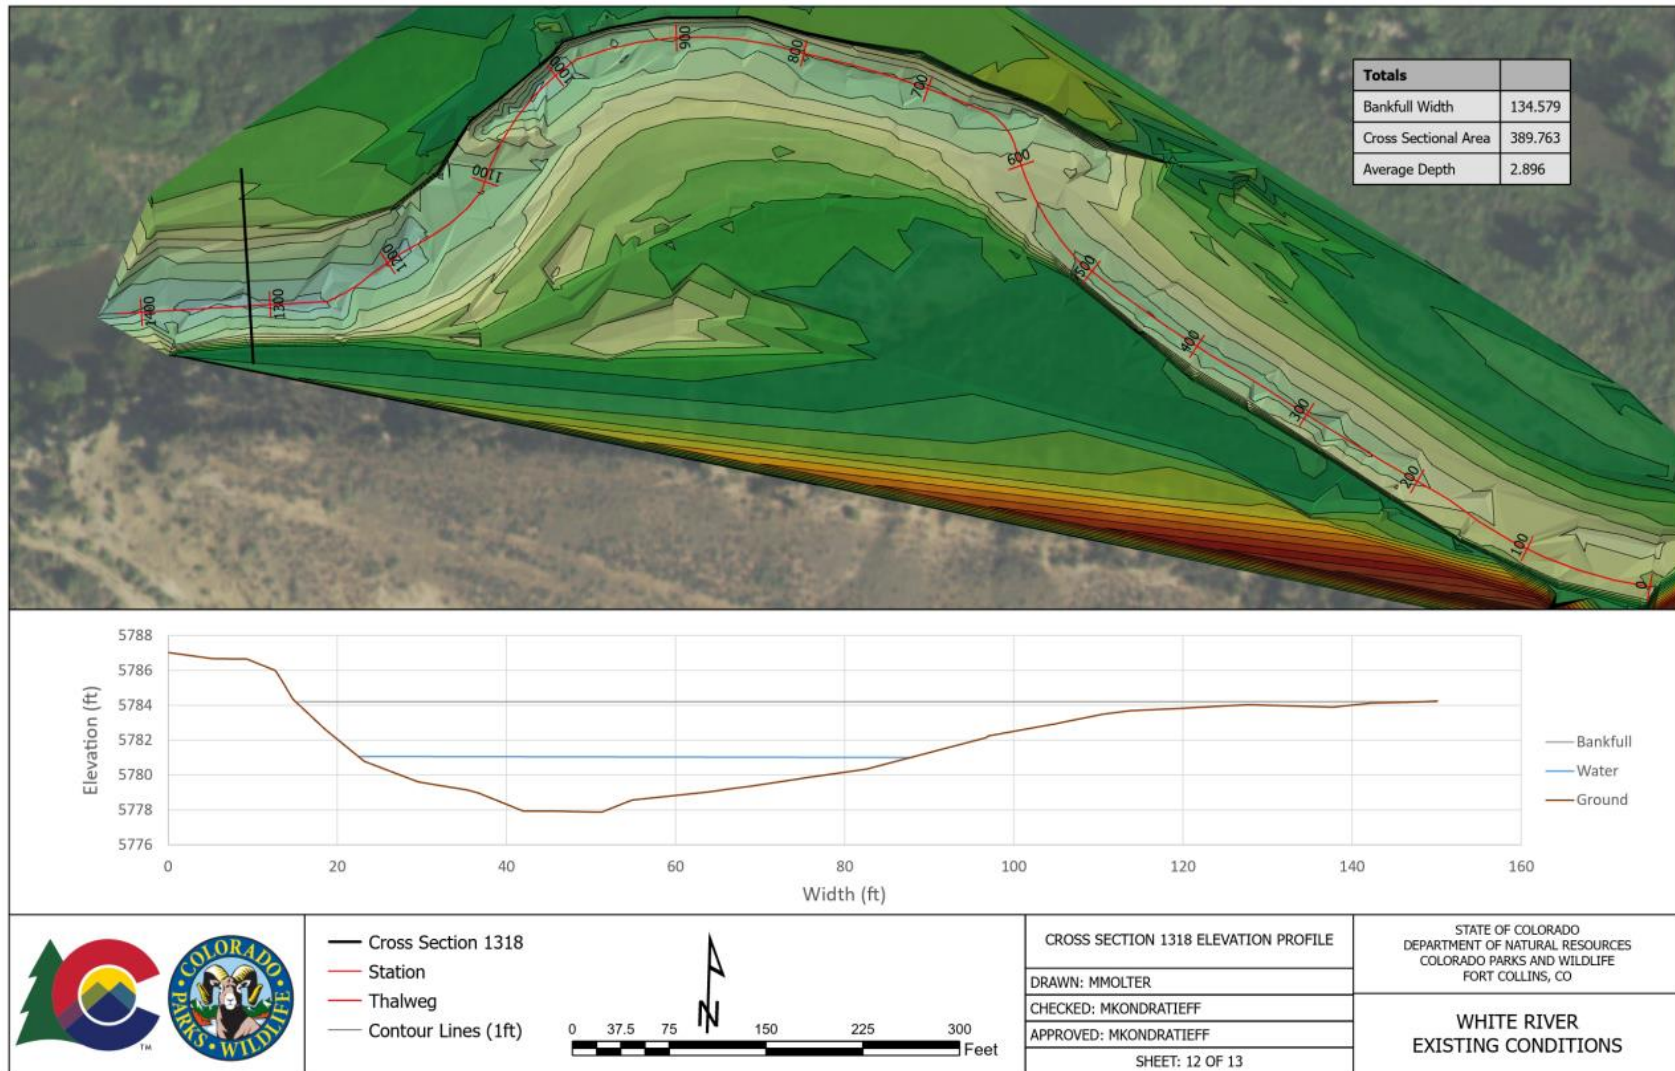
**Figure B12.** Location and profile graph for the cross section at station 1318.

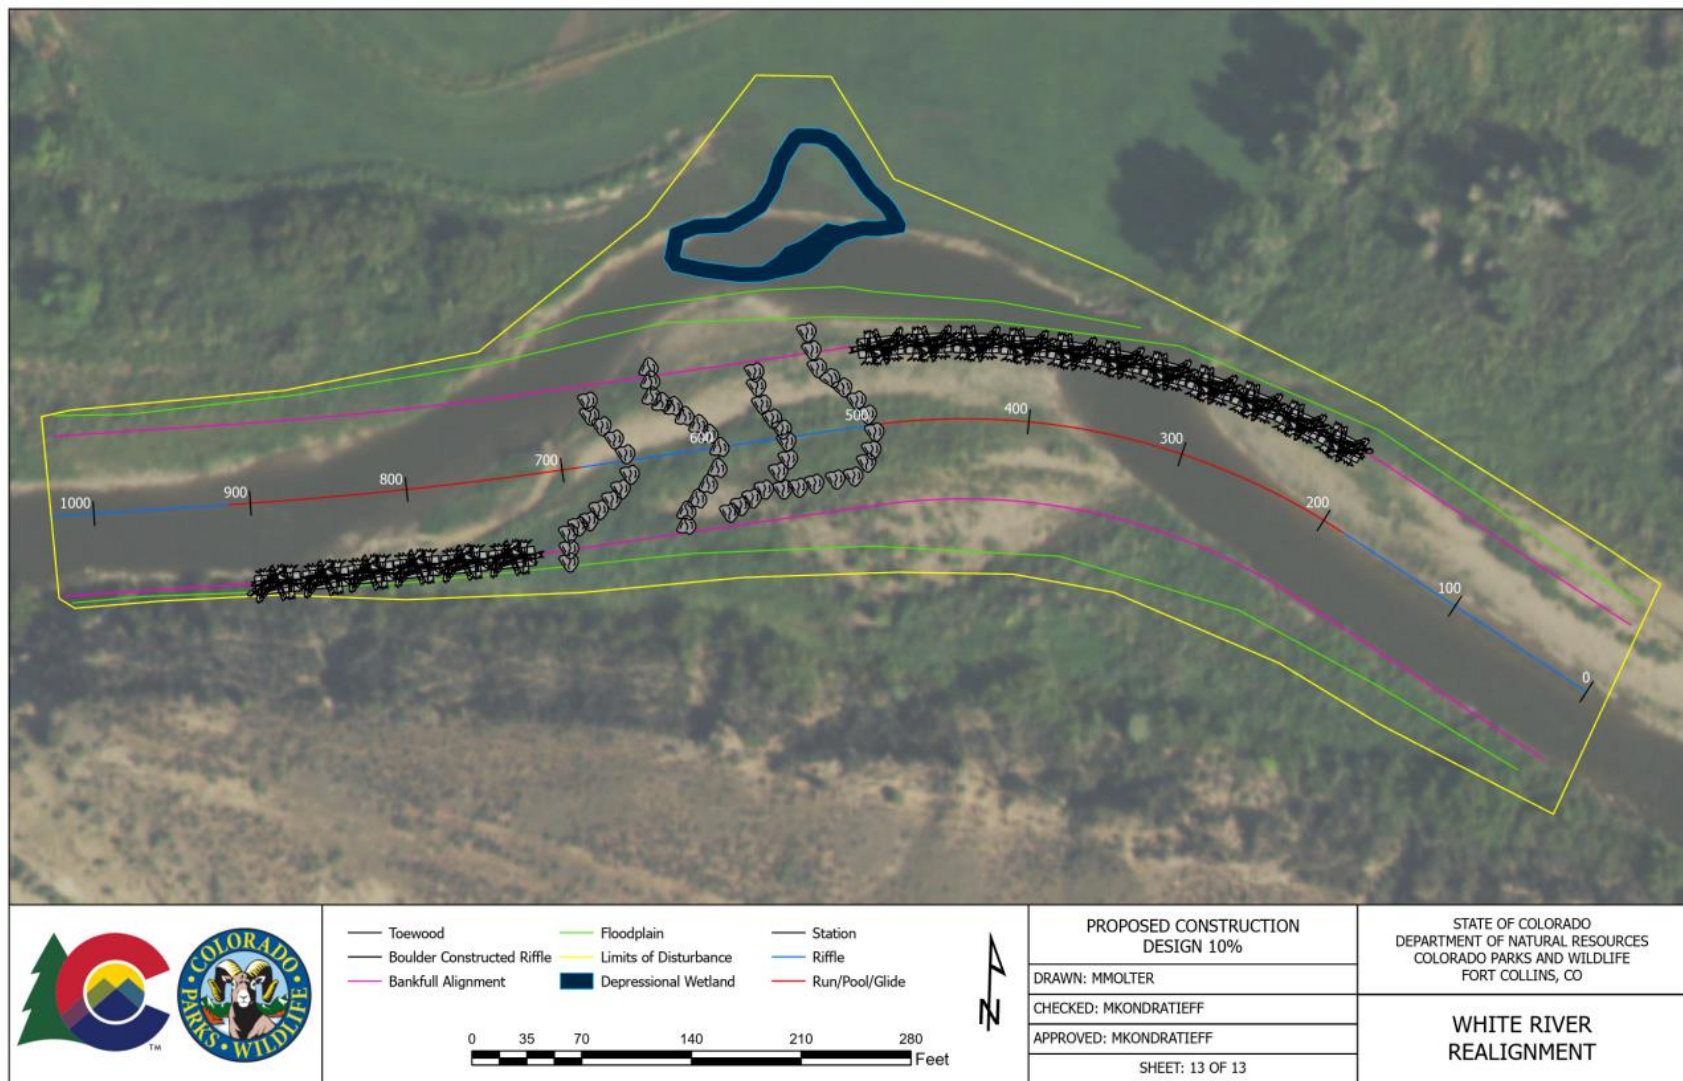
**Figure B13.** Conceptual design for channel realignment, including toewood bend and boulder constructed riffle.
