CONTROLLED MAINTENANCE REQUEST

**OFFICE OF THE STATE ARCHITECT
 AGENCY CONTROLLED MAINTENANCE SUBMITTAL/TRANSMITTAL
 STATE BUILDINGS PROGRAMS**

**OFFICE OF THE STATE ARCHITECT
 CONTROLLED MAINTENANCE REQUEST SUMMARY FY 2013/2014
 STATE BUILDINGS PROGRAMS**

Install sprinkler system in Moby B wing. This project is phase II of a master plan to fully sprinkler the Moby A, B and C wings. (CSU has self-funded sprinkler system installation in A wing, in coordination with the concourse and training room expansions). This project will require extensive asbestos abatement of sprayed-on fireproofing above the ceiling, as well as complete removal of existing ceilings as hazardous waste. Once abatement is complete the sprinklers will be installed and ceilings replaced. Each wing of the building is a stand alone phase. C wing contains the Moby swimming pool and related facilities, and is a low priority for sprinkler installation at this time.

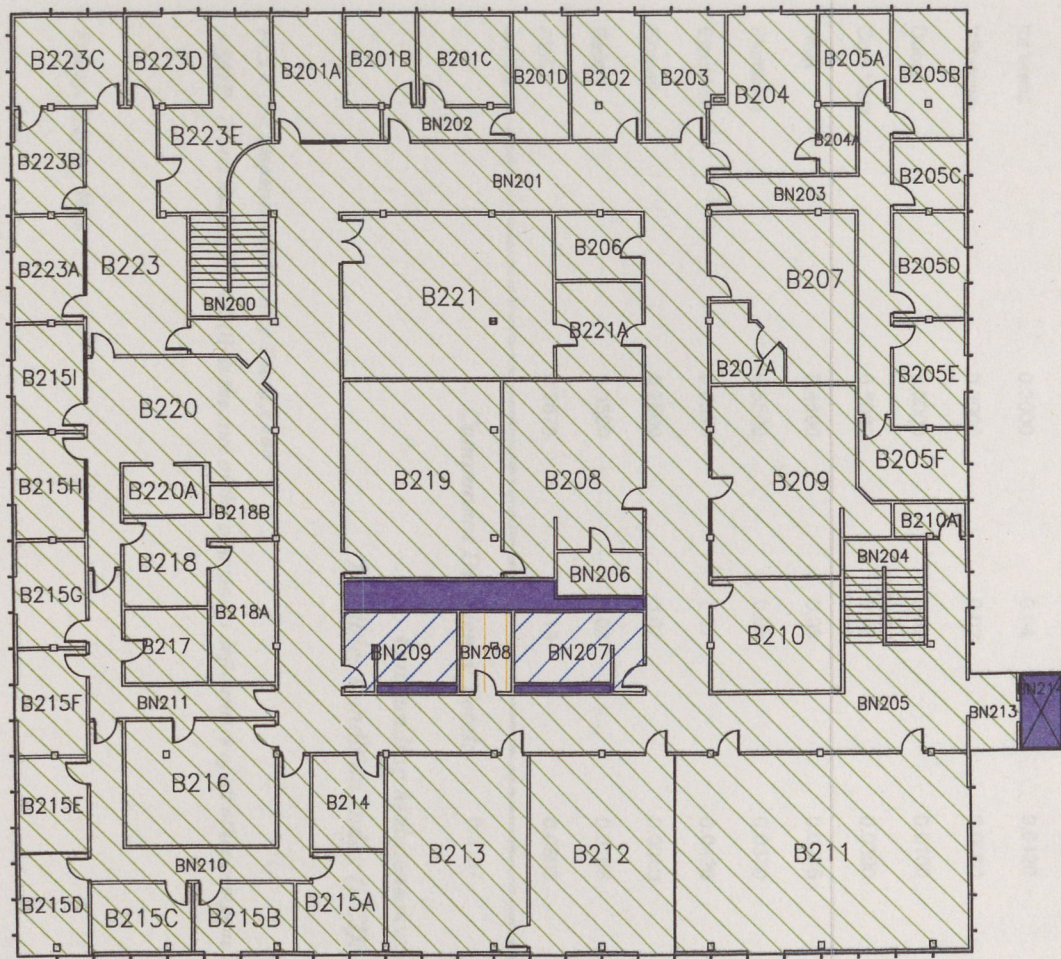
PROJECT NO.: 3891.12	
First Floor	SCALE: Not to Scale
DRAWN BY: NR	DATE: 07-27-12

Colorado State University
 Moby B Wing

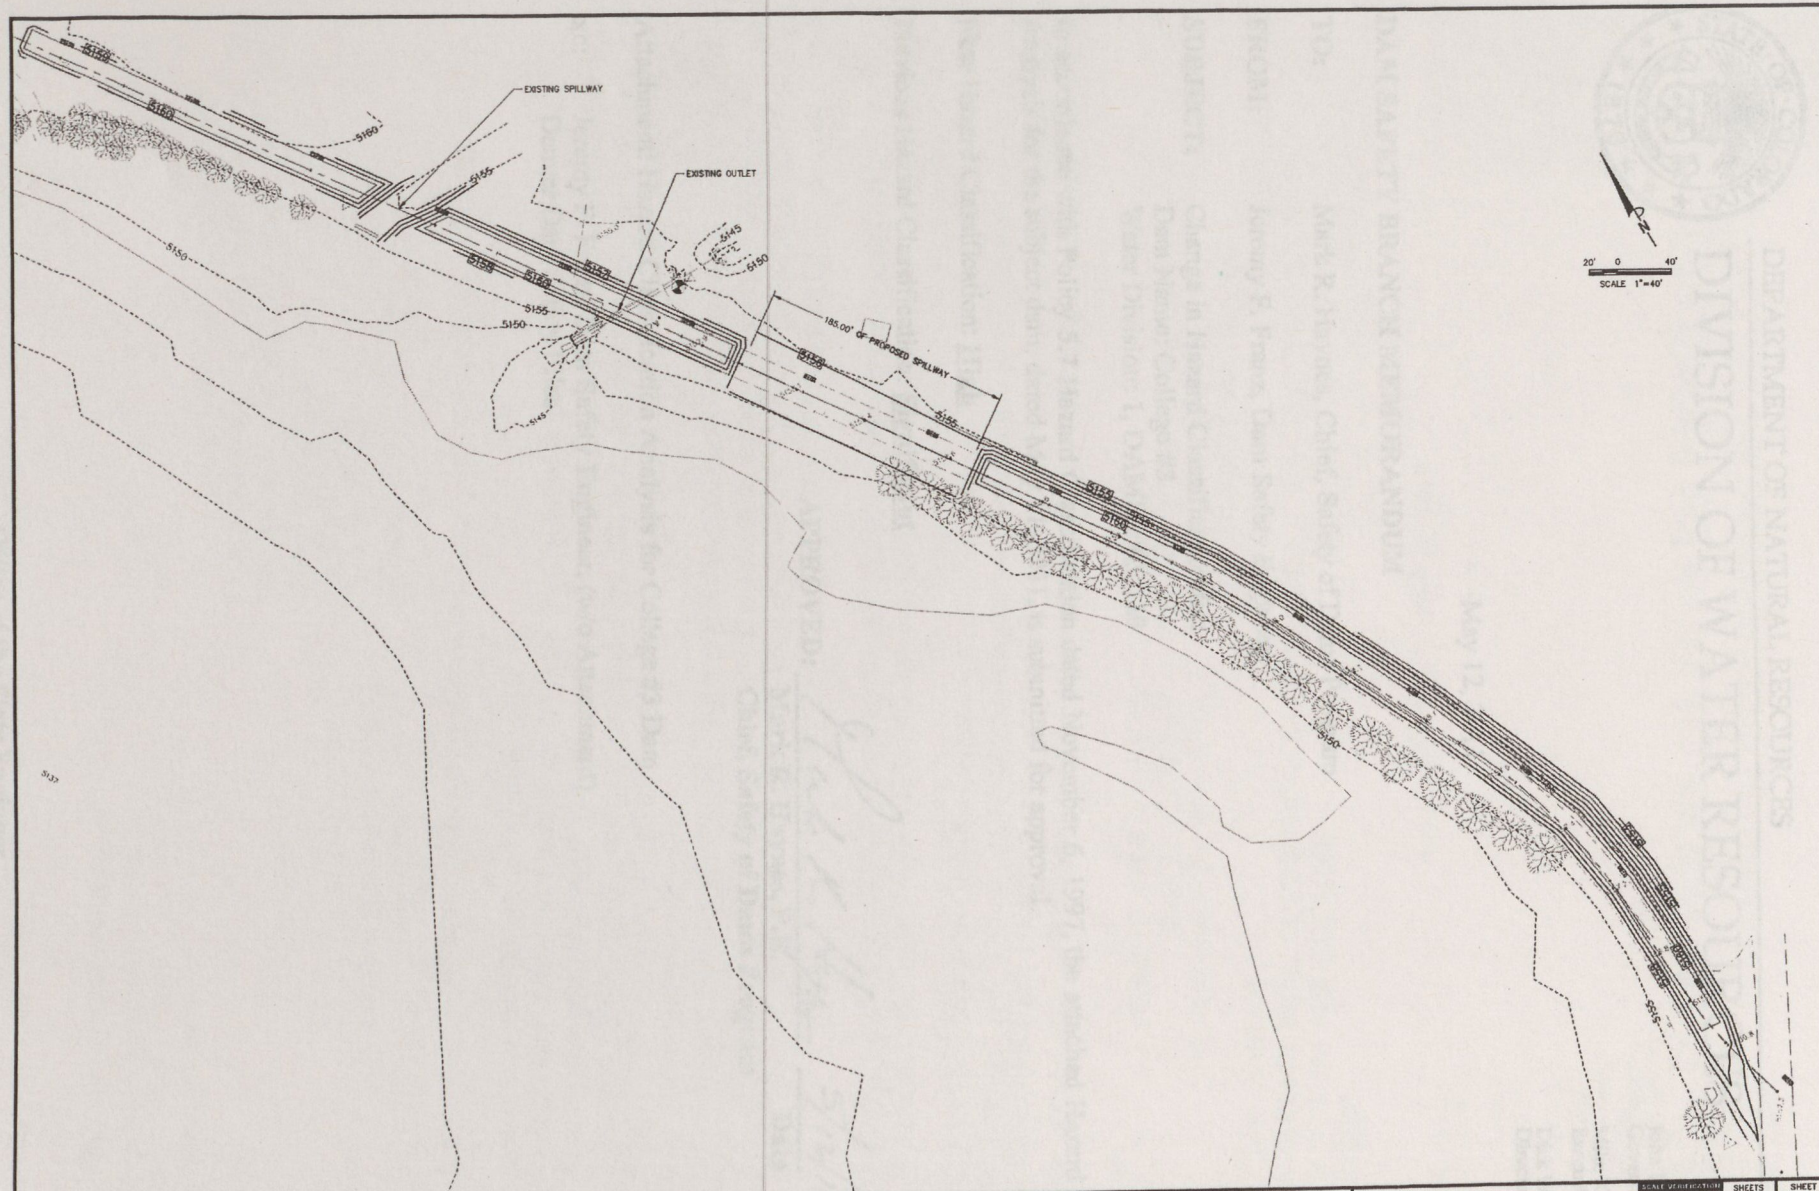
Notes:
 Spillway width of 185 feet
 20' of Riprap and Bedding protection downstream of the new spillway
 Assumes a 21" D50 Riprap with 6" of Bedding
 12"

4.5' fbd.
