## Introduction

# Operable Unit 4 Remedial Work Nearly Complete

## EPA Completes Virginia Canyon Removal Action

## Operable Unit 4 Remedy Status Report

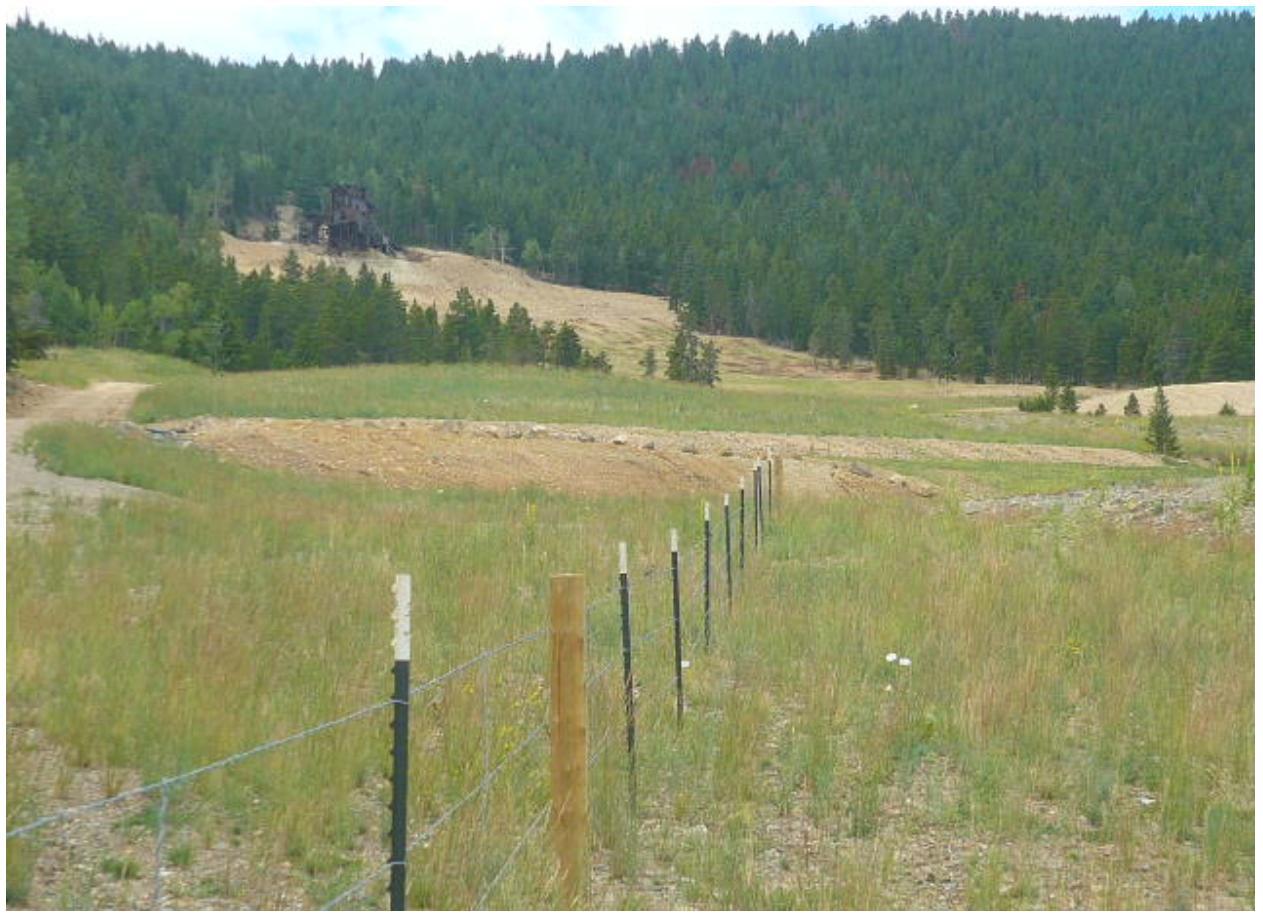
Revegetation of the final cover of the Church Placer Repository began last fall and was completed this spring. Thanks to a wet growing season, the vegetation was well established by mid-summer and native "volunteer" species had begun to spread.

Construction activities included regrading and construction of water-management features, implemented in 2008 and 2009 using a local contractor. Approximately 26,000 cubic yards of waste rock and tailings were consolidated in the repository from Russell, Willis and Nevada gulches. Ten thousand cubic yards of residual capacity remain.

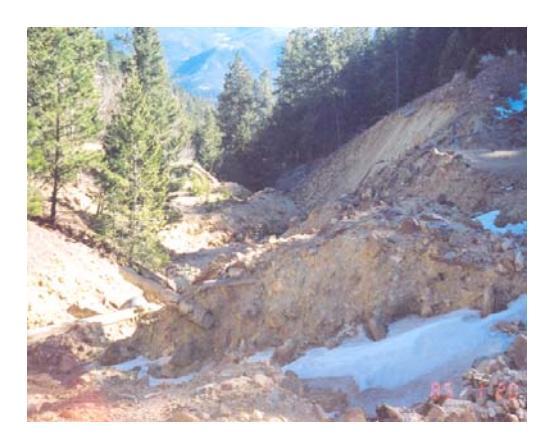
The Diamond Joe Waste Rock Pile (left), Trio Waste Rock Pile (right) and other mine waste rock piles had eroded into the Virginia Canyon channel, which created the need for this summer's removal action by the U.S. Environmental Protection Agency.

An EPA removal action during the summer addressed five major and a few secondary waste rock piles located along the Two Brothers mine road in Virginia Canyon, halfway between Central City and Idaho Springs. The piles were excavated and consolidated at the Rio Grande waste dump.

Work began with the Williams and Rio Grande waste piles, where waste rock in the immediate vicinity of the drainage were excavated and consolidated at the Rio Grande waste dump. Waste rock piles from the Diamond Joe, Lower Clarrisa and Trio also were removed and hauled to the Rio Grande waste dump.

The remaining waste pile and the excavation area was re-contoured and armored to control future precipitation run-off from the area. Grouted rip rap channels run through the area where the waste rock pile was located at the Williams, along the road of the Rio Grande, and along the base of the Trio mine waste pile to help prevent erosion, stabilize piles and contain run-off. This work and the removal of a few secondary mine waste piles was completed in August.

Although run-off from Virginia Canyon into Clear Creek generally is minimal, the water often reaches flood level during heavy rainstorms and post-winter snow melt/run-off events. This water severely undercuts and erodes the various mine waste piles located in Virginia Canyon.

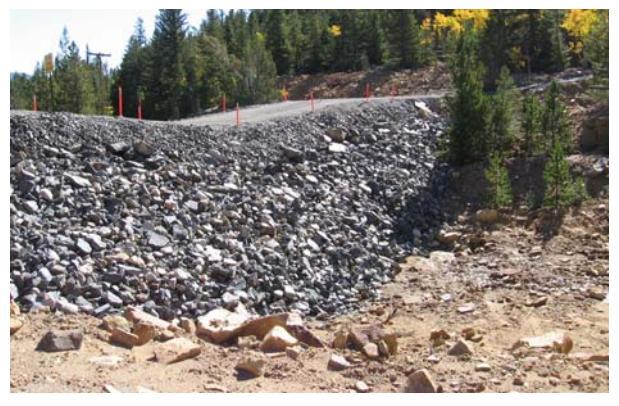
The Nevada Gulch Sediment Retention Basin was constructed in 2007 as part of OU4, Phase I.

Additional sediment-control measures included construction of sediment-retention basins in Russell and Nevada gulches and drop structures and check dams in Russell and Willis gulches.

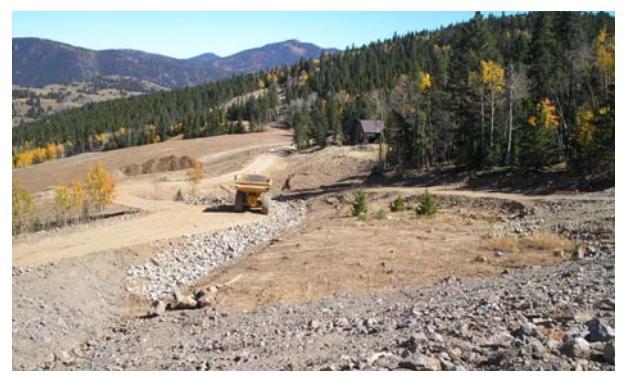
Construction of a new repository cell will start this fall.

Construction of a new cell at the Church Placer Repository will be completed this fall. The cell will accommodate an additional

37,000 cubic yards of mine-related waste from EPA and CDPHE remedial actions. In addition, the town of Black Hawk, the Clear Creek Watershed Foundation, the Colorado Department of Transportation (CDOT), the Colorado Division of Reclamation, Mining and Safety (DRMS) and the Upper Clear Creek Watershed Foundation all have expressed interest in relocating mining-related waste to the new cell.
