Bear Creek Watershed Association

2011 Annual Report for the Water Quality Control Commission

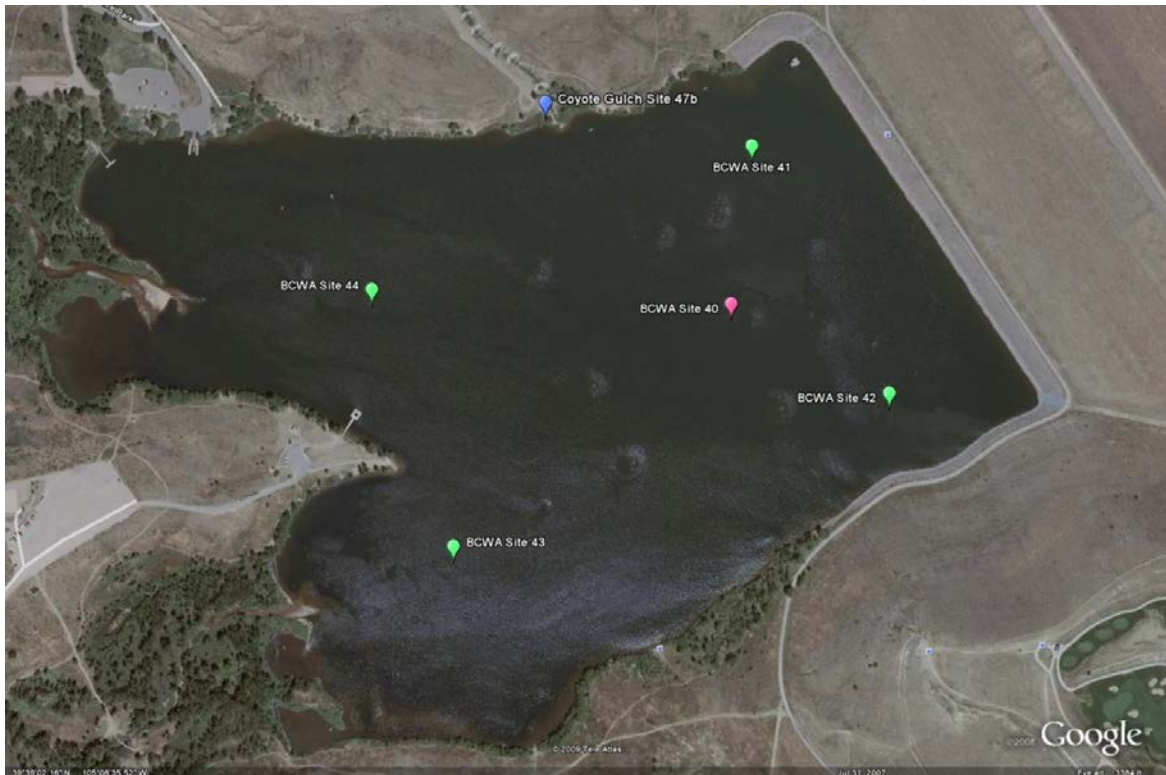
Figure 2 Reservoir Monitoring Stations; Site 2 is the Routine P1 Station

The routine monitoring program (P1) focuses on Turkey Creek drainage and Bear Creek drainage inputs, and discharge from Bear Creek Reservoir (Figure 2) into lower Bear Creek with a central pool characterization of the reservoir near the dam (BCWA site 40). As shown in Figure 2, the outlet structure is near BCWA site 41 with Bear Creek inflow near BCWA site 44 and Turkey Creek inflow near BCWA site 43. The reservoir chemistry and biological characterization monitoring occurs at BCWA site 40. Vertical probe samples for specific conductance, temperature, Dissolved Oxygen, and pH measured at 1-meter intervals at all reservoir sites. The current monitoring program optimizes data generation to evaluate reservoir inflow loading, trophic state changes within the reservoir, and reservoir outflow, while minimizing monitoring cost. The aeration sites are visible in Figure 2. Figure 3 shows all monitoring stations within Bear Creek Park. Figure 4 shows a map of recent sampling sites and wastewater treatment plants.

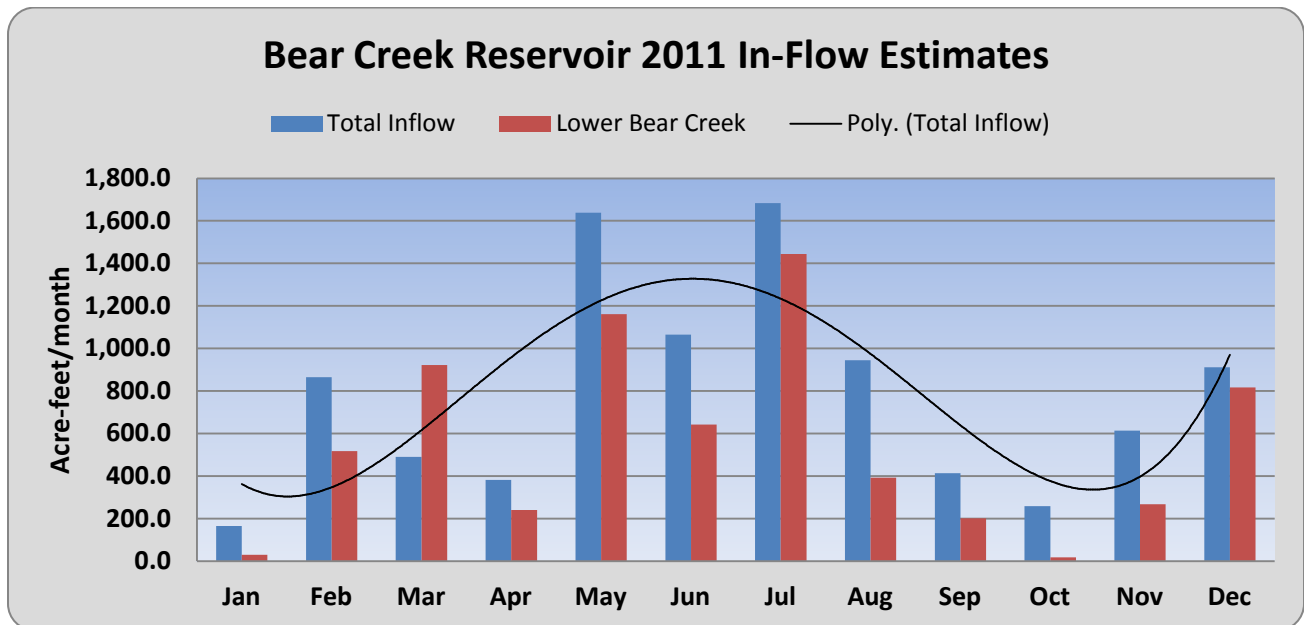
Figure 5 Bear Creek Reservoir Inflow and Outflow

Evaluation of water quality in the reservoir includes examination of the basin hydrology, as well as chemistry. Figure 5 shows the Association estimated 1987-2011 total annual flow discharge into Bear Creek Reservoir. In 2011, the total estimated annual discharge into Bear Creek Reservoir was about 9,432 acre-feet (Figure 5) with about 6,660 acre-feet flow through and 2,773 acre-feet of evaporation. Figure 6 shows the total reservoir inflow trend from 1987-2011.

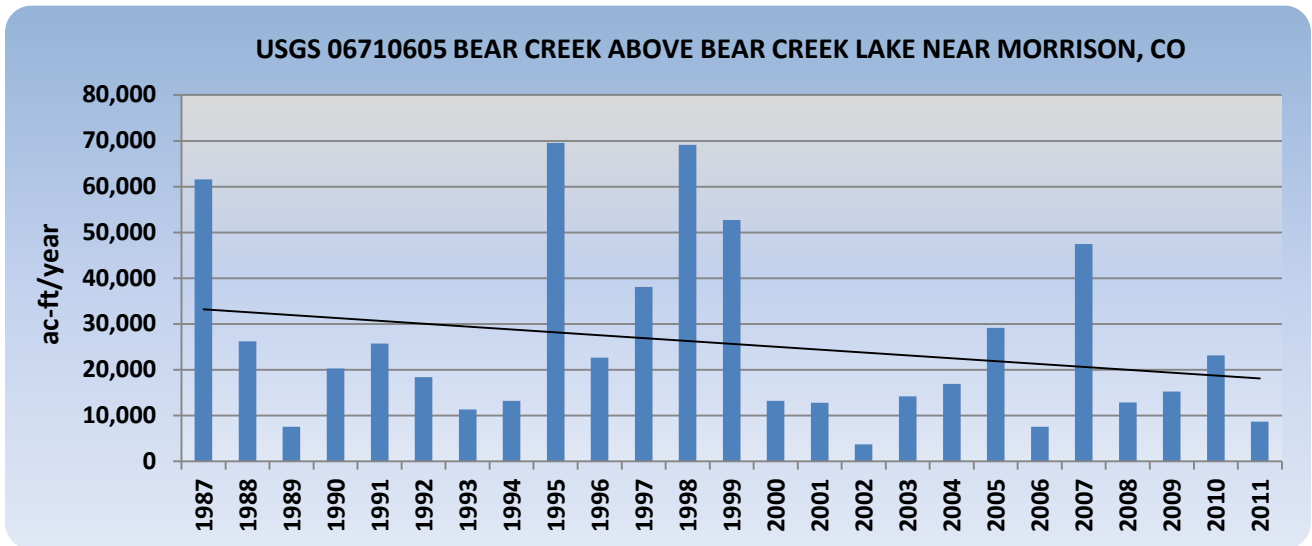
Figure 7 Bear Creek above Bear Creek Reservoir Annual Acre-feet/year Flow

The reservoir inflow represents flows below the water diversions and is not representative of the total watershed water flows. Bear Creek flows above Bear Creek Reservoir (Figure 7) and at the Evergreen gaging station (Figure 8) provide an estimate of the amount of water diverted from the watershed before reaching the reservoir. For example, in 2011 the Bear Creek water use diversion reduced flow to the reservoir by about 6,250 ac-ft (-40 %). Additionally, the longer time trends shown in Figures 6 and 7 depict a basic linear trend of declining flow in Bear Creek. Figure 9 compares the 2011 reservoir monthly inflow estimates from Bear Creek (86%) and Turkey Creek (14%). Peak runoff occurred in May 2011. The increased Bear Creek flow in July came from two large rainfall events.

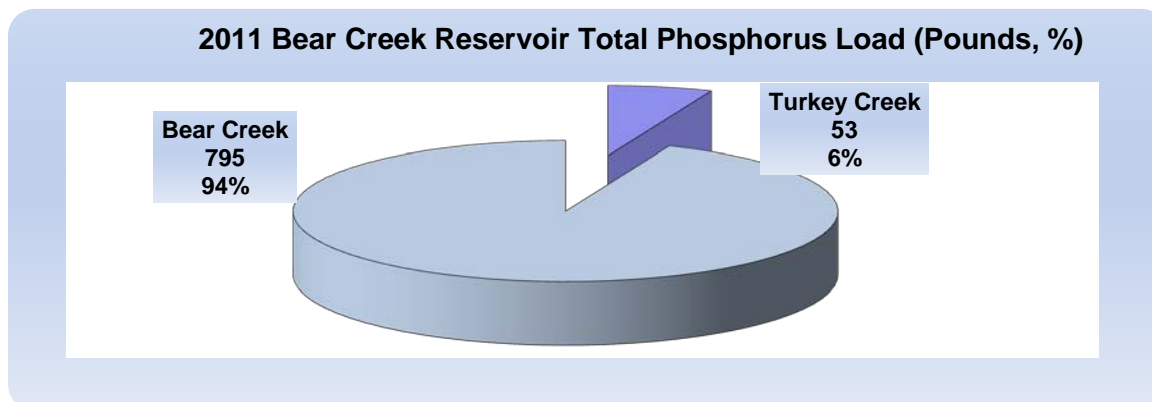
Figure 10 Estimated Total Phosphorus loading in 2010

The total phosphorus load from the watershed comes from a combination of wastewater treatment plant point source loads and nonpoint sources, including runoff. There are over 27,000 septic systems in the watershed. The estimated total phosphorus load in 2011 from all sources reaching the reservoir was 847 pounds at a flow of about 9,432 acre-feet. Bear Creek drainage contributed 94% of the load (Figure 10). Although the point source discharges of total phosphorus were about **910** pounds, the water diversions above the reservoir are removing a portion of this phosphorus load and inflow water before it reaches the reservoir.

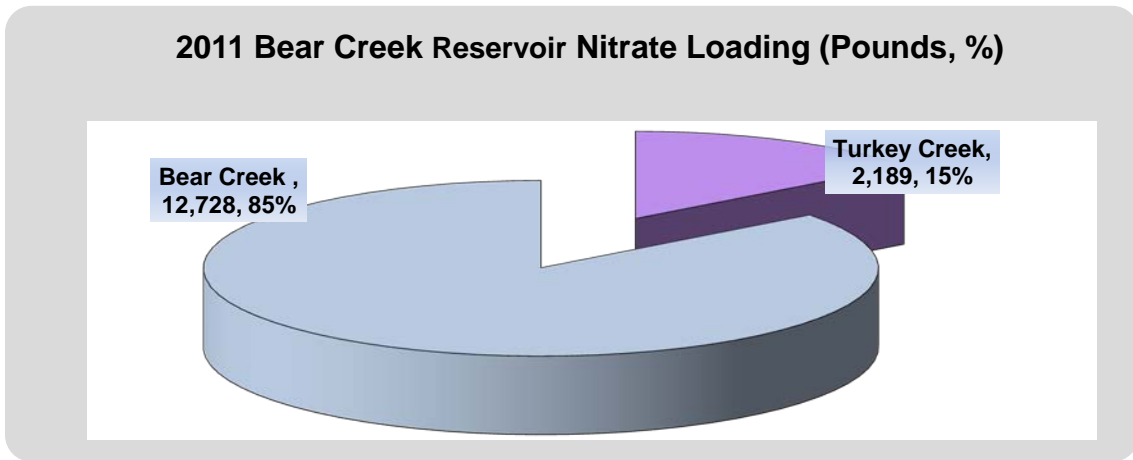
Figure 11 Estimated Nitrate loading in 2010

The nitrate loading (14,917 pounds) was lower than past flow conditions (Figure 11) with 85% of the load coming from Bear Creek. Figure 12 estimates the total nitrogen loading into Bear Creek Reservoir. There was about 21,800 pounds of total nitrogen loading with 89% derived from the Bear Creek drainage. Figure 13 shows the 2011 total phosphorus concentrations at the routine watershed monitoring stations. The management program targets reduction of total phosphorus reaching the reservoir on an annual basis. Figure 14 shows the total phosphorus reservoir trend. Figure 15 shows the 2011 nitrate concentrations at routine watershed monitoring stations. Figure 15 shows the 2011 total nitrogen trends. The reservoir nitrogen data shows a general reduction over the years (Figure 17).

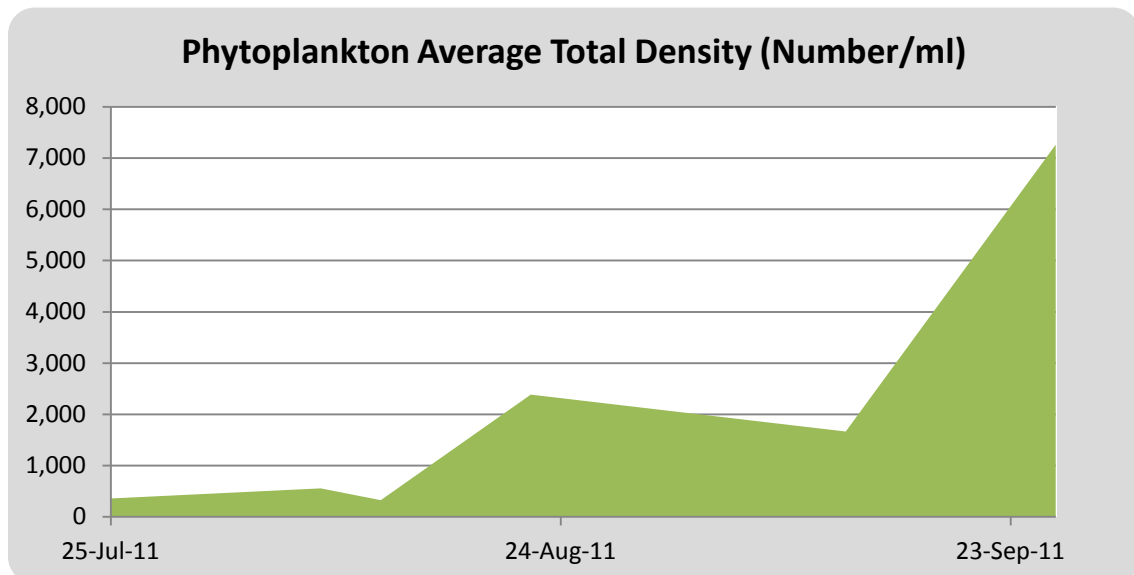
Figure 18 2011 Phytoplankton Summer Total Density

The reservoir had several algal blooms in 2011 as evidenced by the peak September chlorophyll concentration of 17.4 ug/l. In 2011, bloom frequency increased in September, as evidenced by the surface chlorophyll concentrations (Figure 20). The peak phytoplankton density in 2011 was 8,417,438 $\mu\text{m}^3/\text{mL}$ caused by a blue-green phytoplankton species. Historically, blue-green phytoplankton species are associated with major blooms in the reservoir.

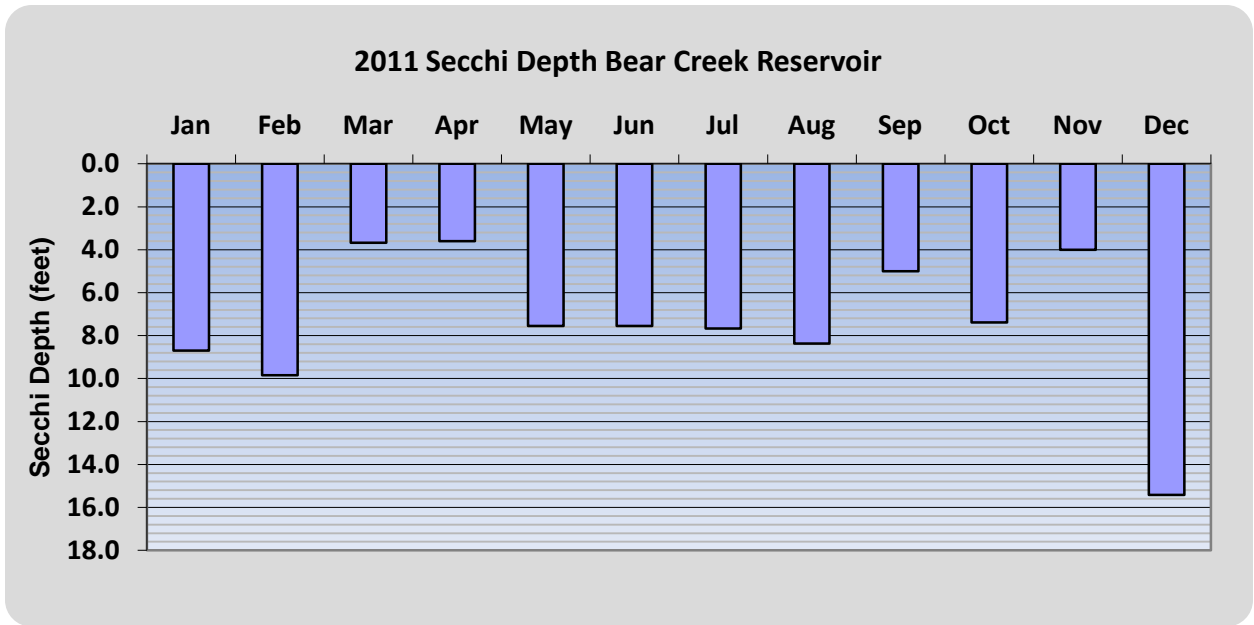
Figure 19 2011 Secchi Depth Bear Creek Reservoir

The Association’s reservoir monitoring program collects samples to analyze nutrient (nitrogen and phosphorus) concentrations, chlorophyll-a, total suspended sediments and Secchi depth as indicator trend variables (Table 3). Table 4 summarizes the 2011 reservoir data compared with the long-term patterns from 1991 through 2011. Overall, 2011 water quality improved over historic trends. Table 5 summarizes the phytoplankton data. Figure 18 shows the phytoplankton total density during summer sampling period. Figure 19 shows the general clarity trend in the water column using Secchi measurements. March and April had the poorest clarity caused by runoff.

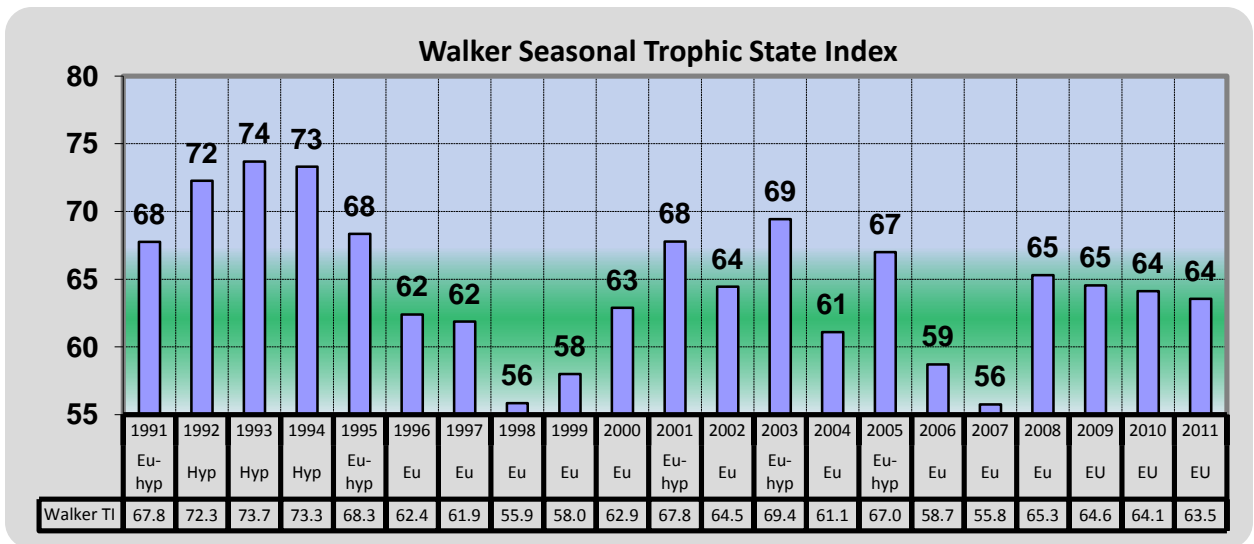
Figure 21 Walker Trophic Index Trend Bear Creek Reservoir

Generally, the reservoir trophic state in 2011 was eutrophic (Walker Index, Figure 21). The Carlson Index shows a similar eutrophic trend. Although external nutrient loads were lower than historic trends, the reservoir continues to have an internal nutrient loading problem, which causes eutrophic water quality conditions.

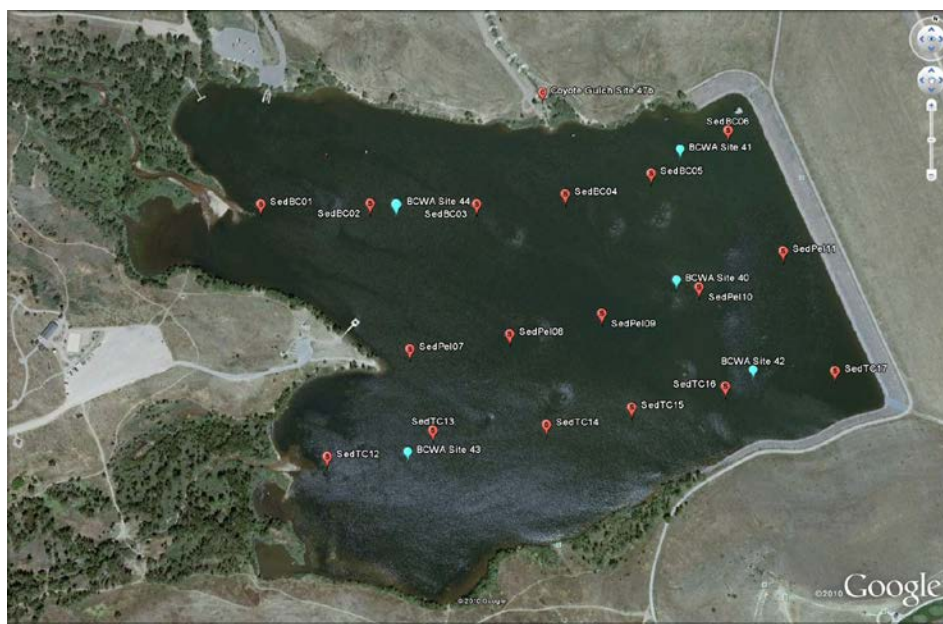
Figure 24 Bear Creek Reservoir Bottom Sample Sites

Field sampled on October 17 and 18, 2011. Bottom samples obtained with a petite Ponar sampler. This sampler takes a grab of the top 5-6 cm of the mud bottom. One dredge drop made at each site resulting in about 0.5 liters of bottom mud. The locations in Figure 24 are estimates. A sub-sample was bagged from the composite mud sampled at the site. The contents of the sample were placed in a drying pan. Samples air dried in a warm room for 48 to 72 hours. A number of the mud samples contained red worms that were about 1/2 cm long. The number of worms observed ranged from 1-14 per sample where present.

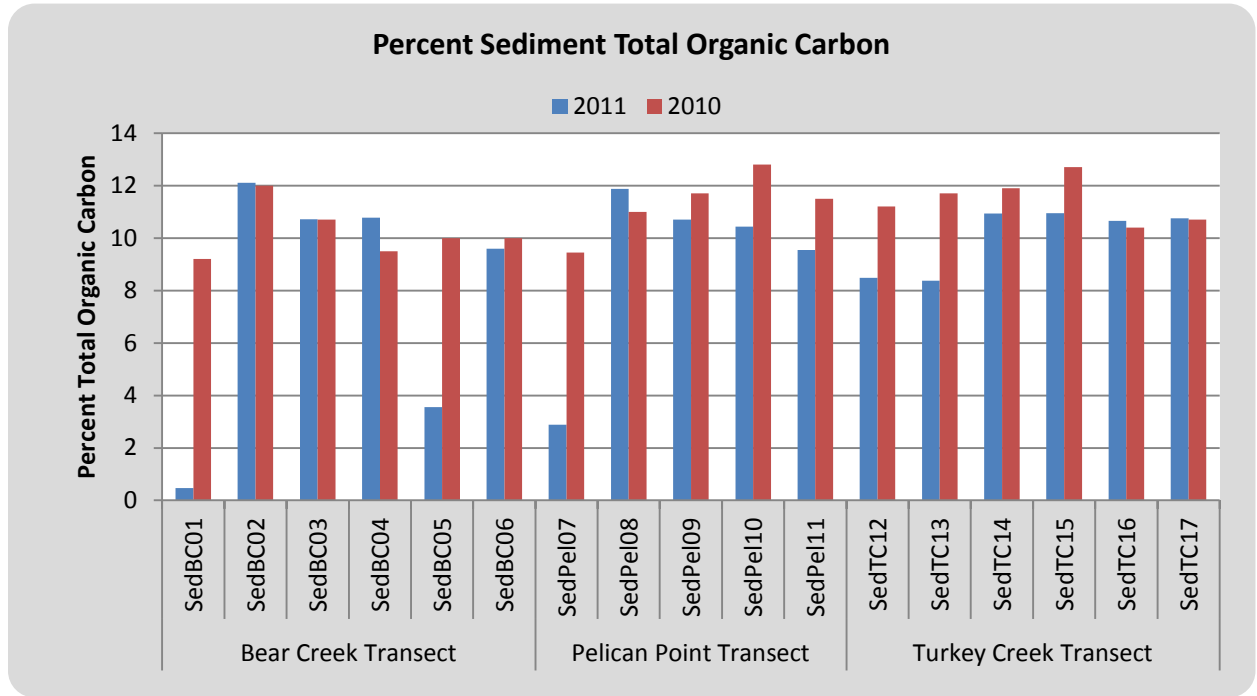
Figure 25 Total Organic Carbon in Bear Creek Reservoir Sediments

Figure 25 summarizes the total organic carbon (TOC) in bottom sediments. The TOC ranges from 3-13 % within the top 1/4m of the bottom sediments. The Association determined the total phosphorus content of the sediment (mg TP/kg Mud) as shown in Table 6. The Total phosphorus content ranged from 0.5 to 11.5 mg TP/kg Mud. There is a considerable amount of phosphorus within the bottom muds. Figure 26 characterizes the sediment grain-size distribution. The bottom sediment contains about 20% clays and silts. The Association will continue the sediment program in 2012.

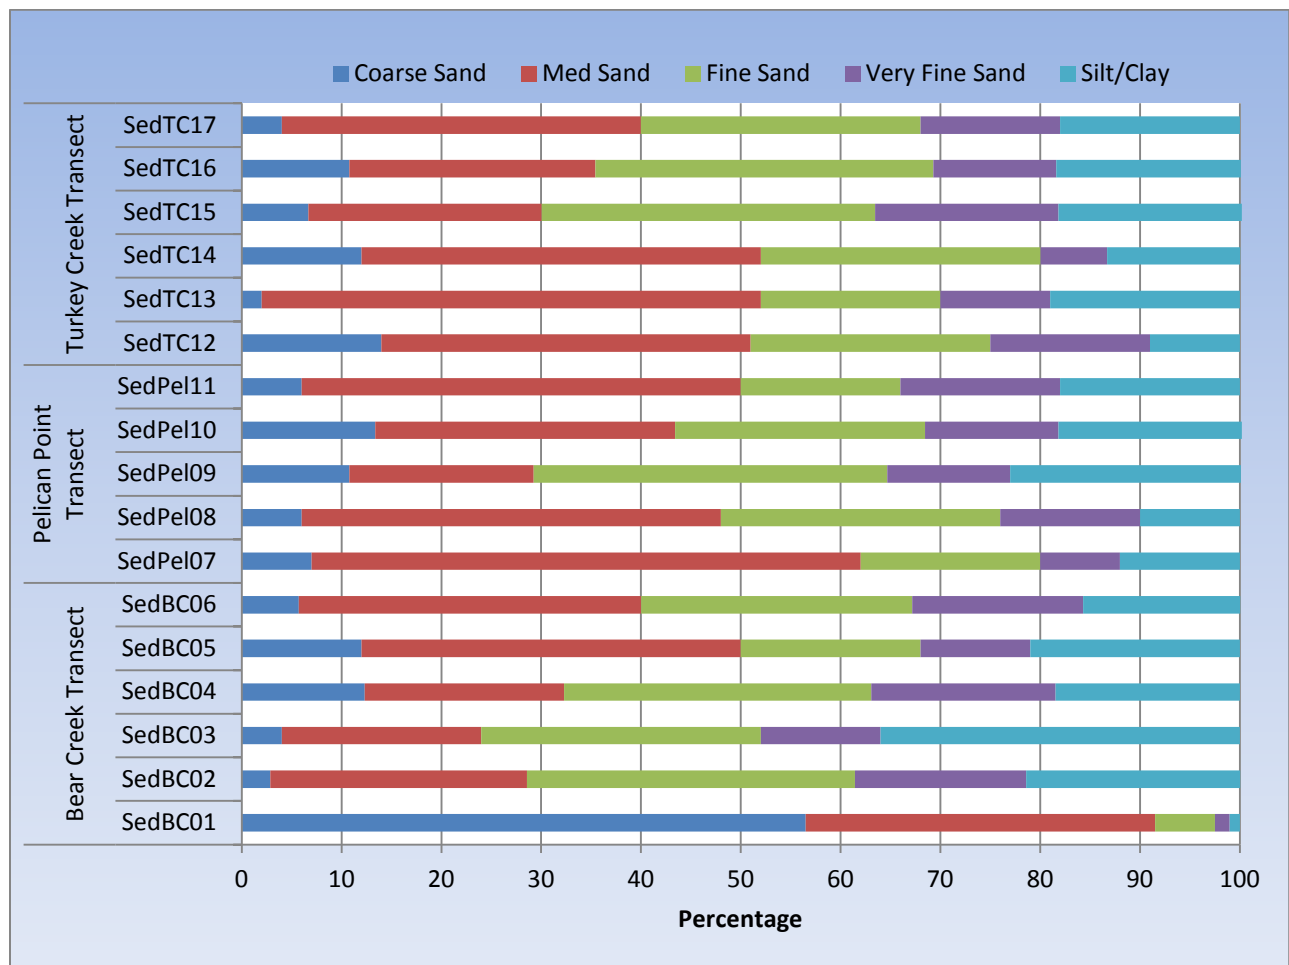
Figure 26 Grain-Size Distribution in Bottom Muds

The total suspended sediment load in the reservoir has been generally constant over the historic monitoring period with periodic storm events dumping large volumes of sediment into the reservoir. The Association in 2011 noted no significant change in reservoir depth. Bottom sediments remain a mixture of fine sand, silt and mud.

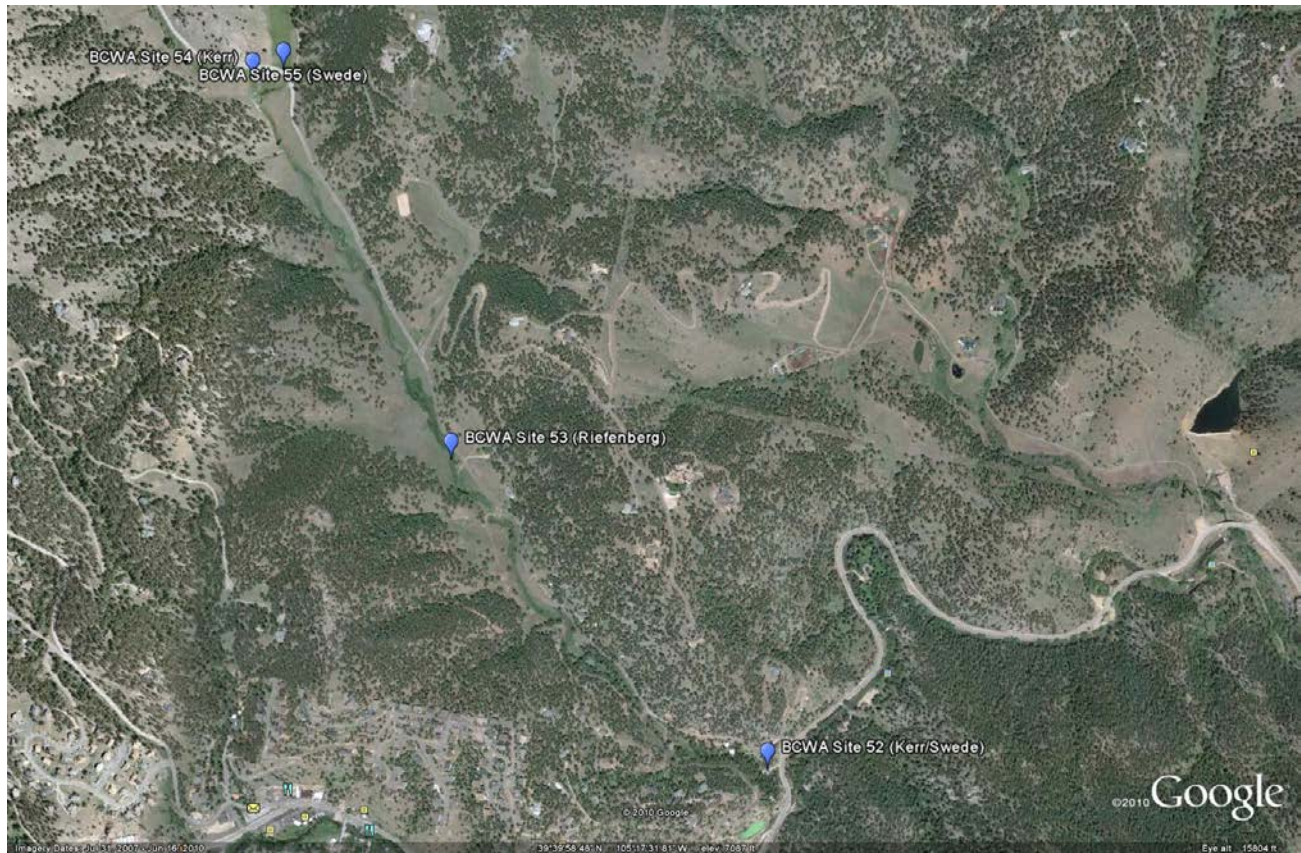
Figure 27 Kerr/Swede Gulch Sample Sites

The Association committed to a 5-years monitoring program to evaluate E. coli on Kerr/Swede Gulch (confluence with Bear Creek, below confluence of Swede Gulch and just upstream of confluence on Kerr Gulch) and lower Swede Gulch. The Association monitors E. coli at 4-sites (Figure 27) from January (provided winter flows) through December. The Association also collects data for temperature, pH, specific conductance and Dissolved Oxygen using the field probe. The Association is using the wastewater treatment plant laboratories for the E. coli analyses.

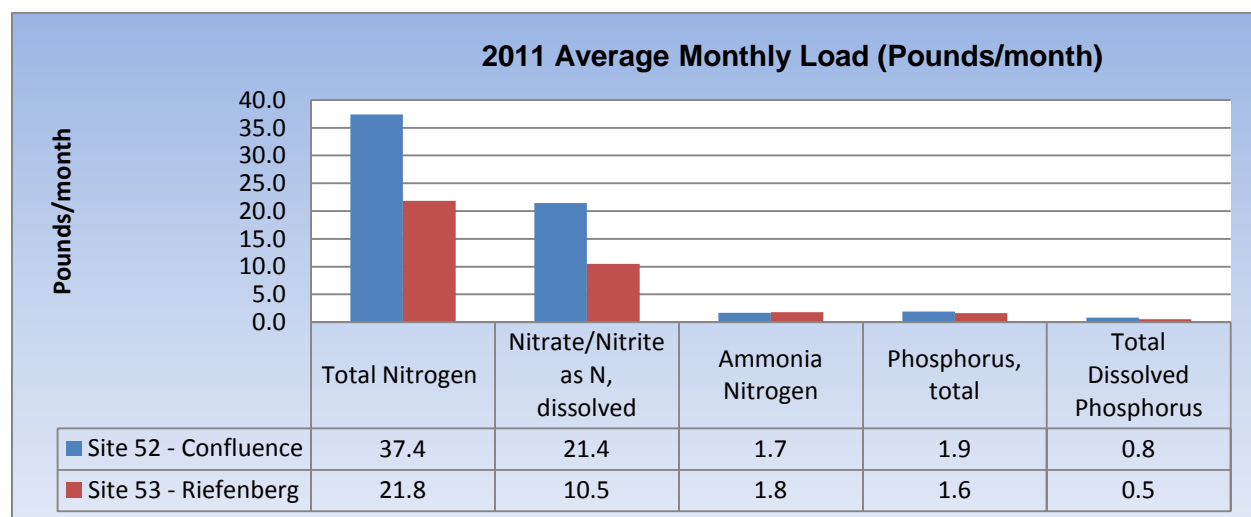
Figure 28 Comparison of Nutrients Between Sites 52 and 53

The Association has two special monitoring efforts in progress to determine surface water quality affected from areas on septic systems: Kerr/Swede Gulch and Cub Creek. The Kerr/Swede Gulch focus on a limited number of septic systems (<35) that potential add nutrients to the lower portion of the drainage between site 52(Confluence) and site 53 (Riefenberg) (Figure 28). The monitoring program suggests there is a nutrient load that potentially is related to septic system discharge.

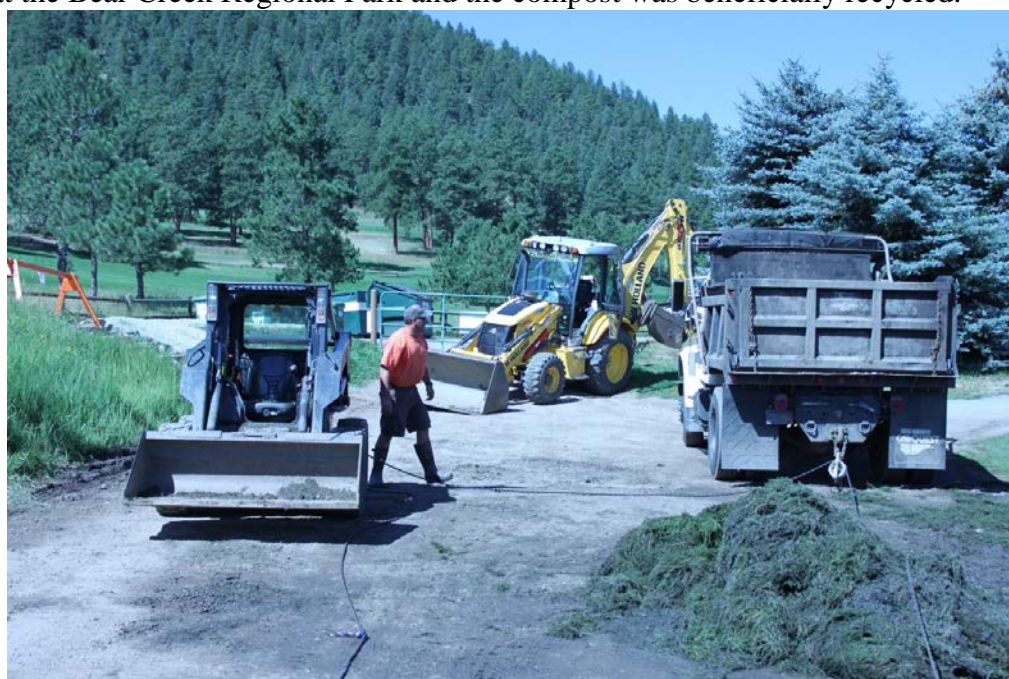
Figure 30 Harvesting Elodea from Evergreen Lake

The Evergreen Metropolitan District and Evergreen Park & Recreation District conducted a harvest and compost project to remove over 17 dump-truck loads of the invasive algae species *Elodea canadensis* from Evergreen Lake (Figure 30). The algal material was composted by the City of Lakewood at the Bear Creek Regional Park and the compost was beneficially recycled.
