Bear Creek Watershed Association

2015 Annual Report

Adopted by Motion BCWA Board May 11, 2016

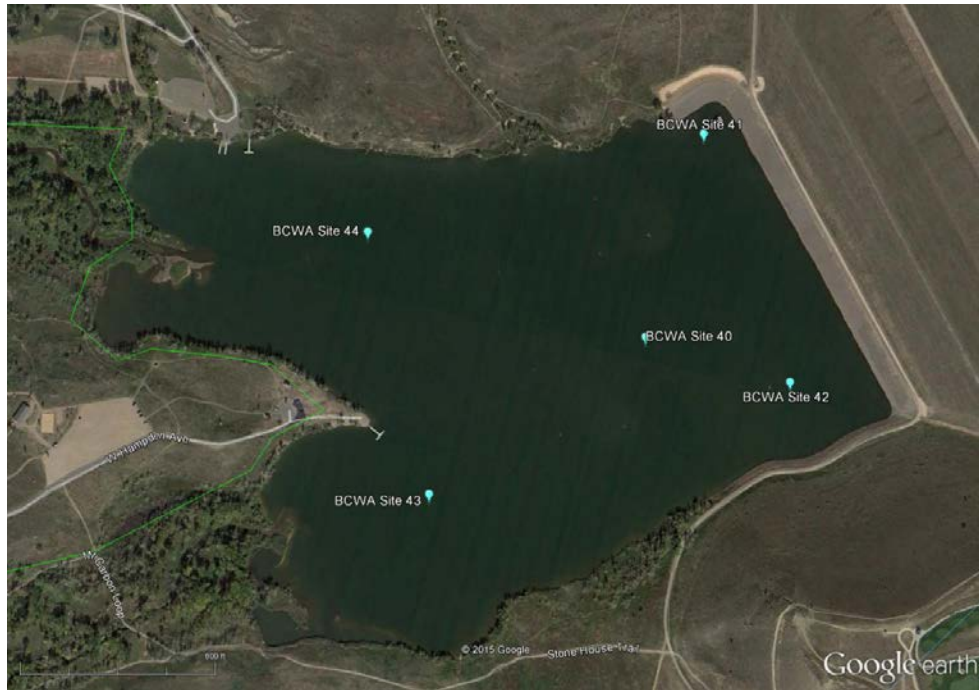
Figure 6 Reservoir Monitoring Stations; Site 2 is the Routine P1 Station (2015 image)

The routine monitoring program (P1) focuses on Turkey Creek drainage and Bear Creek drainage inputs, and discharge from Bear Creek Reservoir into lower Bear Creek with a central pool characterization of the reservoir near the dam (Figure 6; BCWA site 40). The outlet structure is near BCWA site 41 with Bear Creek inflow near BCWA site 44 and Turkey Creek inflow near BCWA site 43. The reservoir chemistry and biological characterization monitoring occurs at BCWA site 40. Vertical probe samples for specific conductance, temperature, dissolved oxygen, and pH measured at ½ and 1-meter intervals at all reservoir sites. The current monitoring program optimizes data generation to evaluate reservoir inflow loading, chemical and biological changes within the reservoir, and reservoir outflow, while minimizing monitoring cost. Figure 7 shows all monitoring stations within Bear Creek Park. The Association maintains maps of recent sampling sites and wastewater treatment plant locations on the Association web site.

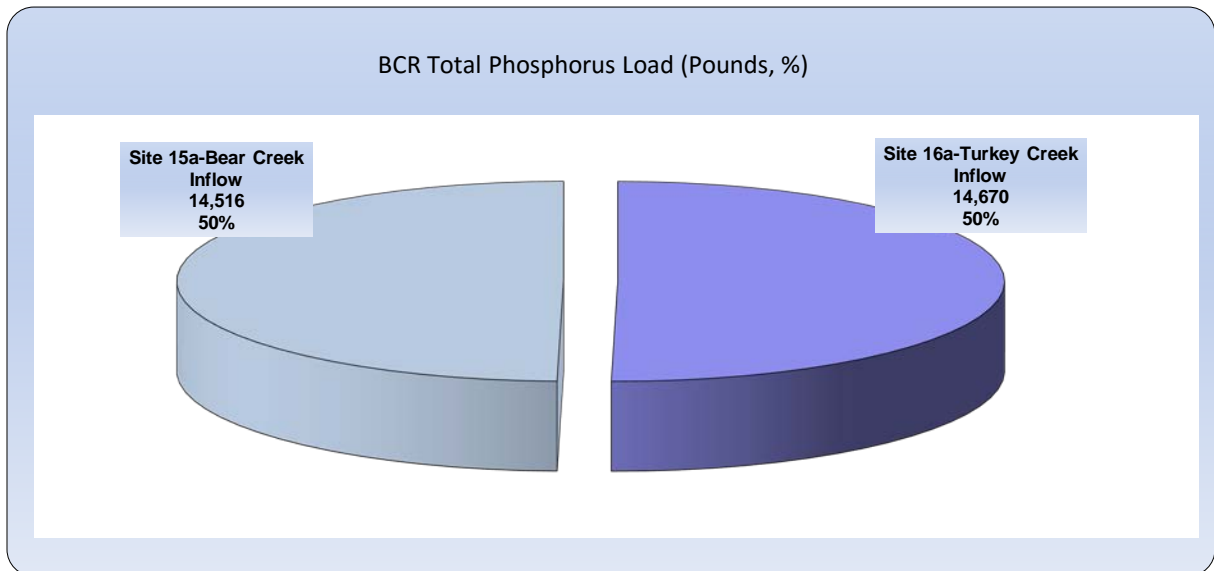
Figure 13 Estimated Total Phosphorus loading into Bear Creek Reservoir

The watershed-monitoring program characterizes nutrient loading into Bear Creek Reservoir from two primary drainages: Bear Creek and Turkey Creek. The Association monitors for total phosphorus, dissolved phosphorus, nitrate-nitrite nitrogen, and total nitrogen on a monthly basis. The Association has established preferred management strategies for Bear Creek Reservoir (*BCWA Policy 20*). The total phosphorus load from the watershed comes from a combination of wastewater treatment plant point source loads, un-regulated point sources, and nonpoint sources, including runoff. There are over 9,000 septic systems in the watershed. The estimated total phosphorus load in 2015 from all sources reaching the reservoir was 29,190 pounds at a flow of about 119,000 acre-feet. Bear Creek drainage contributed 50% of the TP load (Figure 13). The management program targets reduction of total phosphorus reaching the reservoir on an annual basis. Figure 14 shows the total phosphorus reservoir trend.

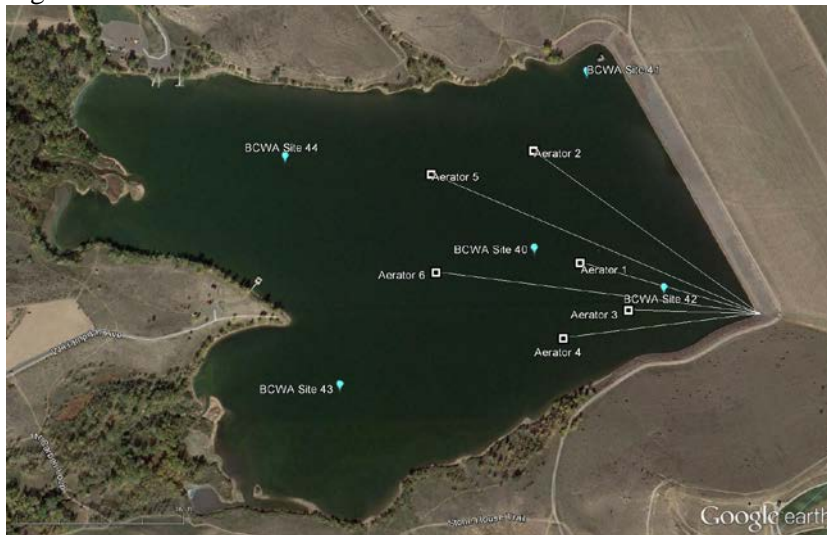
Figure 24 New BCR Aeration Configuration

aeration system on April 30, 2014 (*BCWA TM2014.01 BCR Video Survey Aerators*). The survey demonstrated air supply line damage (kinks and holes), aeration pan displacement, overturned aeration pans, reduced function, and some losses, which reduced the overall system efficiency by 40-70% (*BCWA Fact Sheet 47 New BCR Aeration System*).

Since FEMA requires *like-kind* replacement, Lakewood determined it would be more cost effective to upgrade and replace the aeration system using Lakewood funding. The BCWA assisted with new aeration configuration, system requirements and replacement options. BCWA and Lakewood staff removed most of the old aeration system and recycled these materials. The company *Underwater Repairs Specialist* installed 6 Quad Duraplate Diffusers (DDP9X4 Keeton Industries) and weighted line in November 2014 with assistance of Lakewood staff that corresponds to the pattern shown in Figure 24. The diffusers are fine bubble (air supplied by a 15 hp compressor) and they will increase the dissolved oxygen transfer into the reservoir water column. Lakewood and BCWA will conduct an evaluation on the effectiveness and efficiency of the new aeration system in the spring/ summer growing season of 2016.

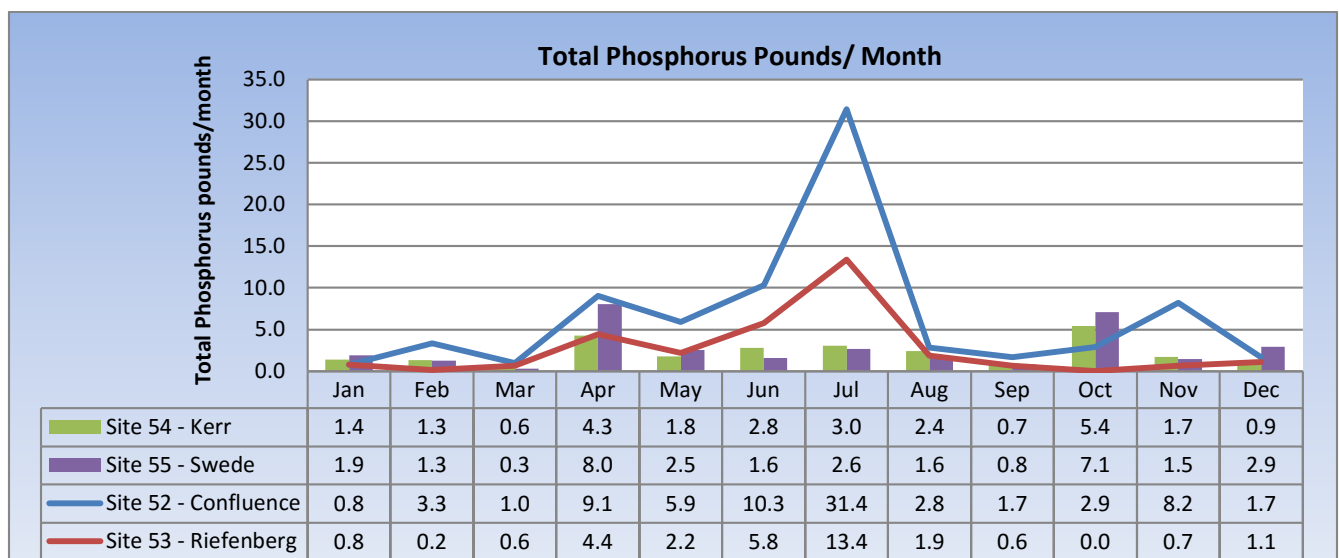
Figure 28 Onsite System Study - Comparison of Total Phosphorus Between Sites 52 and 53

The Association is also monitoring upstream and downstream on Cub Creek where there are > 1,000 OWTS. The total phosphorus load distinctly increases from upstream to downstream by 90% on average. However, the nitrogen decreases in comparison, with instream uptake. The coverage of hard substrate in lower Cub Creek in late summer is generally over 50%.
