# Bear Creek Watershed Association

## 2017 Annual Report

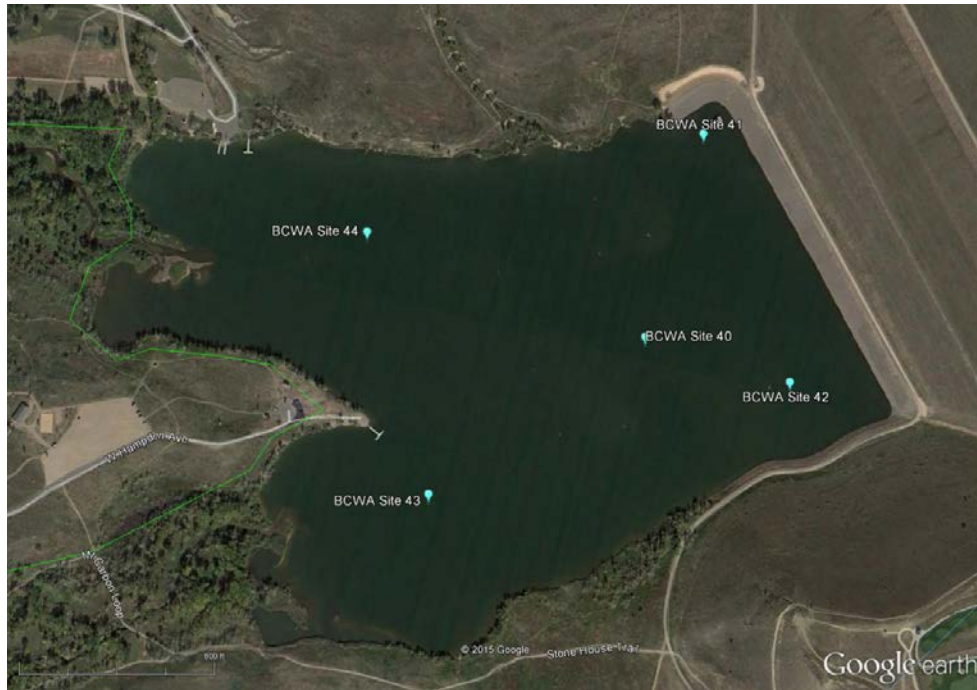
**Figure 8 Reservoir Monitoring Stations; Site 40 is the Routine P1 Station (2015 image)**

The routine monitoring program (P1) focuses on Turkey Creek drainage and Bear Creek drainage inputs, and discharge from Bear Creek Reservoir into lower Bear Creek with a central pool characterization of the reservoir near the dam (Figure 8; BCWA site 40). The outlet structure is near BCWA site 41 with Bear Creek inflow near BCWA site 44 and Turkey Creek inflow near BCWA site 43 (Site 43 and site 44 were not monitored in 2017). The reservoir chemistry and biological characterization monitoring occurs at BCWA site 40. Vertical probe samples for specific conductance, temperature, dissolved oxygen, and pH measured at ½ and 1-meter intervals at all reservoir sites. The current monitoring program optimizes data generation to evaluate reservoir inflow loading, chemical and biological changes within the reservoir, and reservoir outflow, while minimizing monitoring cost. Figure 9 shows all monitoring stations within Bear Creek Park. The Association maintains maps of recent sampling sites and wastewater treatment plant locations on the Association web site.

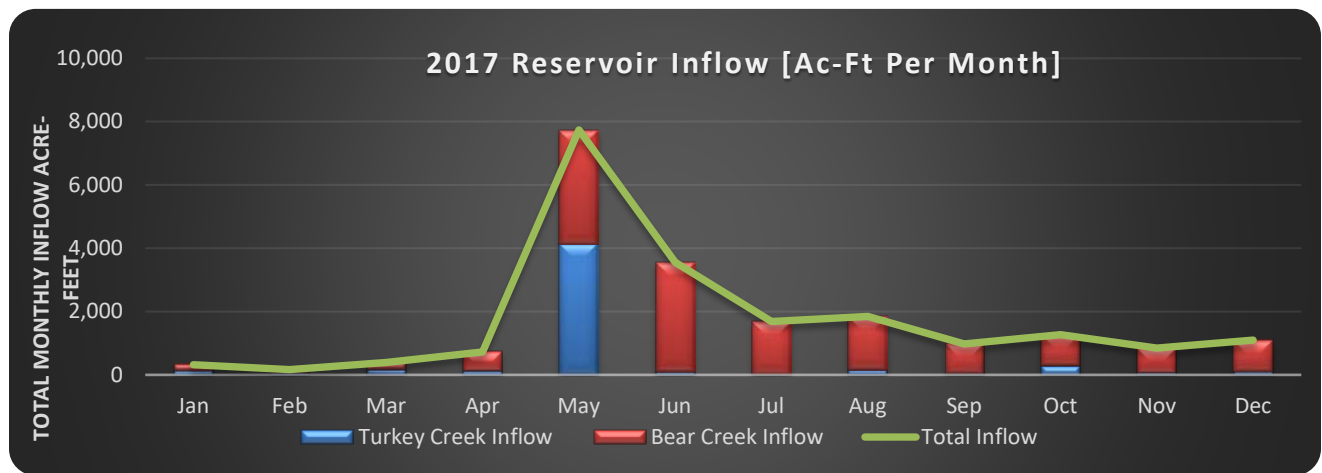
**Figure 12 Annual Flows into Bear Creek Reservoir**

The reservoir inflow represents flows below the water diversions and is not representative of the total watershed water flows. Figure 12 compares the 2017 reservoir monthly inflow estimates from Bear Creek (74%) and Turkey Creek (26%). Peak spring and stormwater runoff occurred in May 2017. Figure 13 shows the Bear Creek in-flow estimates (1987-2017) above Bear Creek Reservoir, in Bear Creek Park. Figure 14 shows the flow estimates at the Evergreen station. Additionally, the longer time trends shown in Figures 13 and 14 depict a basic linear trend of declining flow in Bear Creek.

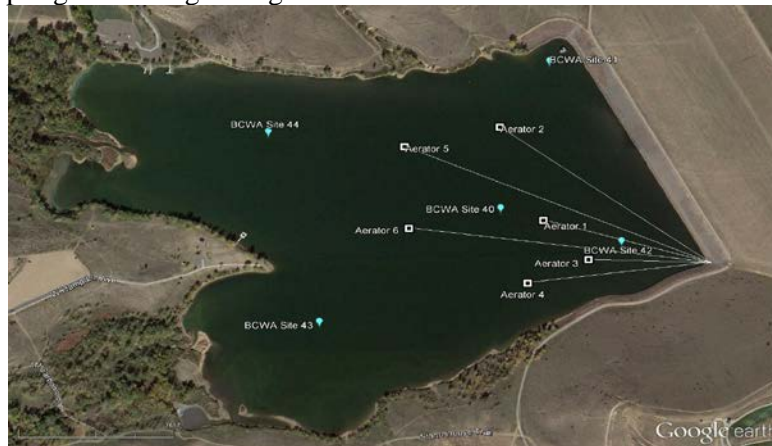
**Figure 25** New BCR Aeration Configuration

The September 2013 flood event used Bear Creek Reservoir as a major flood control structure, which caused displacement and reduced efficiency of the in-reservoir aeration system as installed by the City of Lakewood and monitored by the BCWA (*BCWA Fact Sheet 6 Aeration BCR*). A video survey was completed on the BCR aeration system on April 30, 2014 (*BCWA TM2014.01 BCR Video Survey Aerators*). The survey demonstrated air supply line damage (kinks and holes), aeration pan displacement, overturned aeration pans, reduced function, and some losses, which reduced the overall system efficiency by 40-70% (*BCWA Fact Sheet 47 New BCR Aeration System*).

Since FEMA requires *like-kind* replacement, Lakewood determined it would be more cost effective to upgrade and replace the aeration system using Lakewood funding. The BCWA assisted with new aeration configuration, system requirements and replacement options. BCWA and Lakewood staff removed most of the old aeration system and recycled these materials. The company *Underwater Repairs Specialist* installed 6 Quad Duraplate Diffusers (DDP9X4 Keeton Industries) and weighted line in November 2014 with assistance of Lakewood staff that corresponds to the pattern shown in Figure 25. The diffusers are fine bubble (air supplied by a 15 hp compressor) and they will increase the dissolved oxygen transfer into the reservoir water column. Lakewood and BCWA are conducting a three-year evaluation (2016-2018) on the effectiveness and efficiency of the new aeration system in the spring/ summer growing season.

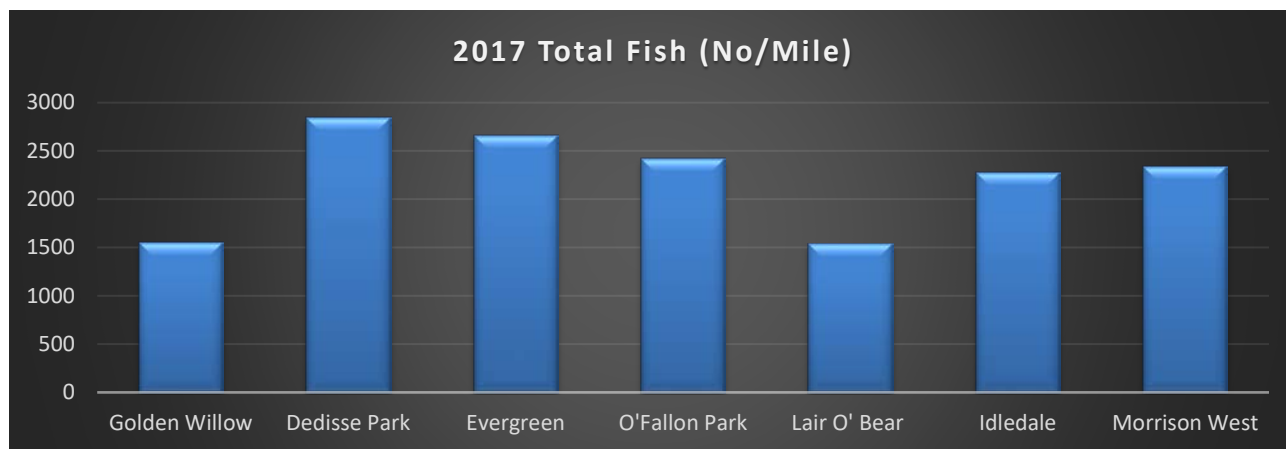
**Figure 32 2017 Total Fish per Mile**

Station	Width (ft)	Species	2017		
			No/Mile Total	No./Acre Total	lbs/Acre Total
Golden Willow	23	Brown	1551	556	107
		Rainbow	0	0	0
		Total	1551	556	107
Dedisse Park	33	Brown	2666	666	80
		Rainbow	184	46	5
		Total	2849	712	85
Evergreen	34	Brown	1932	469	147
		Rainbow	726	176	55
		Total	2658	645	202
O'Fallon Park	28	Brown	2364	697	122
		Rainbow	57	17	3
		Total	2421	713	125
Lair O' the Bear	29	Brown	1363	388	95
		Rainbow	176	50	12
		Total	1538	438	107
Idledale	30	Brown	2130	703	203
		Rainbow	151	50	14
		Total	2281	753	217
Morrison West	30	Brown	2163	595	144
		Rainbow	177	49	12
		Total	2341	644	156
