Bear Creek Watershed Association

2018 Annual Report

Adopted May 10, 2019

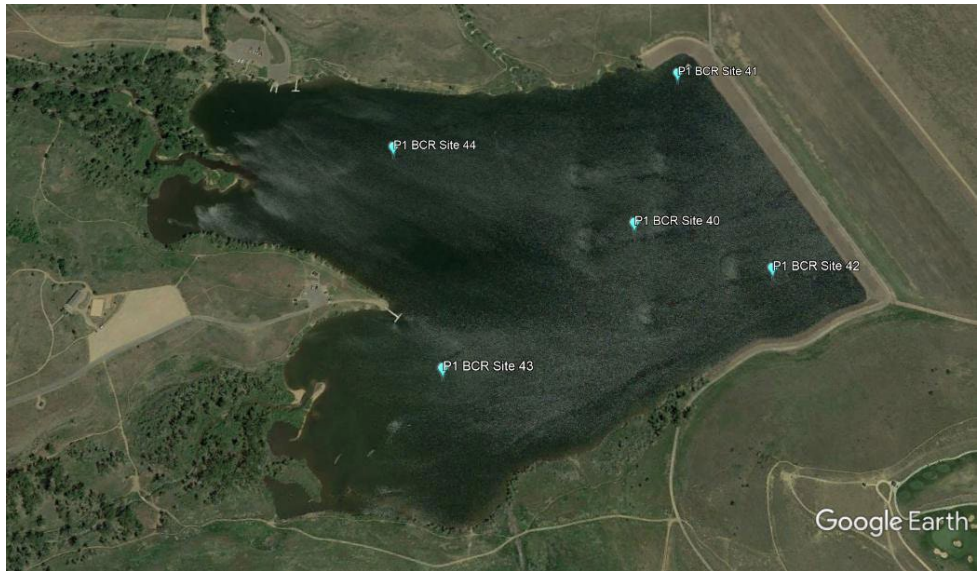
Figure 8 Reservoir Monitoring Stations; Site 40 is the Routine P1 Station (2018 image)

The routine monitoring program (P1) focuses on Turkey Creek drainage and Bear Creek drainage inputs, and discharge from Bear Creek Reservoir into lower Bear Creek with a central pool characterization of the reservoir near the dam (Figure 8; BCWA site 40). The outlet structure is near BCWA site 41 with Bear Creek inflow near BCWA site 44 and Turkey Creek inflow near BCWA site 43 (Site 43 and site 44 were not monitored in 2018). The reservoir chemistry and biological characterization monitoring occurs at BCWA site 40. Vertical probe samples for specific conductance, temperature, dissolved oxygen, and pH measured at ½ and 1-meter intervals at all reservoir sites. The current monitoring program optimizes data generation to evaluate reservoir inflow

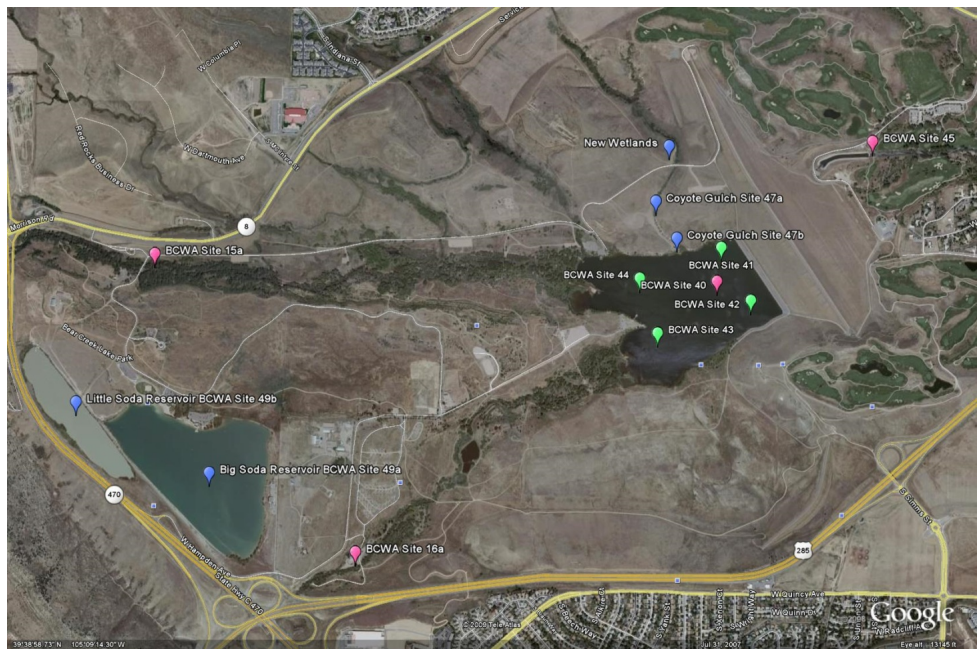
Figure 9 Monitoring Stations (Active and Historic) in Bear Creek Lake Park

loading, chemical and biological changes within the reservoir, and reservoir outflow, while minimizing monitoring cost. Figure 9 shows all active and historic monitoring stations within Bear Creek Park. The Association maintains maps of recent and historic sampling sites, wastewater treatment plant locations and special study areas in the Association’s electronic watershed plan.
