# Bear Creek Watershed Association

## 2019 Annual Report

**May 13 2020**

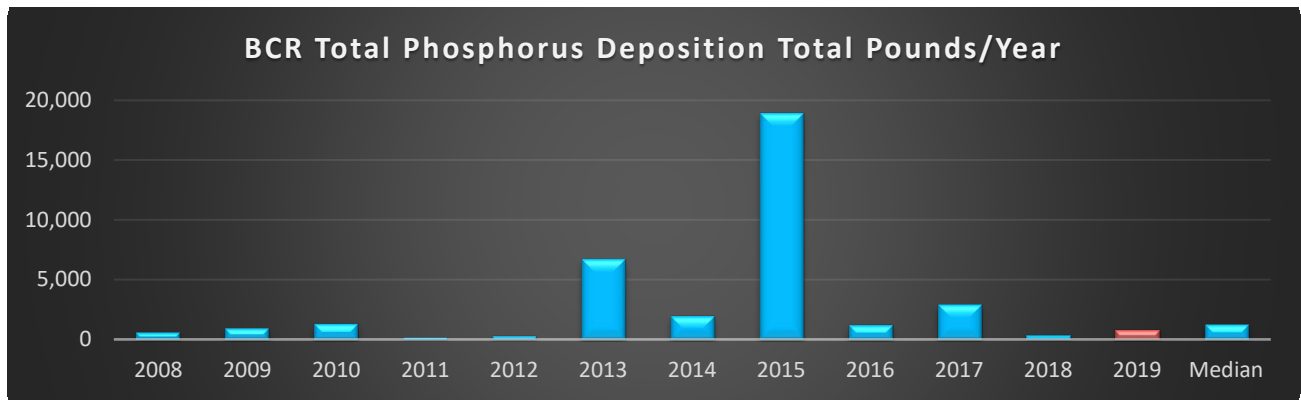
**Figure 2 Annual Total Phosphorus Pounds Deposition into Bear Creek Reservoir Bottom Sediments**

The estimated annual Bear Creek inflow into Bear Creek Reservoir was about 16,340 acre-feet (89%) and 2,111 acre-feet (11%) from Turkey Creek. The internal loading problem (total phosphorus) with Bear Creek Reservoir has not diminished over the last 11-years (Figure 2). The total phosphorus deposition into reservoir bottom sediments is about 36,721 pounds since 2008.

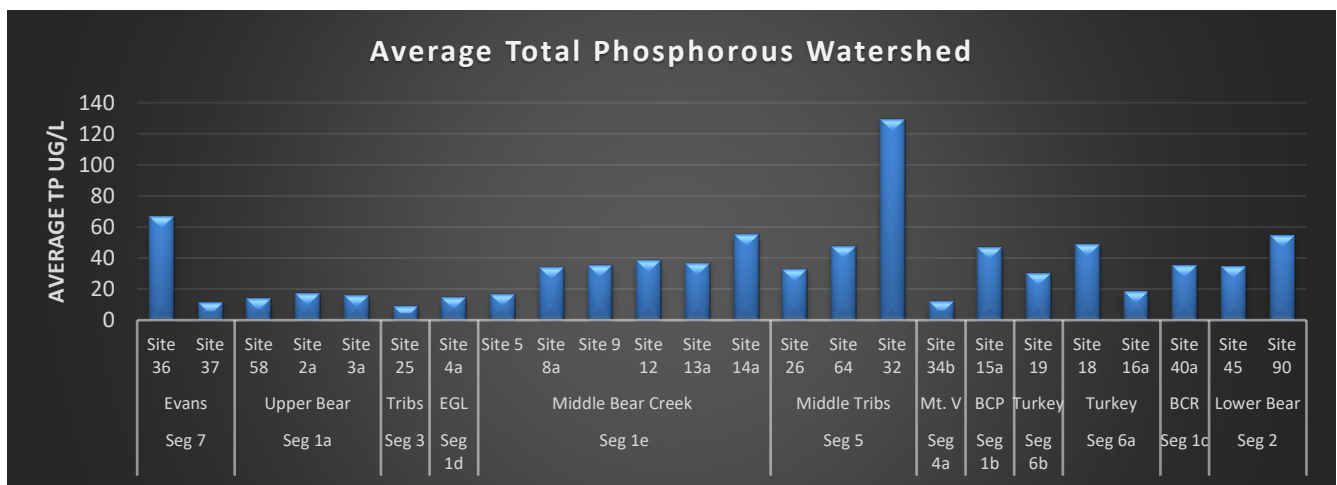
**Figure 3 Total Phosphorus Concentrations by Stream Segments in the Watershed**

The Association monitors watershed nutrients by major stream segments beginning near Mt. Evans (segment 7) and extending downstream to Bear Creek Reservoir. 2019 was an average nutrient loading year with 54% of the total phosphorus (Figure 3) and 33% of the total nitrogen (Figure 4) load occurring in the June-July runoff period. Most nutrient load is generated within the urbanized corridor of segment 1a (above Evergreen Lake to the Clear Creek County Line), and segment 1e, which is the mainstem of Bear Creek from Evergreen Lake to the Harriman Ditch Diversion. Although nutrient concentrations from the tributaries maybe high (e.g., Figure 3 and 4, Site 32), the actual poundage loading is reduced because of lower flows (Figure 5, site 32).

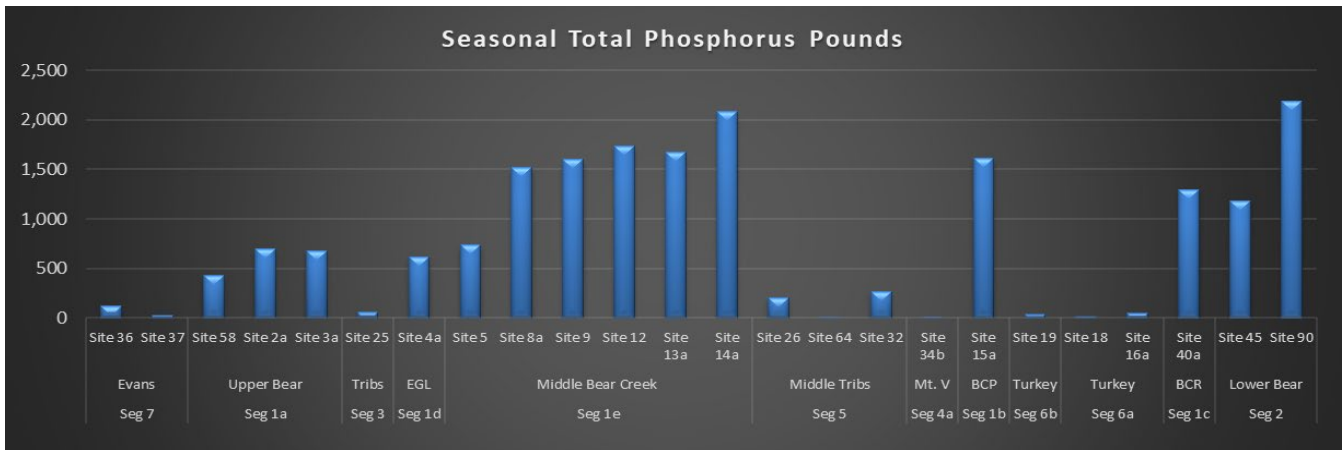
**Figure 5 Total Phosphorus Loading (pounds) by Stream Segment in the Watershed**

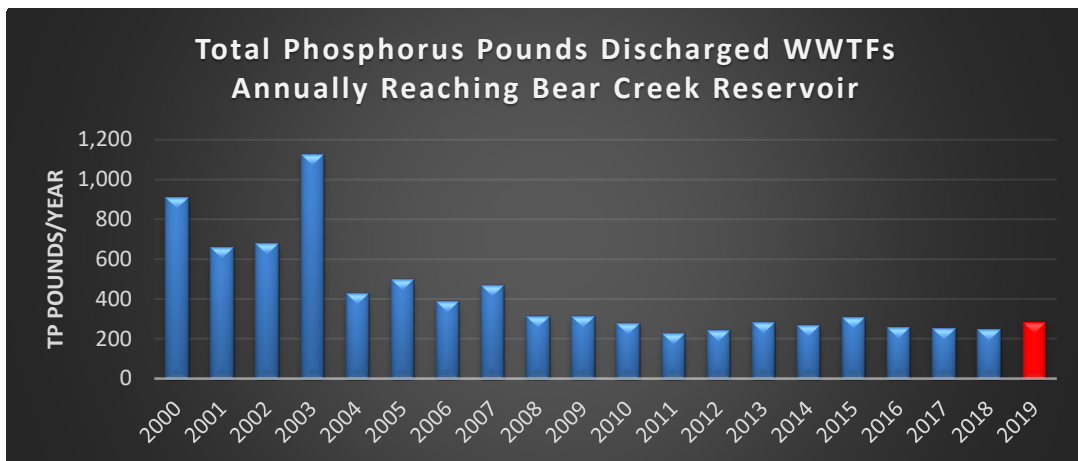
**Figure 6 Point Source Load Reaching Bear Creek Reservoir**

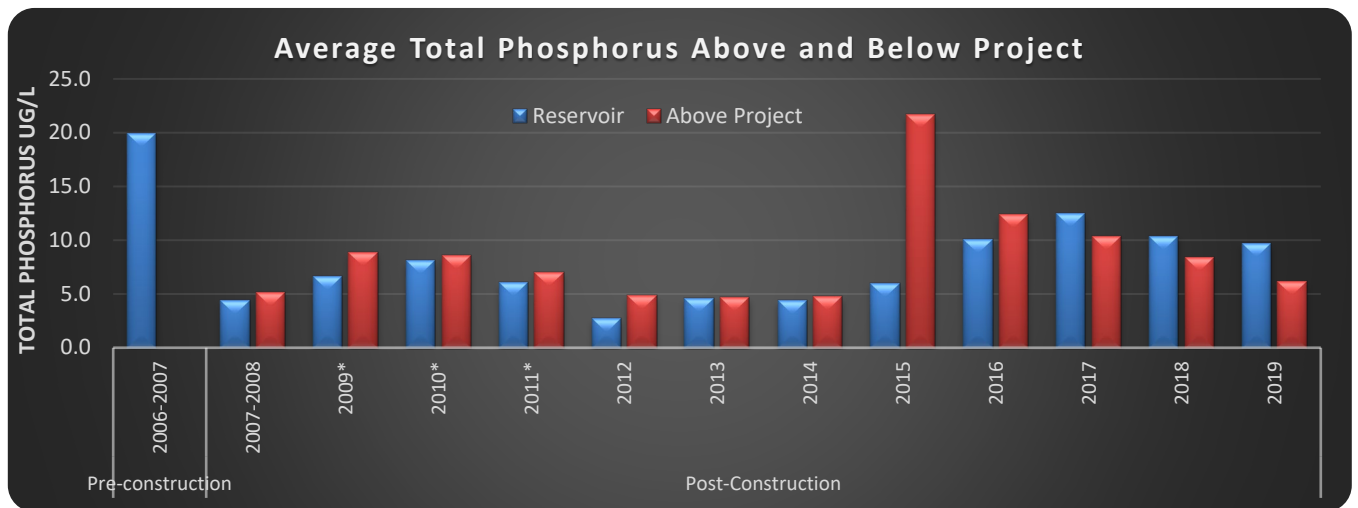
**Figure 7 Total Phosphorus Reduction at Coyote Gulch Restoration Site**

There was no active total phosphorus trading by Association membership in 2019 (See Table 24 in the *BCWA 2019 Annual Report* for a status of trading activity summary). The Association has established four trading policies to improve future trading programs (*BCWA Policy 1 Trading Program, BCWA Policy 19 Nutrient Trading Program Eligibility, BCWA Policy 26 Point to Point Trade Administration, and BCWA Policy 35 Membership Entity Termination and Permit Closure*). The Association Coyote Gulch Restoration Project has established the annual available total phosphorus trade pounds consistent with the Association trade program at 76.9 pounds (*BCWA TM 2019.03 Coyote Gulch Summary*). The project has effectively reduced total phosphorus loading by about 75% on an annual basis (Figure 7).

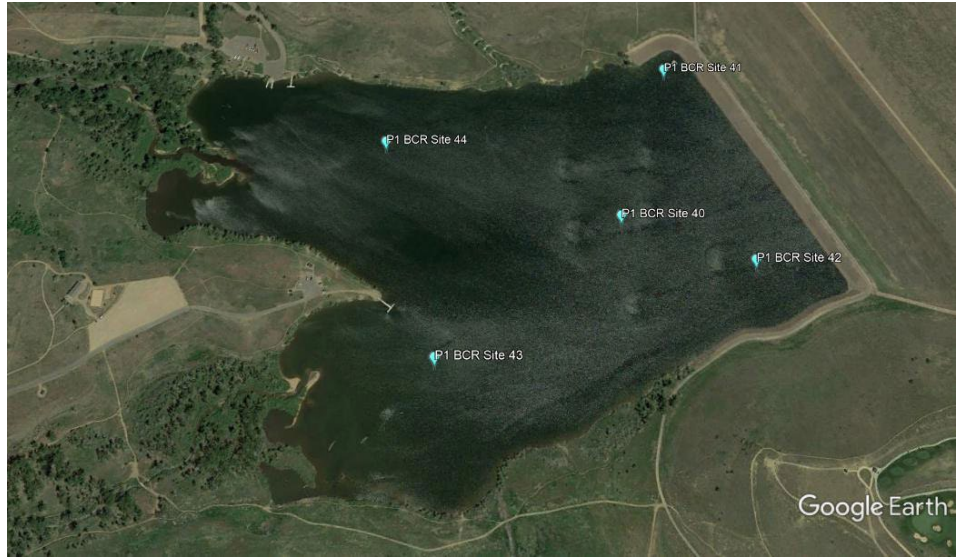
**Figure 9 Reservoir Monitoring Stations; Site 40 is the Routine P1 Station**

The routine monitoring program (P1) focuses on Turkey Creek drainage and Bear Creek drainage inputs, and discharge from Bear Creek Reservoir into lower Bear Creek with a central pool characterization of the reservoir near the dam

(Figure 9; BCWA site 40). The outlet structure is near BCWA site 41 with Bear Creek inflow near BCWA site 44 and Turkey Creek inflow near BCWA site 43 (Site 43 and site 44 were not monitored in 2019). The reservoir chemistry and biological characterization monitoring occurs at BCWA site 40. Vertical probe samples for specific conductance, temperature, dissolved oxygen, and pH measured at ½ and 1-meter intervals at all reservoir sites. The current monitoring program optimizes data generation to evaluate reservoir inflow loading, chemical and biological changes within the reservoir, and reservoir outflow, while minimizing monitoring cost. Figure 10 shows all active and historic monitoring stations within Bear Creek Park. The Association maintains maps of recent and historic sampling sites, wastewater treatment plant locations and special study areas in the Association’s electronic watershed plan.

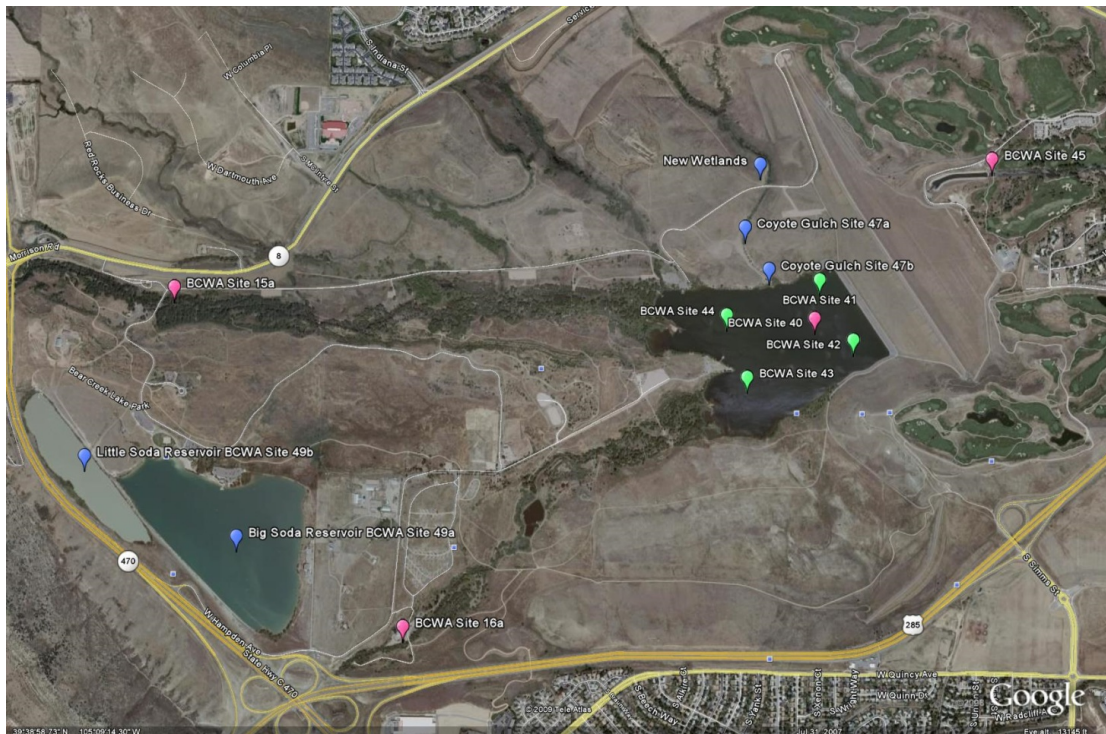
**Figure 10 Monitoring Stations (Active and Historic) in Bear Creek Lake Park**

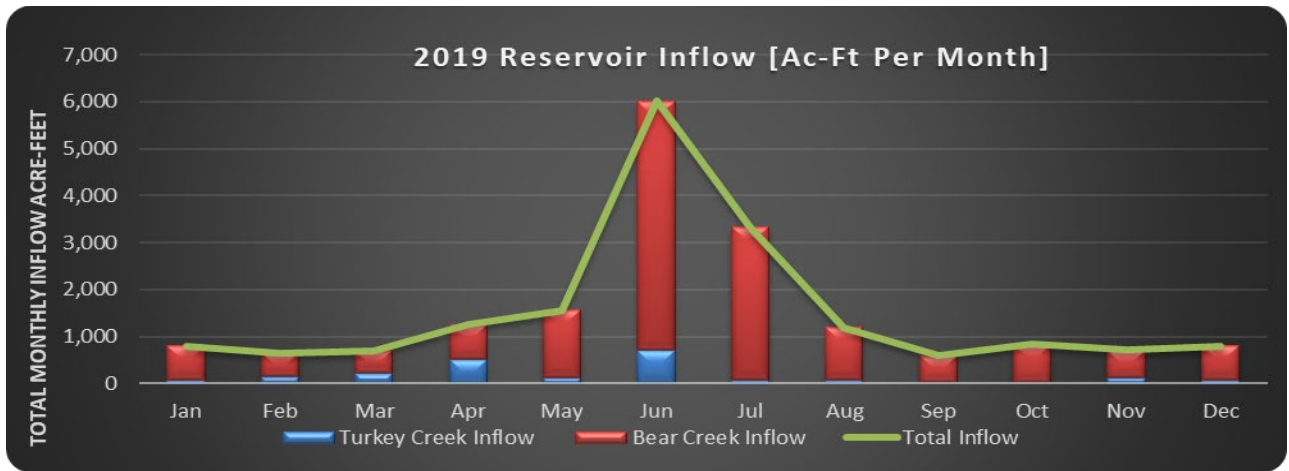
**Figure 11 In-Flow Estimates by Month into Bear Creek Reservoir**

The BCWA evaluates the basin hydrology. The average inflow into Bear Creek Reservoir from both Turkey Creek & Bear Creek (1987-2012) was 27,100 acre-feet per year. From 2013-2019 the average inflow into Bear Creek Reservoir was 39,966 acre-feet. The 2019 inflow is estimated at 18,450 acre-feet (Figure 11) with most of the flow in June and July. The reservoir wasn't in flood stage in 2019 (Figure 12). The pool level was lowered from January through April.

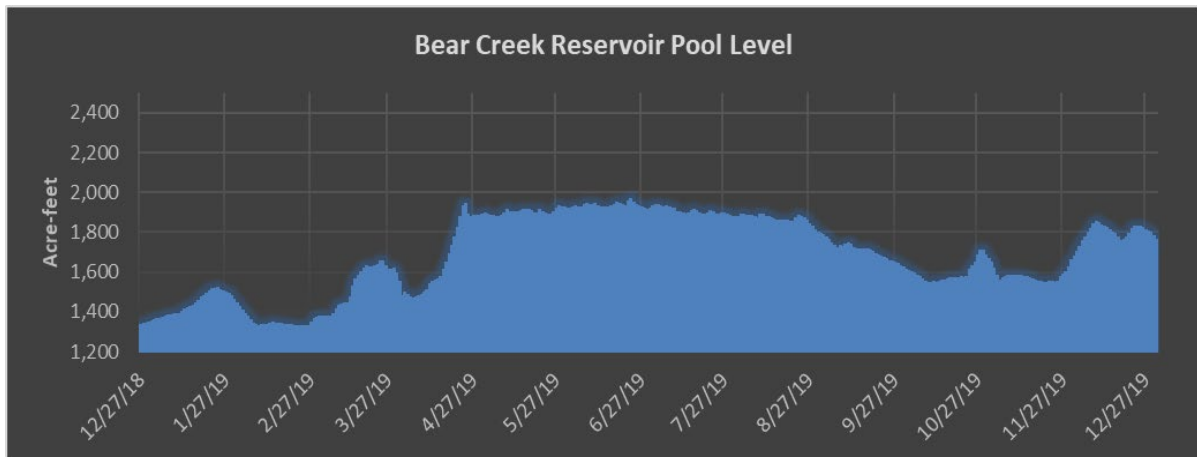
**Figure 12 Flood Stage in Bear Creek Reservoir**

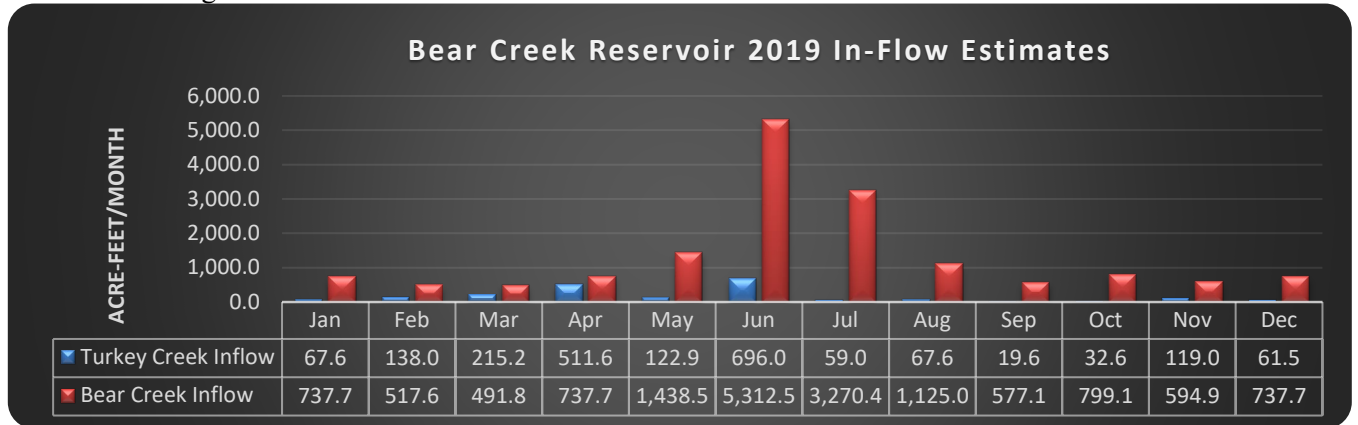
**Figure 13** Annual Flows into Bear Creek Reservoir

The reservoir inflow represents flows below the water diversions and is not representative of the total watershed flows. Figure 13 compares the 2019 reservoir monthly inflow estimates from Bear Creek (89%) and Turkey Creek (11%). Peak spring and stormwater runoff occurred in June 2019 (51% of annual flow). Figure 14 shows the Bear Creek in-flow estimates (1987-2019) above Bear Creek Reservoir, in Bear Creek Park. Figure 15 shows the flow estimates at the Evergreen station. Additionally, the longer time trends shown in 15 depict a basic linear trend of declining flow in Bear Creek.

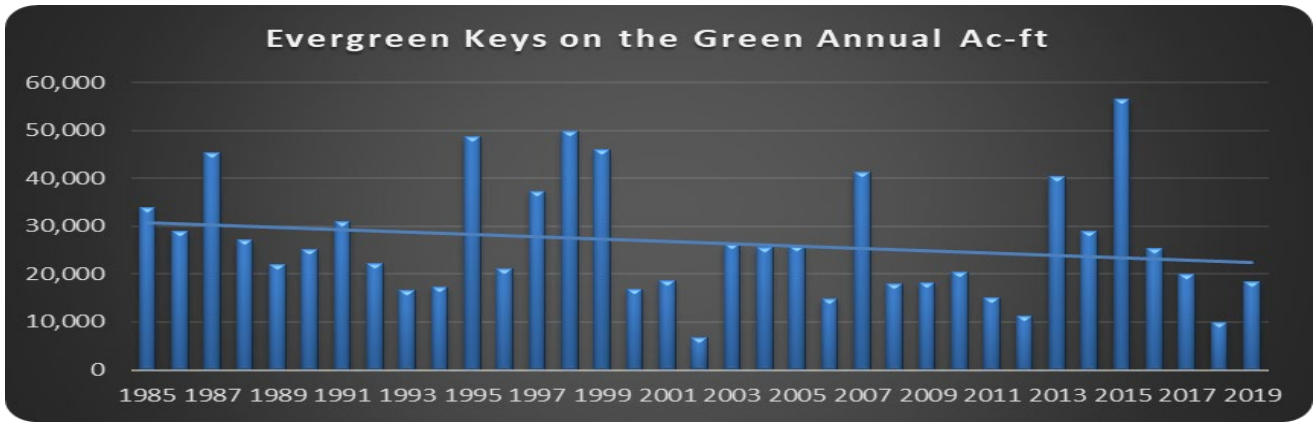
**Figure 15** Bear Creek at Keys-on-the-Green, above Evergreen

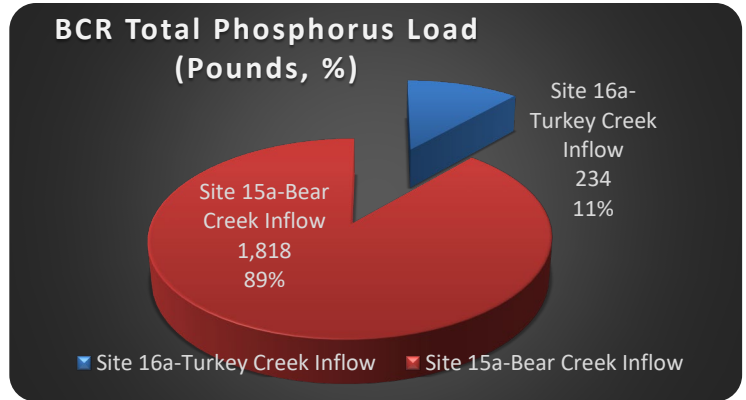
**Figure 16 Estimated Total Phosphorus loading into Bear Creek Reservoir**

The watershed-monitoring program characterizes nutrient loading into Bear Creek Reservoir from two primary drainages: Bear Creek and Turkey Creek. The Association monitors for total phosphorus and total nitrogen monthly. The Association has established preferred management strategies for Bear Creek Reservoir (*BCWA Policy 20*). The total phosphorus load from the watershed comes from a combination of wastewater treatment plant point source loads, un-regulated point sources, and nonpoint sources, including runoff. There are over 9,000 septic systems in the watershed. The estimated total phosphorus load in 2019 from all sources reaching the reservoir was 2,052 pounds at a flow of about 18,450 acre-feet. Bear Creek drainage contributed 90% of the TP load (Figure 16). The management program targets reduction of total phosphorus reaching the reservoir on an annual basis. Figure 17 shows the total phosphorus reservoir trend.

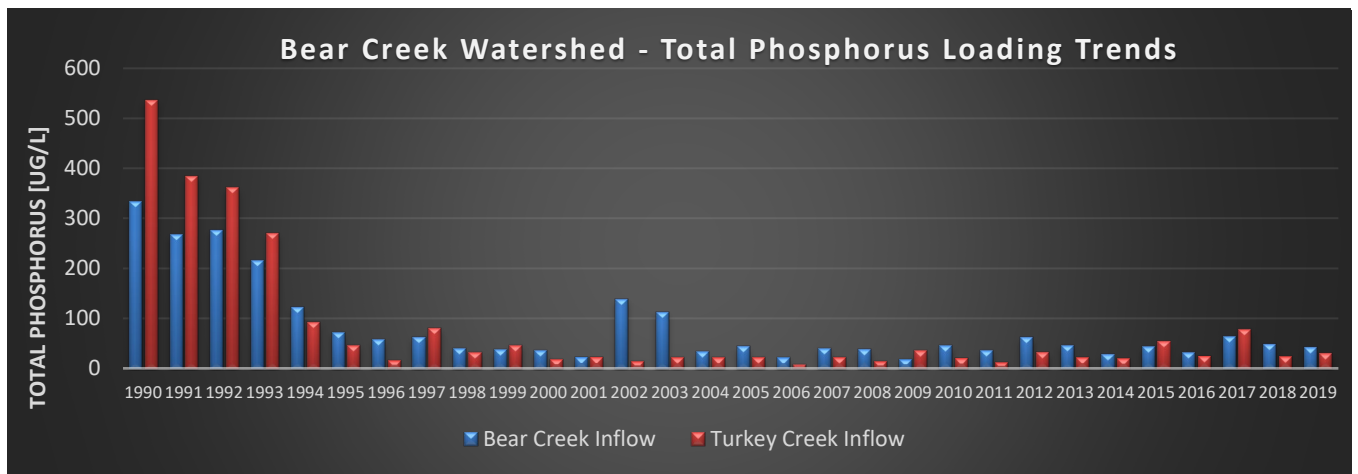
**Figure 17 Total Phosphorus Trend BCR**

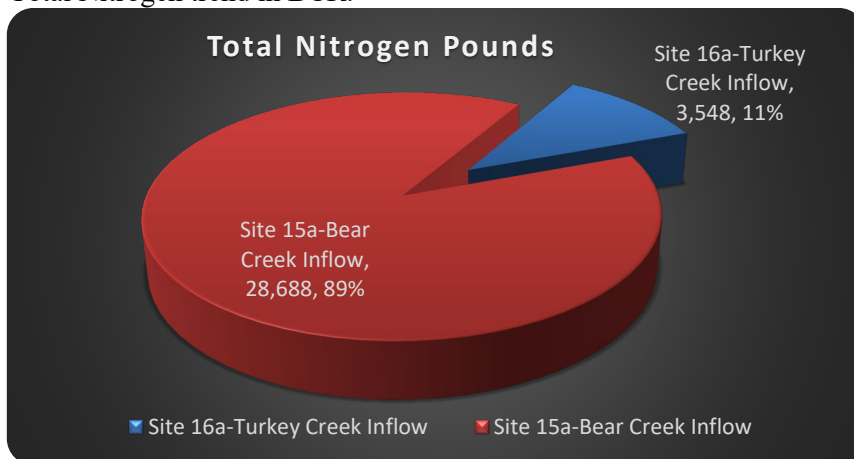
**Figure 18 Total Nitrogen Loading into Bear Creek Reservoir**

The total nitrogen loading (Figure 18, about 32,240 pounds) had 89% of the load coming from Bear Creek. Figure 19 shows the Total Nitrogen trend in BCR.

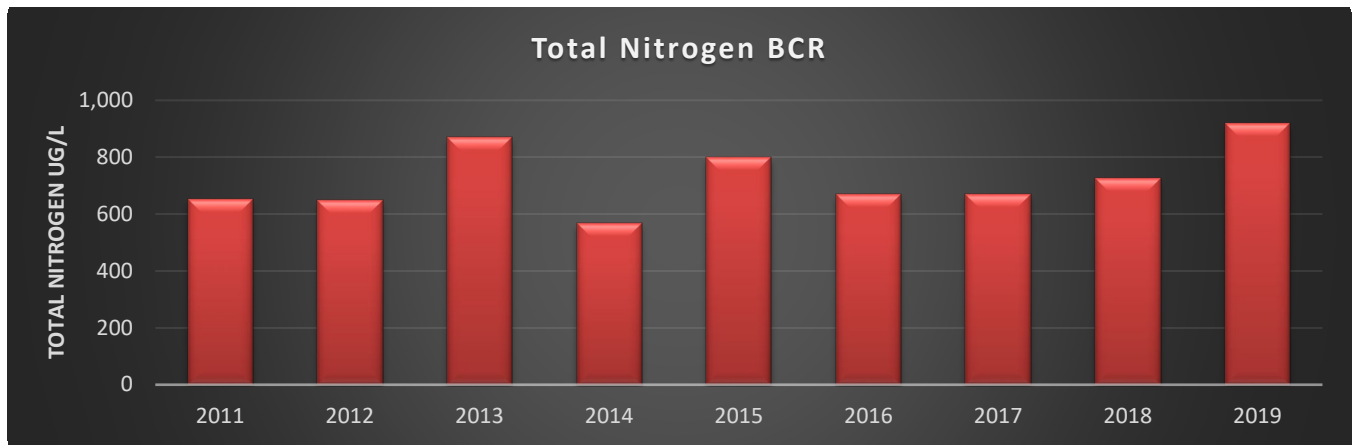
**Figure 19 Estimated Total Nitrogen Loading Trend for Bear Creek Reservoir**

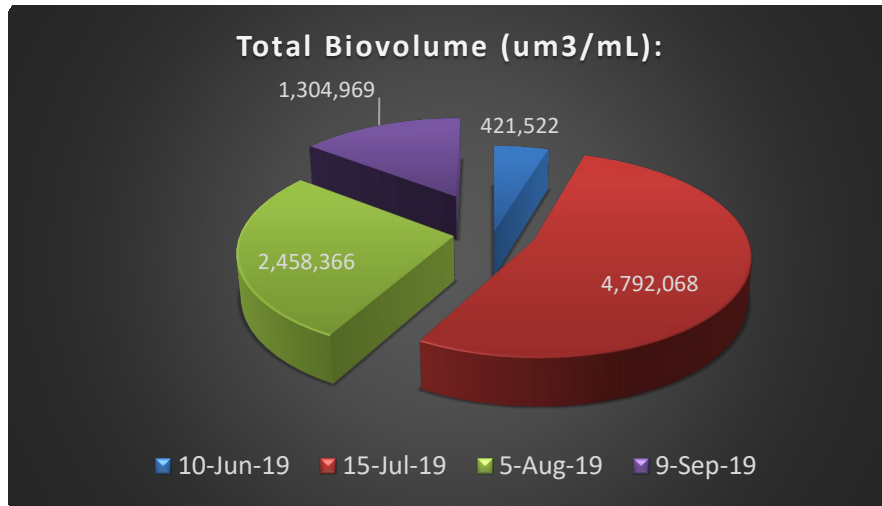
**Figure 20 Bear Creek Reservoir Phytoplankton Biovolume**

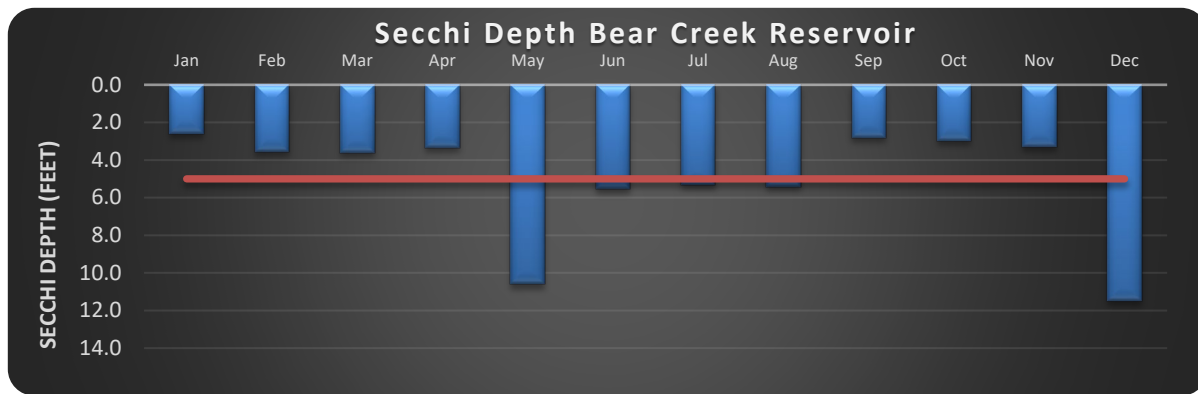
**Figure 21 Secchi Depth Bear Creek Reservoir**

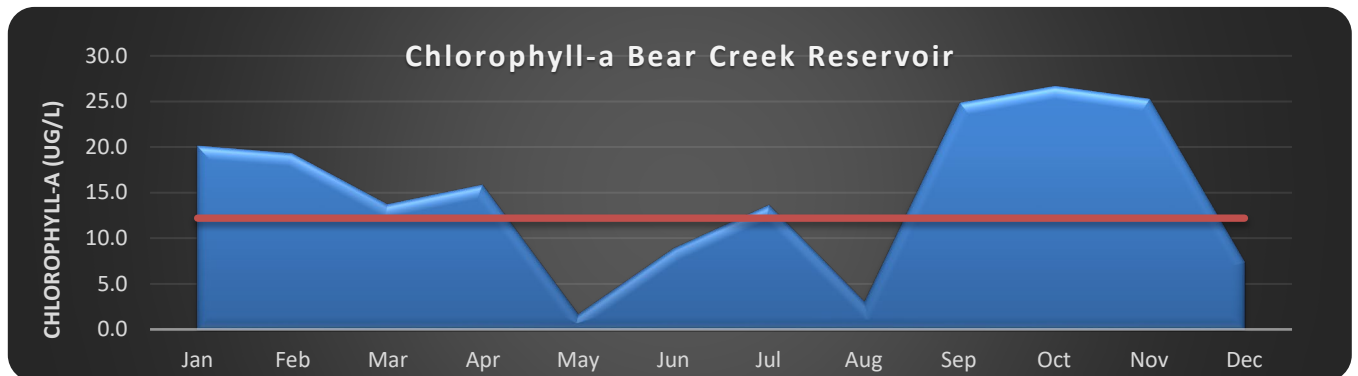
**Figure 22 Bear Creek Reservoir Chlorophyll Trend**

The reservoir had several algal blooms in 2019 as evidenced by peak August through November chlorophyll concentrations (Figure 22). The peak *Fragilaria crotonensis* phytoplankton biovolume was 2,280,056 um<sup>3</sup>/mL caused by diatom phytoplankton bloom. Historically, blue-green phytoplankton species are associated with major blooms in the reservoir (*BCWA Fact Sheet 57 Cyanotoxins*, *BCWA Fact Sheet 58 Cyanobacteria Guide BCR*, *Fact Sheet 60 Managing Harmful Algal Blooms*, and *Fact Sheet 61 HABs Exposure and Risks*). The reservoir trophic state was eutrophic (Walker Index, Figure 23). The Carlson Index shows a similar eutrophic trend. Although external nutrient loads were lower than historic trends, the reservoir continues to have an internal nutrient loading problem, which causes eutrophic water quality conditions.

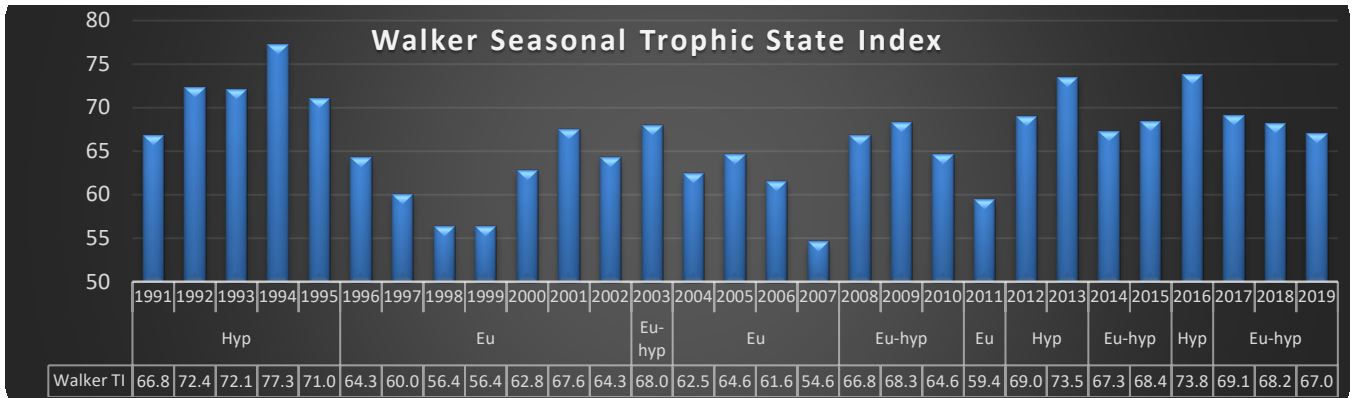
**Figure 23 Walker Trophic Index Trend Bear Creek Reservoir**

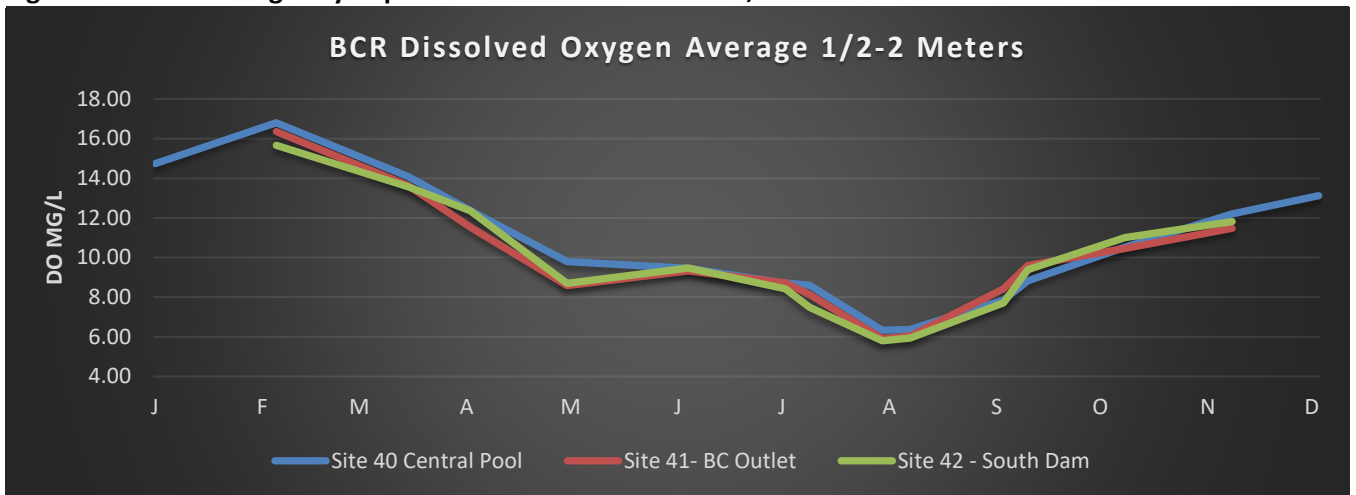
**Figure 25 Bear Creek Reservoir Dissolved Oxygen Trend**

Reservoir aeration is also a necessary management tool in low flow conditions. The aeration system has been operational since the summer of 2002 and uses a fine-bubble diffusion system with aerators distributed across the hypolimnion. In 2019, the Association and Lakewood operated the aeration system to maximize oxygen transfer during phased on-off cycling (Figure 25), with the aeration system phased on in the growing season. In 2019, the dissolved oxygen in the upper water column was below the standard in mid August. The aeration system can increase the dissolved oxygen concentrations throughout the water column by about 2 mg/l within a two-week period.

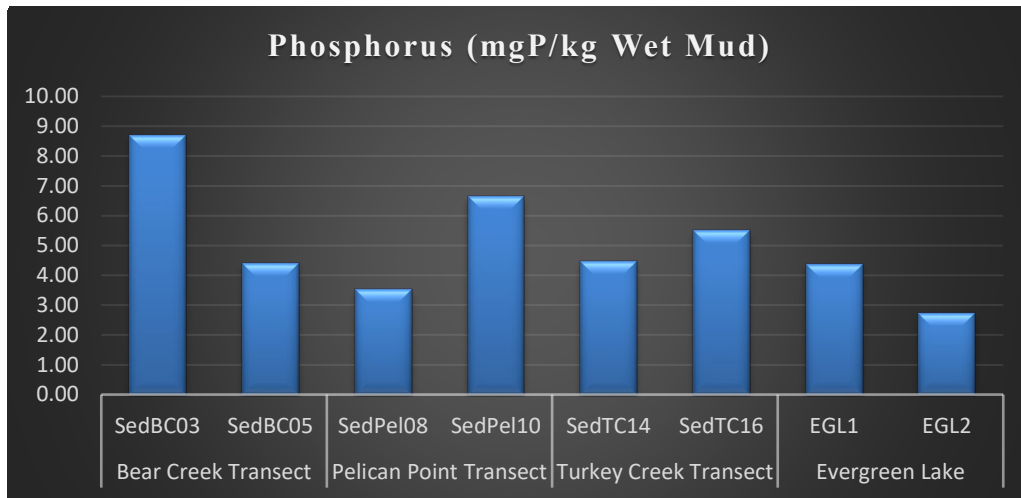
**Figure 27 Sediment Phosphorus by Transect in BCR**

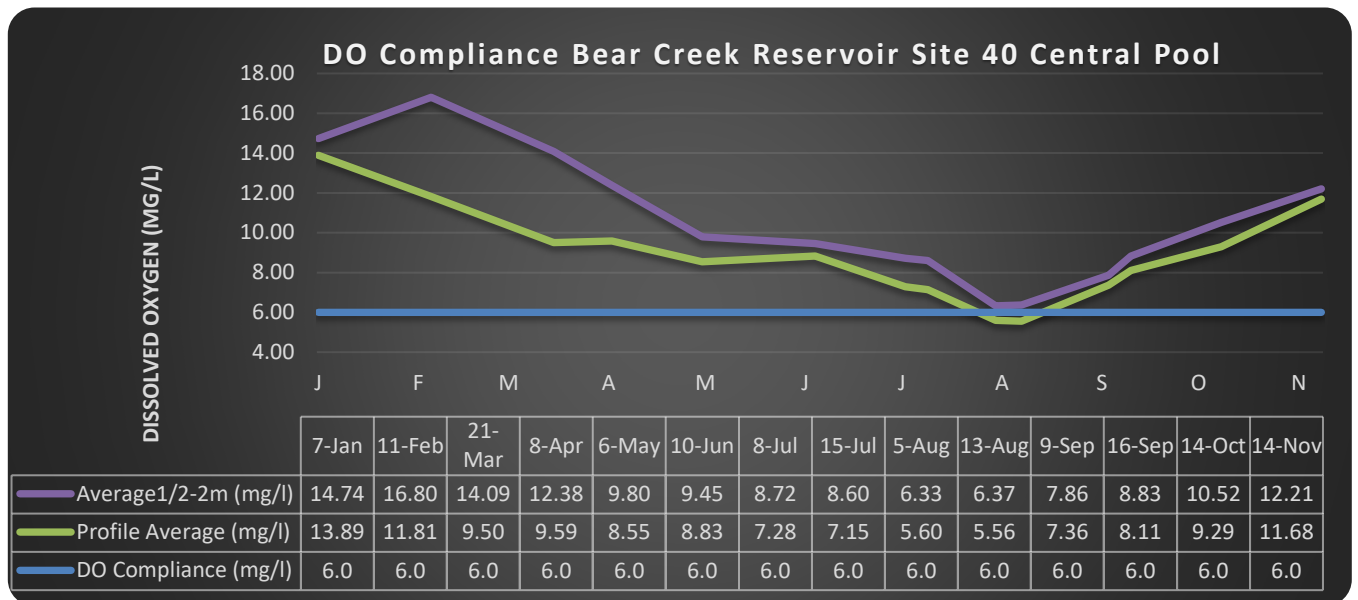
**Figure 28 DO Compliance Bear Creek Reservoir**

The Association takes multiple profile readings at three profile stations in the reservoir to determine dissolved oxygen compliance. The Association dissolved oxygen data set from 2003-2019 for Bear Creek Reservoir shows over 99% compliance with the standard for the upper water column (surface through the mixed layer). The monthly dissolved oxygen values in the mixed layer in 2019 were generally greater than 6 mg/l (Figure 28). There was an oxygen sag in early August, that correlated with a phytoplankton bloom. Data collected in the 2019 growing season shows the aeration system adds a maximum of 1.5 mg/l dissolved oxygen to the water column when under normal operation. Generally, the aeration system increases water column dissolved oxygen by about 1 mg/l, which results in dissolved oxygen compliance within the mixed layer.

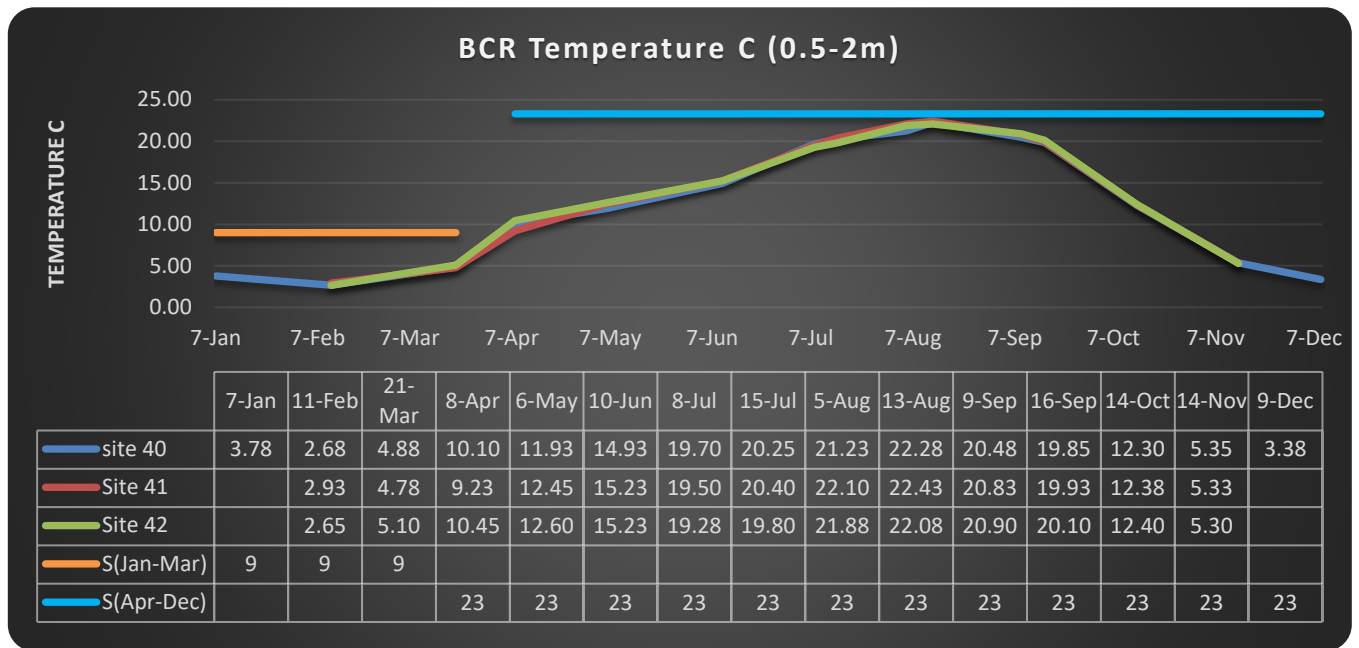
**Figure 29 Temperature Compliance Bear Creek Reservoir**

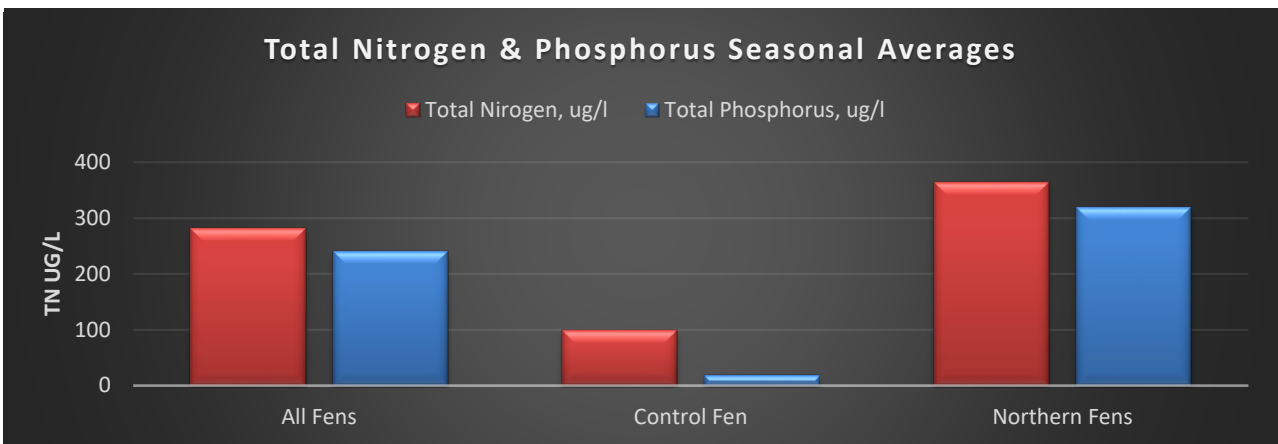
**Figure 30 Total Phosphorus and Total Nitrogen Seasonal Averages in Fen Complex**

The Association summarized evidence in the Regulation #38 Rulemaking Hearing for South Platte Basin Standards that suggests fen wetlands have background phosphorus levels that exceed Table Value Standards (TVS) even though streams in the same segment do not have elevated phosphorus levels (*Fact Sheet 53 BCR 2015 Regulation 38 Update*). It is not yet known what background level would be appropriate or if it varies among these fens. The Colorado Water Quality Commission applauds the efforts of BCWA to obtain data that improves our understanding of existing conditions. Site-specific standards are needed for all, or part, of Segment 7 for which phosphorus standards are required, but there is uncertainty about the habitat type or the geographic scope of applicability for site-specific standards (or conversely for the TVS). Resolving the uncertainty will require additional sampling to obtain representative data. Delaying the effective date by five years gives BCWA, time to collect additional data and propose site-specific phosphorus and total nitrogen standards as appropriate for the Fen complex. Total phosphorus standards were delayed until an effective date of 12/31/2020. In 2017, the Association established a control fen located on the south side of Bear Creek. This site has no visible human impact. All the fens on the north side of Bear Creek have varying degrees of anthropogenic degradation (*BCWA TM 2019.02 UBCW Summary*) (Figure 30).

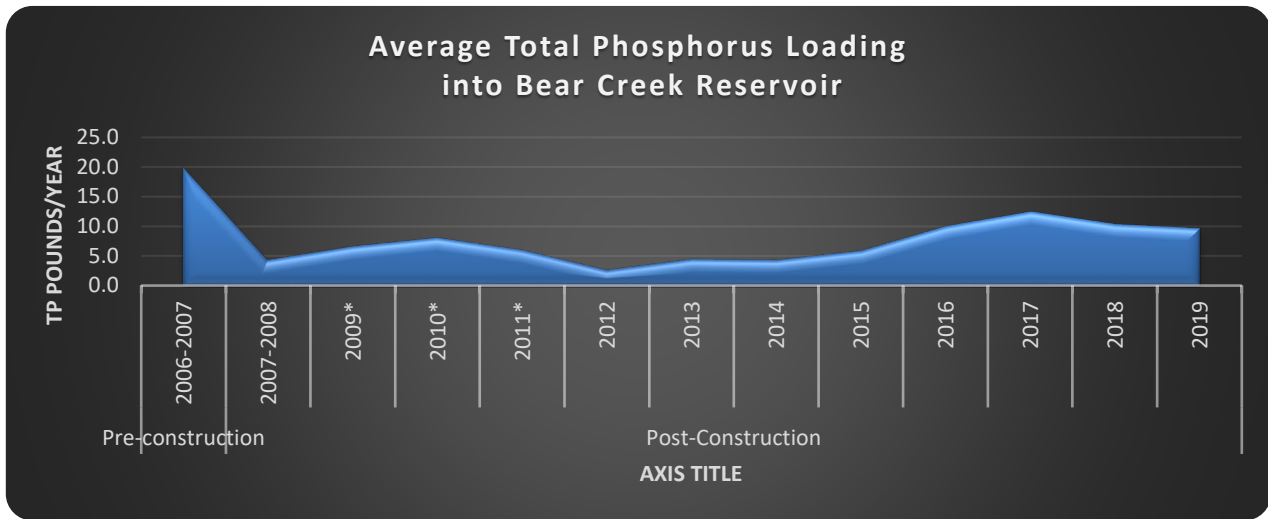
**Figure 31 Total Phosphorus Reduction at Coyote Gulch Project**
