Bear Creek Watershed Association

2021 Annual Report

June 24, 2022

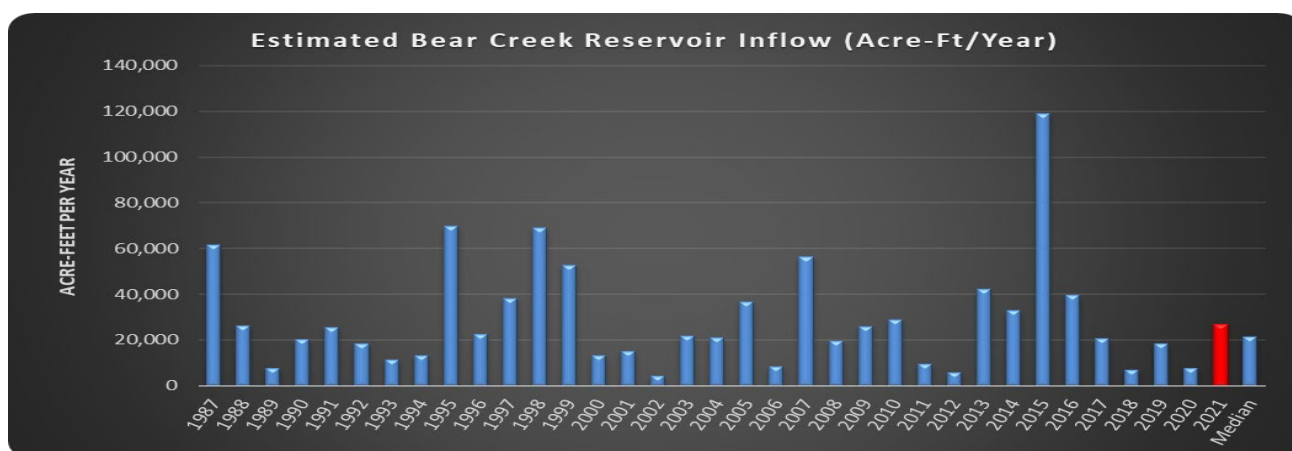
Figure 1 Estimated Bear Creek Reservoir Inflow 1987-2021

The average inflow into Bear Creek Reservoir from both Turkey Creek & Bear Creek (1987-2021) was 29,062 acre-feet per year. The 2021 inflow is estimated at 26,935 acre-feet (Figure 1) with the May/June runoff flow at 79% of the annual total flow. There was no flood stage (> 2,000 ac-ft) for BCR. The reservoir was well below normal (<1,300 acre-feet) from January through early May. The U.S. Army Corps of Engineers lowered BCR from September to December by about 300 ac-ft.

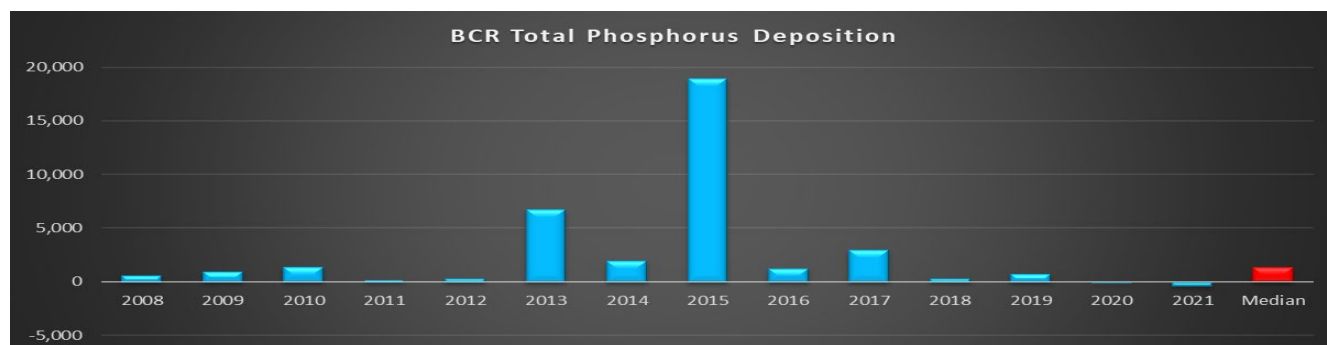
Figure 2 Annual Total Phosphorus Pounds Deposition into Bear Creek Reservoir Bottom Sediments

The estimated annual Bear Creek inflow into Bear Creek Reservoir was about 22,616 acre-feet (88%) and 6,472 acre-feet (22%) from Turkey Creek. Although there was no net phosphorus deposition into bottom sediments in 2020, the internal loading problem (total phosphorus) with Bear Creek Reservoir has not diminished over the last 12-years (Figure 2). The total phosphorus deposition into reservoir bottom sediments is about 36,211 pounds since 2008.

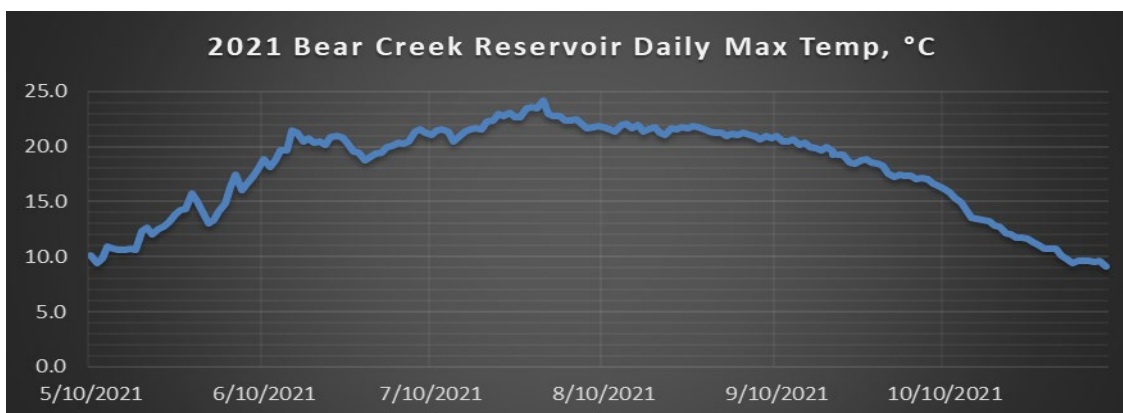
Figure 7 Bear Creek Reservoir Daily Maximum Temperatures at Site 40(0.5m)

The 2021 average seasonal total phosphorus of 45.2 µg/L in Bear Creek Reservoir far exceeds the 22.2 µg/L goal-standard. Average seasonal chlorophyll-a of 9.8 µg/L was below the 12.2 µg/L standard. The trophic status of the reservoir remains at the Eutrophic-Hypertrophic boundary based on Carlson and Walker indices. Seasonal average reservoir temperature in the top 2-meters of the water column were normal. There were no exceedances at Site 40 of the *Weekly Average Temperature* (MWAT 23.3 °C) or the *Daily Maximum Temperature* (DM 23.8 °C).

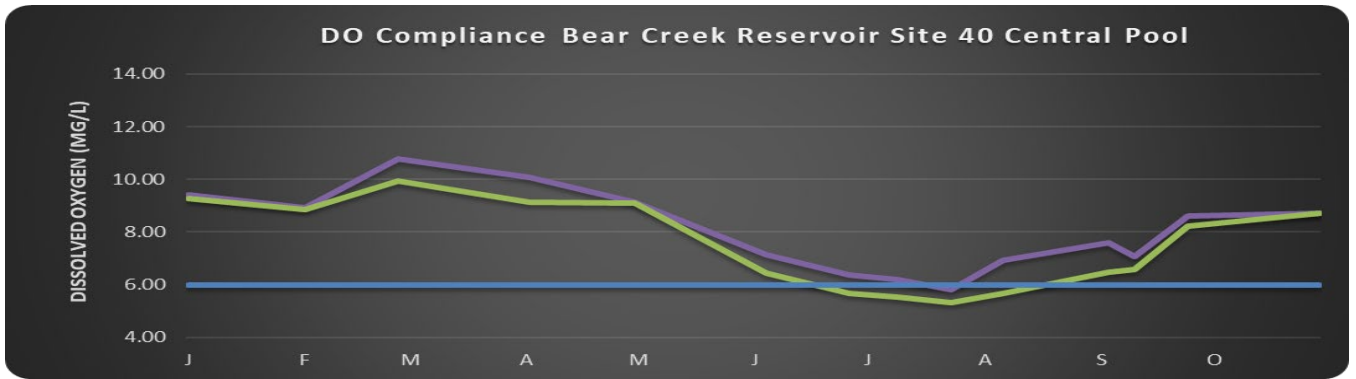
Figure 8 Dissolved Oxygen Compliance in Bear Creek Reservoir

The Association is monitoring the effectiveness of the aeration configuration and oxygen transfer during the growing season (BCWA Fact Sheet 47 New BCR Aeration System, BCWA Fact Sheet 62 BCR Aeration System Operation and BCWA Fact Sheet 63 2014 BCR Aeration System Evaluation). Lake aeration generally maintained dissolved oxygen levels at or above 6 mg/L throughout the growing season. The aeration system helps maintain an exceptional recreational fishery throughout the year (Figure 8).

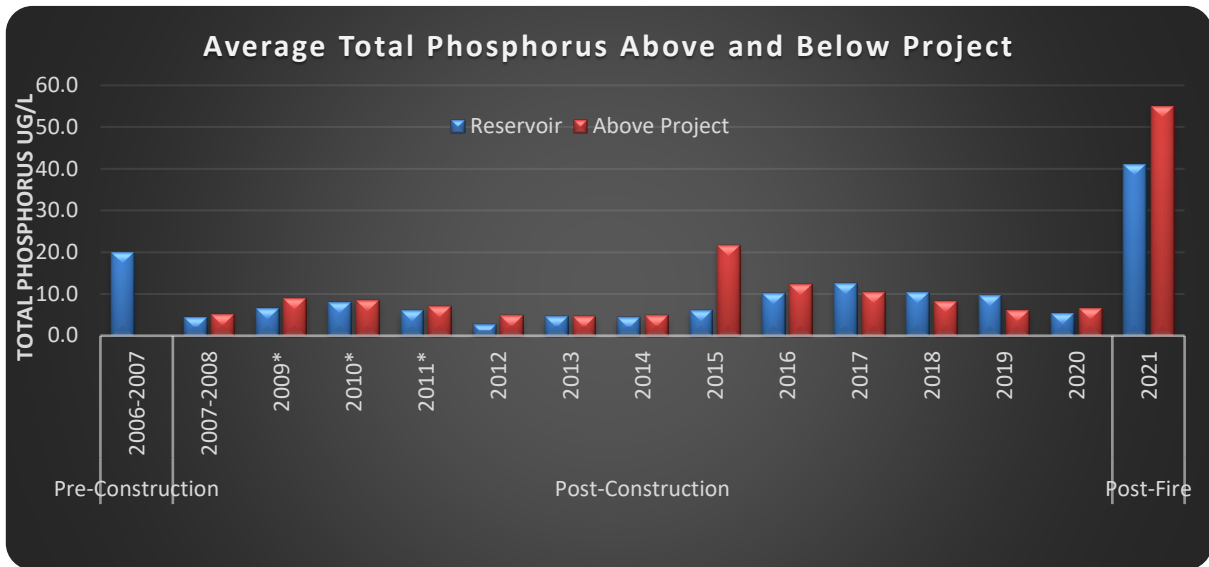
Figure 9 Total Phosphorus Reduction at Coyote Gulch Restoration Site

The project has effectively reduced total phosphorus loading by about 75% on an annual basis prior to the 2021 fire (Figure 7). The wetland and grassland complex upstream of the project was heavily burned in a wildland fire, February 7, 2021. (TM 2021.03 Coyote Gulch Summary). A major portion of upper Coyote Gulch and most of Coyote Crossing drainage within the BCLP was burned. The monitoring program was shifted to monthly sampling to better track burn water quality impacts. The 2021 runoff greatly increased nutrient loading throughout the year reaching Bear Creek Reservoir. The February nutrient loads for Total Nitrogen were significantly increased from historical conditions. The nutrient loading increased about 500-600% over the previous post construction baseloads. There was also an increased sediment loading, and subsequent erosion in the upper Coyote Gulch and along Coyote Crossing.

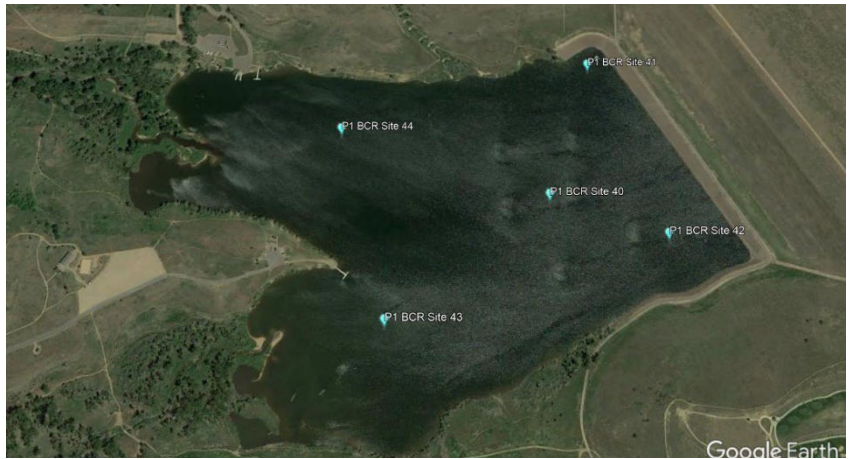
Figure 11 Reservoir Monitoring Stations; Site 40 is the Routine P1 Station

The BCWA monitoring plan details the 2021 reservoir and watershed monitoring programs as approved by the BCWA Board and submitted to the Water Quality Control Division staff (WQCD). This monitoring plan serves as a supplement to the adopted Association Quality Assurance Project Plan (Bear Creek Watershed Association, 2006). The 2021 monitoring program (version 2021.01) details changes, updates, major continuation studies and monitoring program elements. The *BCWA Policy 14 Data Collection in the Bear Creek Watershed* defines expectations for other groups or agencies that conduct overlapping monitoring activities within the watershed.

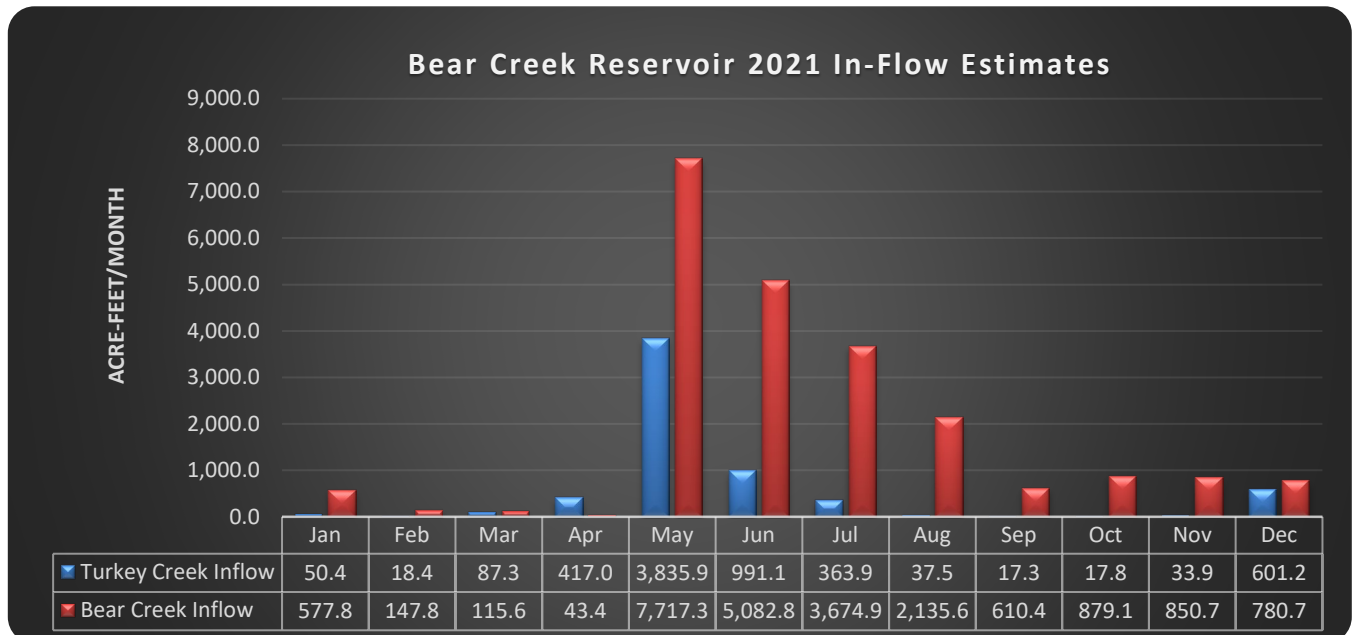
Figure 15 **Annual Flows into Bear Creek Reservoir**

The reservoir inflow represents flows below the water diversions and is not representative of the total watershed flows. Figure 15 compares the 2021 reservoir monthly inflow estimates from Bear Creek (88%) and Turkey Creek (22%). Peak spring and stormwater runoff occurred in May-June 2021 (61% of annual flow). Figure 16 shows the Bear Creek in-flow estimates (1987-2021) above Bear Creek Reservoir, in Bear Creek Park. Figure 17 shows the flow estimates at the Evergreen station. Additionally, the longer time trends shown in 17 depict a basic linear trend of declining flow in Bear Creek.

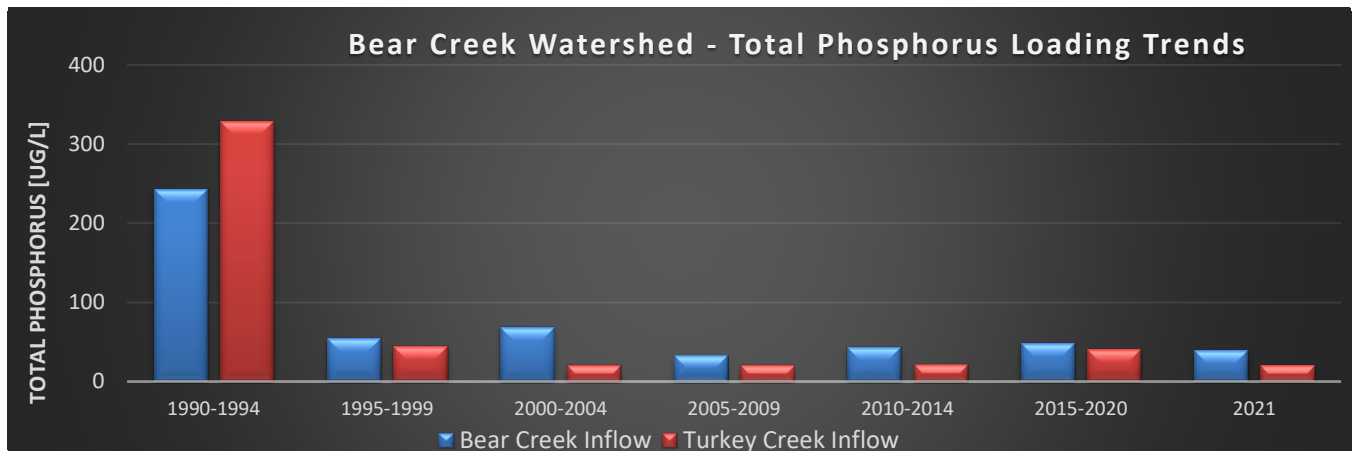
Figure 19 5-Year Average Total Phosphorus Trend BCR Compared with 2021

The watershed-monitoring program characterizes nutrient loading into Bear Creek Reservoir from two primary drainages: Bear Creek and Turkey Creek. The Association monitors for total phosphorus and total nitrogen monthly. The Association has established preferred management strategies for Bear Creek Reservoir (*BCWA Policy 20*). The total phosphorus load from the watershed comes from a combination of wastewater treatment plant point source loads, un-regulated point sources, and nonpoint sources, including runoff. There are over 9,000 septic systems in the watershed. The estimated total phosphorus load in 2021 from all sources reaching the reservoir was 3,260 pounds at a flow of about 29,088 acre-feet. Bear Creek drainage contributed 81% of the TP load (Figure 18). The management program targets reduction of total phosphorus reaching the reservoir on an annual basis. Figure 19 shows the total phosphorus reservoir loading trend.

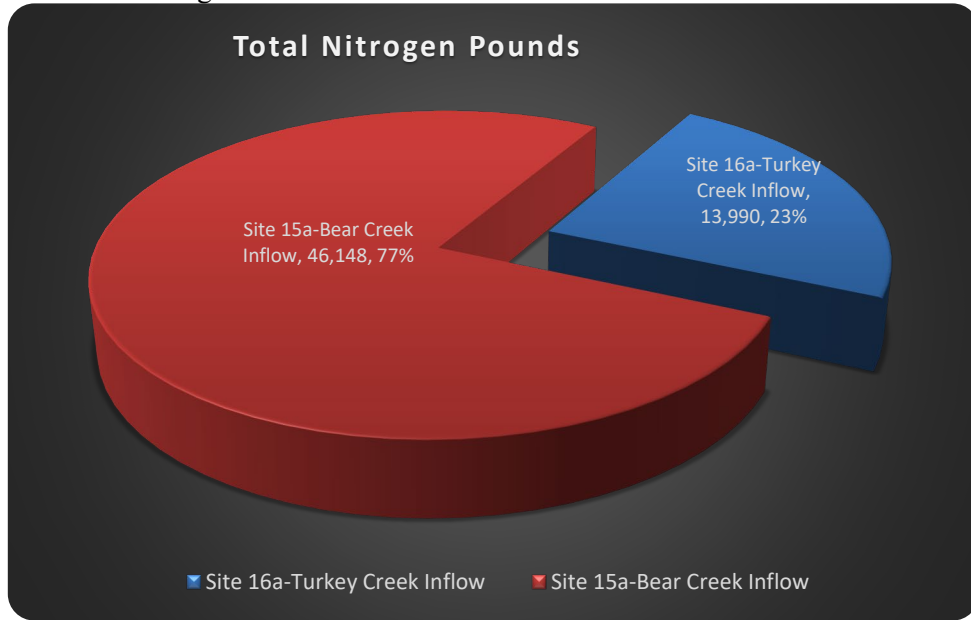
Figure 20 Total Nitrogen Loading into Bear Creek Reservoir

The total nitrogen loading (Figure 20, about 60,138 pounds) had 77% of the load coming from Bear Creek. Figure 21 shows the Total Nitrogen trend in BCR.

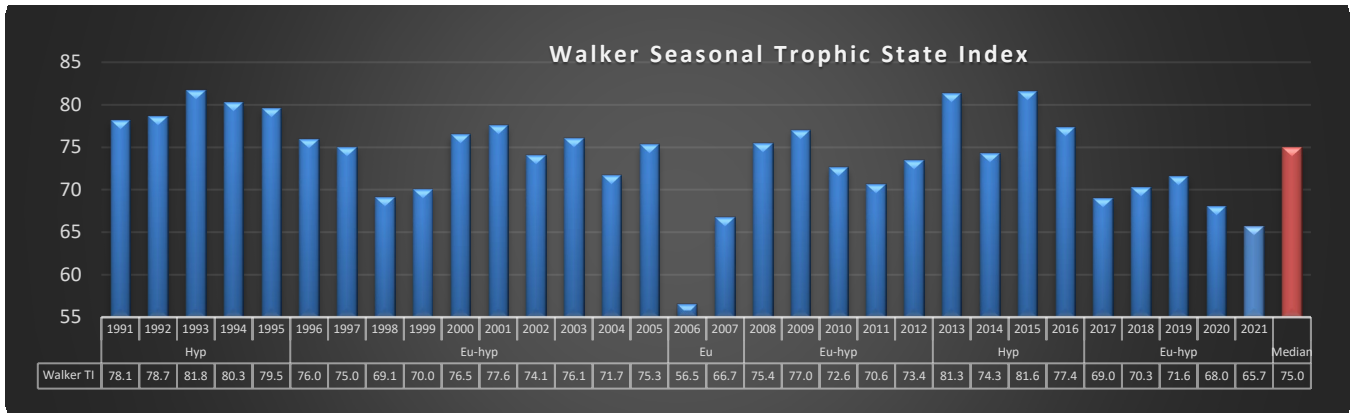
Figure 24 Walker Trophic Index Trend Bear Creek Reservoir

The reservoir trophic state was eutrophic (Walker Index, Figure 24). The Carlson Index shows a similar eutrophic trend. Although external nutrient loads were lower than historic trends, the reservoir continues to have an internal nutrient loading problem, which causes eutrophic water quality conditions.

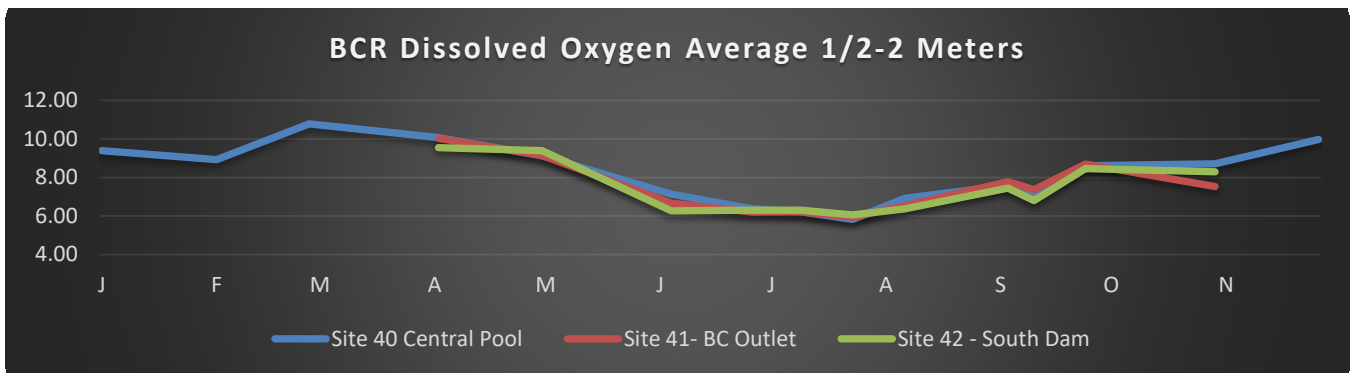
Figure 25 Bear Creek Reservoir 2021 Dissolved Oxygen Trend

Reservoir aeration is also a necessary management tool in low flow conditions. The aeration system has been operational since the summer of 2002 and uses a fine-bubble diffusion system with aerators distributed across the hypolimnion. In 2021, the Association and Lakewood operated the aeration system to maximize oxygen transfer during phased on-off cycling (Figure 25), with the aeration system phased on in the growing season. In 2020, the dissolved oxygen in the lower water column was below the standard in mid-August. The aeration system can increase the dissolved oxygen concentrations throughout the water column by about 2 mg/l within a two-week period.

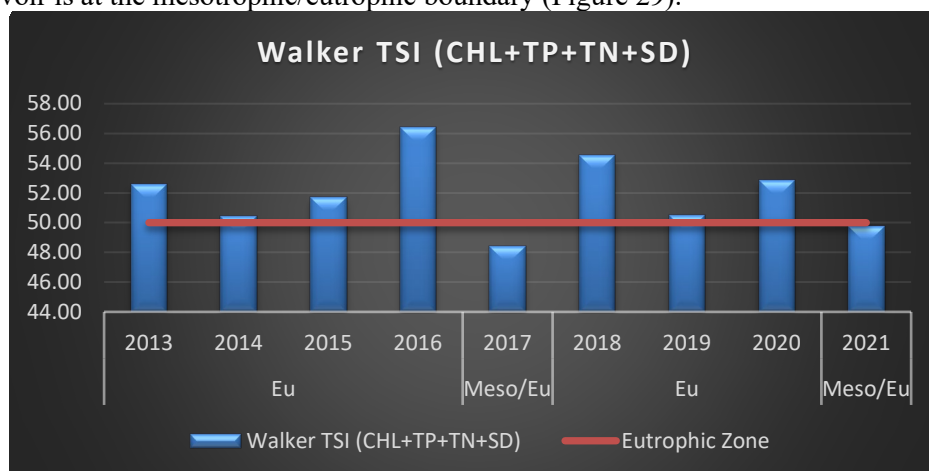
Figure 28 Trophic State of Evergreen Lake using Walker Index

The trophic state of Evergreen Lake is currently balance on the Eutrophic boundary (Figure 28 and 29). The Walker Index suggests the reservoir has already tipped into a Eutrophic state (Figure 28). The Carlson Index suggest the reservoir is at the mesotrophic/eutrophic boundary (Figure 29).

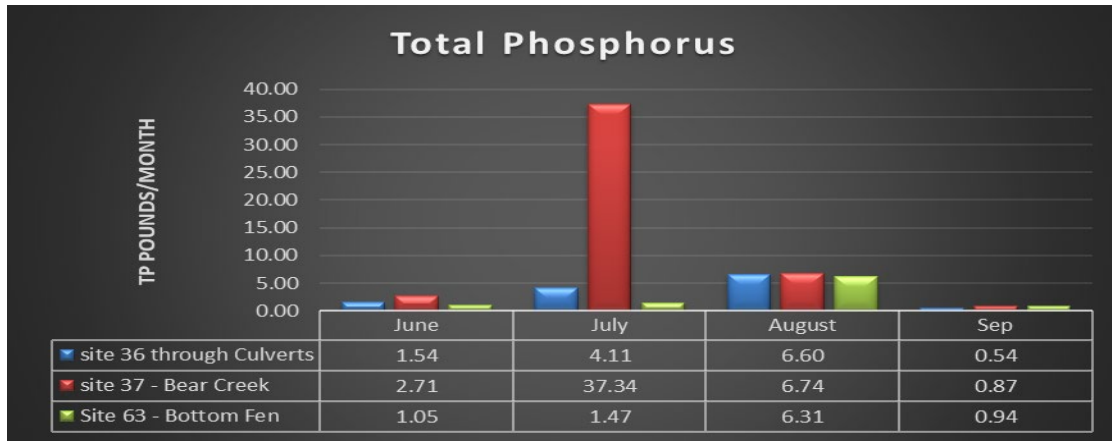
Figure 31 Total Phosphorus loading Summit Lake

Bear Creek Watershed Association continued to monitor three sampling stations at Summit Lake and upper Bear Creek, Mt Evans Wilderness, Clear Creek County Colorado (*BCWA Technical Memorandum 2021.02 - UBCW*). The Association historic sampling Site 36 (Summit Lake at outfall) and Upper Bear Creek Site 37 monitor “background” conditions. The pollution plume is monitored at station 63, which is at the bottom of the fen complex prior to discharge into upper Bear Creek. Monitoring data show atypical water quality results for an alpine ecoregion. The station data demonstrates there is a pollution source(s) causing elevated nutrient loads (Figures 31 and 32), low pH conditions and reduced dissolved oxygen.

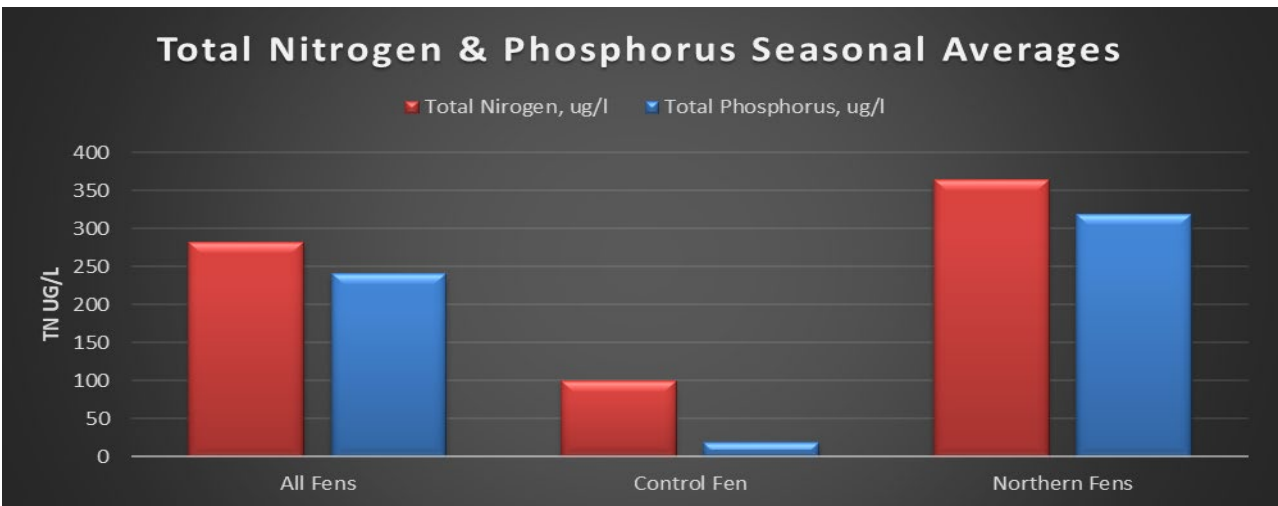
Figure 33 Total Phosphorus and Total Nitrogen Seasonal Averages in Fen Complex

The Association summarized evidence in the Regulation #38 Rulemaking Hearing for South Platte Basin Standards that suggests fen wetlands have background phosphorus levels that exceed Table Value Standards (TVS) even though streams in the same segment do not have elevated phosphorus levels (*Fact Sheet 53 BCR 2015 Regulation 38 Update*). It is not yet known what background level would be appropriate or if it varies among these fens. The Colorado Water Quality Commission applauds the efforts of BCWA to obtain data that improves our understanding of existing conditions. Site-specific standards are needed for all, or part, of Segment 7 for which phosphorus standards are required, but there is uncertainty about the habitat type or the geographic scope of applicability for site-specific standards (or conversely for the TVS). Resolving the uncertainty will require additional sampling to obtain representative data. Delaying the effective date by five years gives BCWA, time to collect additional data and propose site-specific phosphorus and total nitrogen standards as appropriate for the Fen complex. Total phosphorus standards were delayed until an effective date of 12/31/2020. In 2017, the Association established a control fen located on the south side of Bear Creek. This site has no visible human impact. All the fens on the north side of Bear Creek have varying degrees of anthropogenic degradation (*BCWA TM 2020.02 UBCW Summary*) (Figure 33).

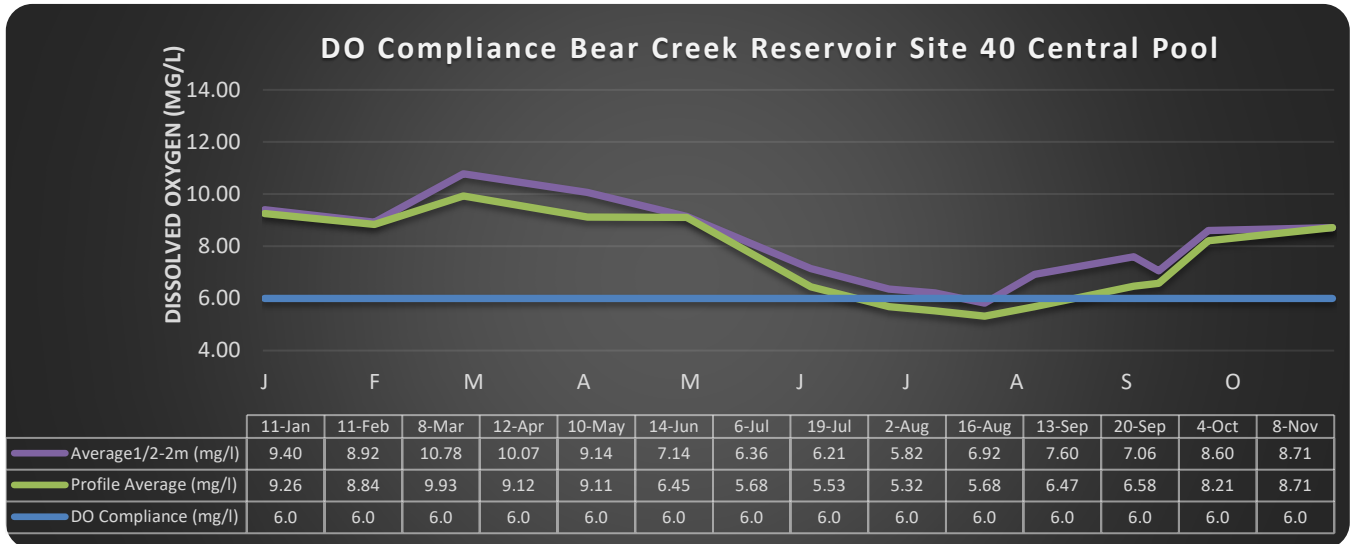
Figure 34 DO Compliance Bear Creek Reservoir

The Association takes multiple profile readings at three profile stations in the reservoir to determine dissolved oxygen compliance. The Association dissolved oxygen data set from 2003-2021 for Bear Creek Reservoir shows over 99% compliance with the standard for the upper water column (surface through the mixed layer). The monthly dissolved oxygen values in the mixed layer in 2021 were generally greater than 6 mg/l (Figure 30). There was an oxygen sag in early August, which correlated with a phytoplankton bloom. Data collected in the 2021 growing season shows the aeration system adds a maximum of 1.5 mg/l dissolved oxygen to the water column when under normal operation. Generally, the aeration system increases water column dissolved oxygen by about 1 mg/l, which results in dissolved oxygen compliance within the mixed layer.
