Bear Creek Watershed Association

2022 Annual Report

May 31, 2023

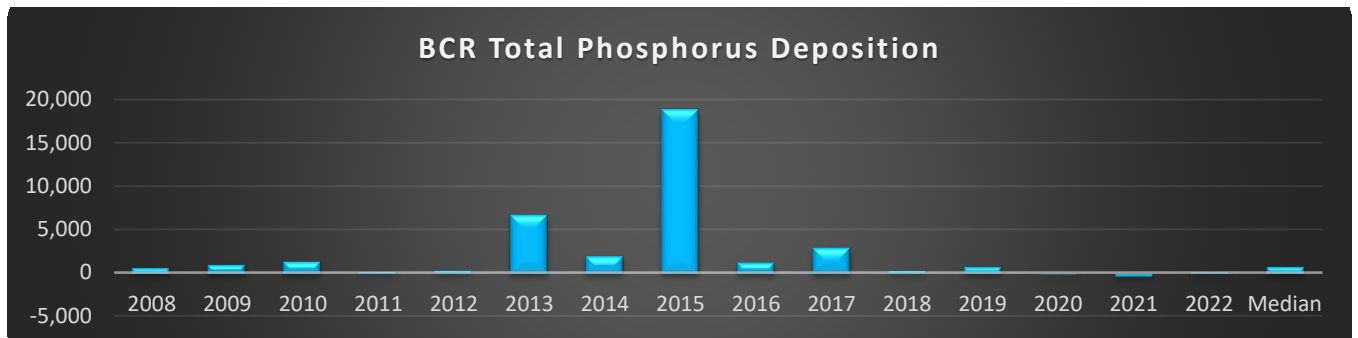
Figure 2 Annual Total Phosphorus Pounds Deposition into Bear Creek Reservoir Bottom Sediments

The estimated annual Bear Creek inflow into Bear Creek Reservoir was about 14,175 acre-feet (88%) and 1,961 acre-feet (12%) from Turkey Creek. Although there was minimal net phosphorus deposition into bottom sediments in 2022, the internal loading problem (total phosphorus) within Bear Creek Reservoir has not diminished over the last 15-years (Figure 2). The total phosphorus deposition into reservoir bottom sediments is about 36,395 pounds since 2008. The median annual deposit is about 800 pounds per year.

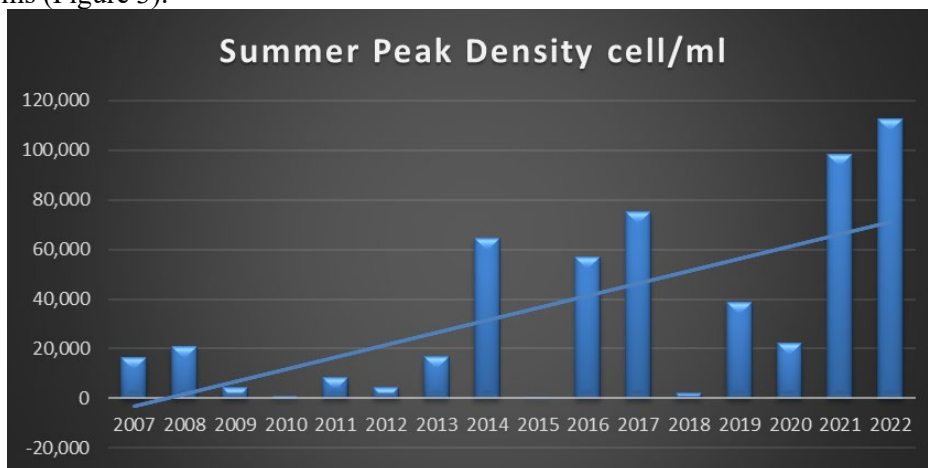
Figure 3 Summer Peak Bluegreen Density in Bear Creek Reservoir

BCWA Fact Sheet 57 Cyanotoxins provides information on the potential toxic risk from high concentrations of bluegreens and BCWA Fact Sheet 58 Cyanobacteria Guide BCR can be used to visually identify major species. Fact Sheet 60 Managing Harmful Algal Blooms and Fact Sheet 61 HABs Exposure and Risks were developed by the BCWA to help manage problem bluegreen blooms. Fact Sheet 66 discusses the problem with HABs and Pets. Several pets were reported as sick in 2022 likely caused by cyanotoxins. The BCWA has identified some strategies to address the internal loading problem (BCWA Policy 20 Preferred Management Strategies EGL and BCR). The summer peak density of bluegreens has been increasing since 2007 with 2021 and 2022 having more problematic blooms (Figure 3).

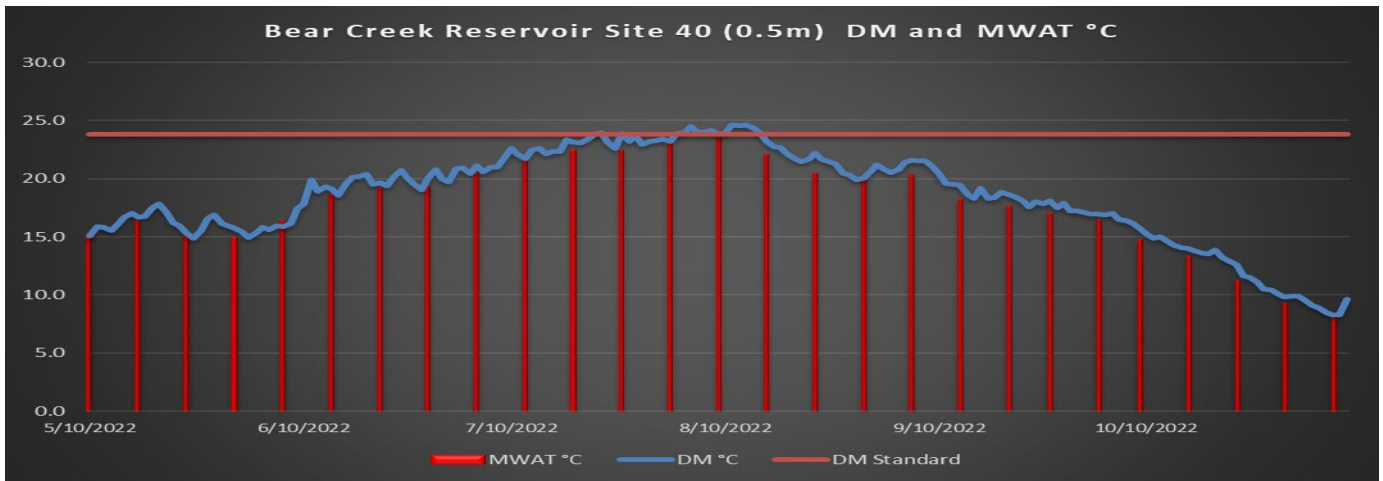
Figure 9 Bear Creek Reservoir Daily Maximum Temperatures at Site 40(0.5m)

The 2022 average seasonal total phosphorus of 129.3 µg/L in Bear Creek Reservoir far exceeds the 22.2 µg/L goal standard. Average seasonal chlorophyll-a of 104.4 µg/L far exceeds the 12.2 µg/L standard. The trophic status of the reservoir shifted to the Hypertrophic based on Carlson and Walker indices. Seasonal average reservoir temperature in the top 2-meters of the water column were above normal. There was one exceedance at Site 40 of the *Weekly Average Temperature* (MWAT 23.3 °C) and 15 exceedances of the *Daily Maximum Temperature* (DM 23.8 °C) (Figure 9).

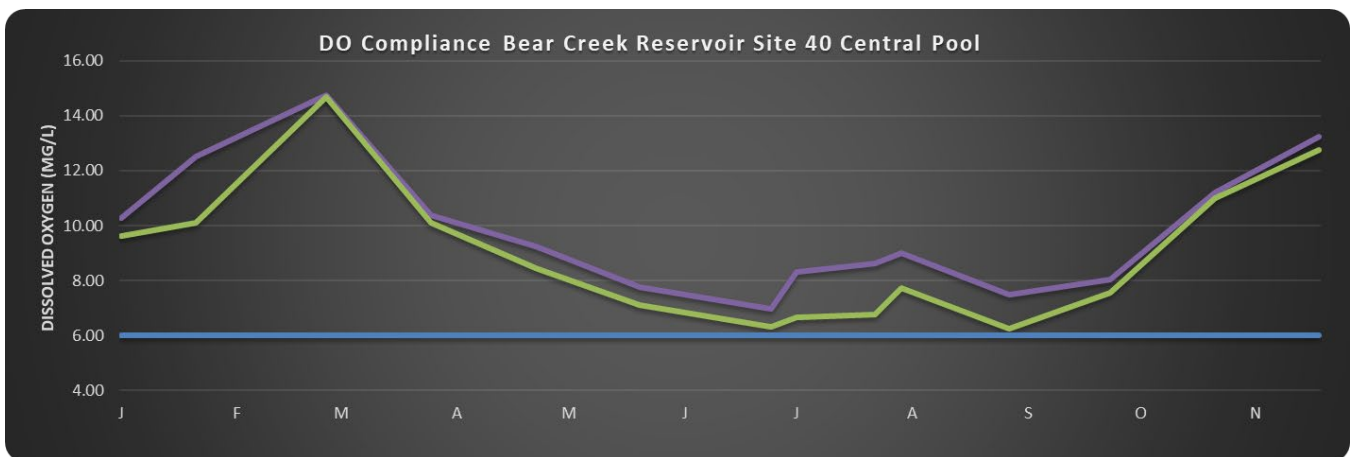
Figure 10 Dissolved Oxygen Compliance in Bear Creek Reservoir

The Association is monitoring the effectiveness of the aeration configuration and oxygen transfer during the growing season (BCWA Fact Sheet 47 New BCR Aeration System, BCWA Fact Sheet 62 BCR Aeration System Operation and BCWA Fact Sheet 63 2014 BCR Aeration System Evaluation). Lake aeration generally maintained dissolved oxygen levels at or above 6 mg/L throughout the growing season. The aeration system helps maintain an exceptional recreational fishery throughout the year (Figure 10).

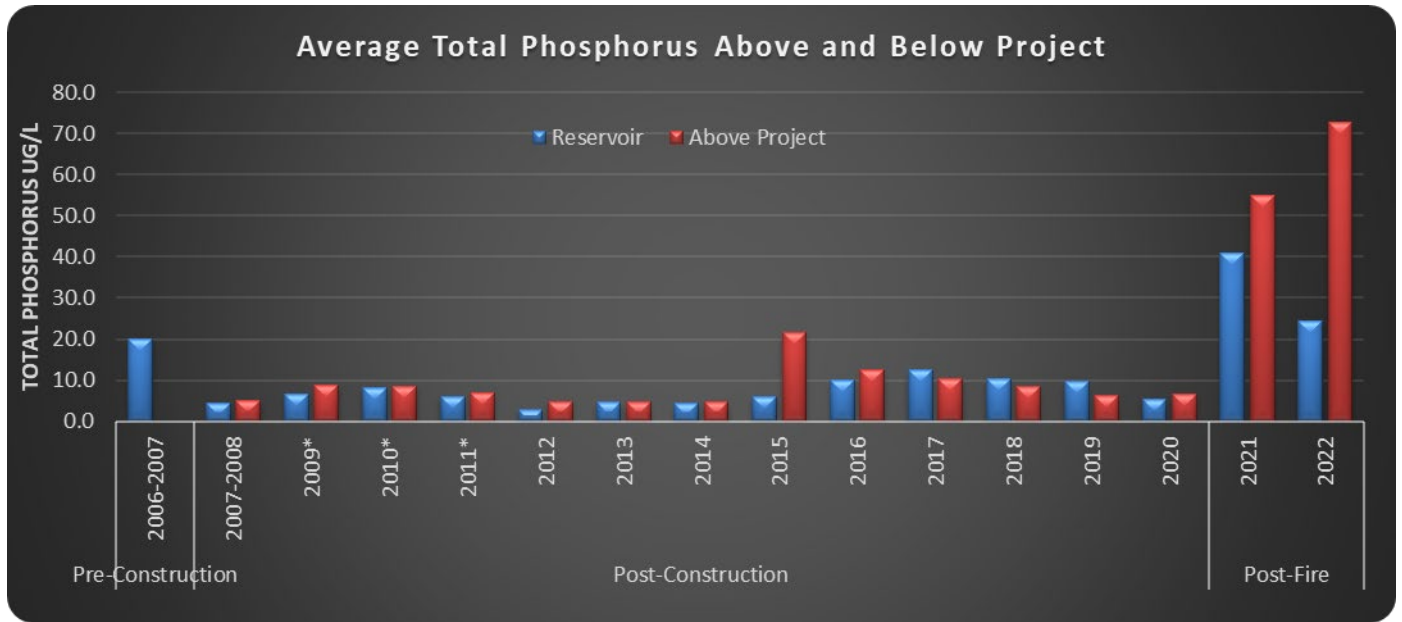
Figure 11 Total Phosphorus Reduction at Coyote Gulch Restoration Site

The project has effectively reduced total phosphorus loading by about 75% on an annual basis prior to the 2021 fire (Figure 11). The wetland and grassland complex upstream of the project was heavily burned in a wildland fire, February 7, 2021. (TM 2022.03 Coyote Gulch Summary). A major portion of upper Coyote Gulch and most of Coyote Crossing drainage within the BCLP was burned. The monitoring program was shifted to monthly sampling to better track burn water quality impacts. The 2022 runoff increased nutrient loading throughout the year reaching Bear Creek Reservoir. The nutrient loads for Total Nitrogen were significantly increased from historical conditions. The nutrient loading increased about 500-600% over the previous post construction baseloads. There was also an increased sediment loading, and subsequent erosion in the upper Coyote Gulch and along Coyote Crossing.

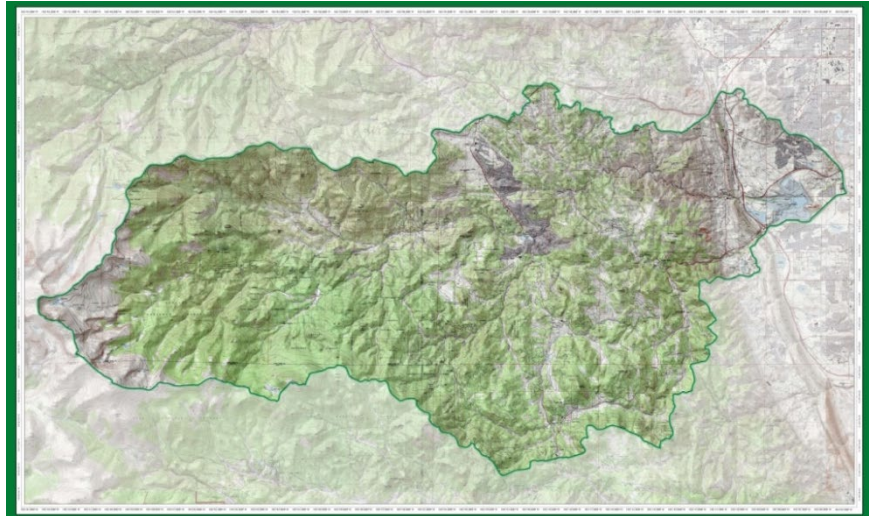
Figure 12 Bear Creek Watershed

The Bear Creek Watershed (Figure 12) is a specific geographic area identified in the Bear Creek Watershed State Control Regulation (Regulation #74, 5 CCR 1002-74) (Control Regulation) requiring special water quality management. The watershed includes all tributary water flows that discharge into Bear Creek Reservoir (*BCWA Policy 13 Watershed Boundary*). The watershed extends from the Mount Evans Wilderness on the western end to the Town of Morrison on the eastern end (*BCWA Map 01 Watershed Boundary*). The two major tributaries are Bear Creek and Turkey Creek. The goal of the Control Regulation is to attain site-specific water quality standards and classifications through control of total phosphorus and chlorophyll (*BCWA Fact Sheet 10 Control Regulation 74*). The Bear Creek Watershed Association (Association) oversees implementation of the Control Regulation (*BCWA Fact Sheet 1 BCWA Overview; BCWA Policy 12 Vision Mission & Targets*).

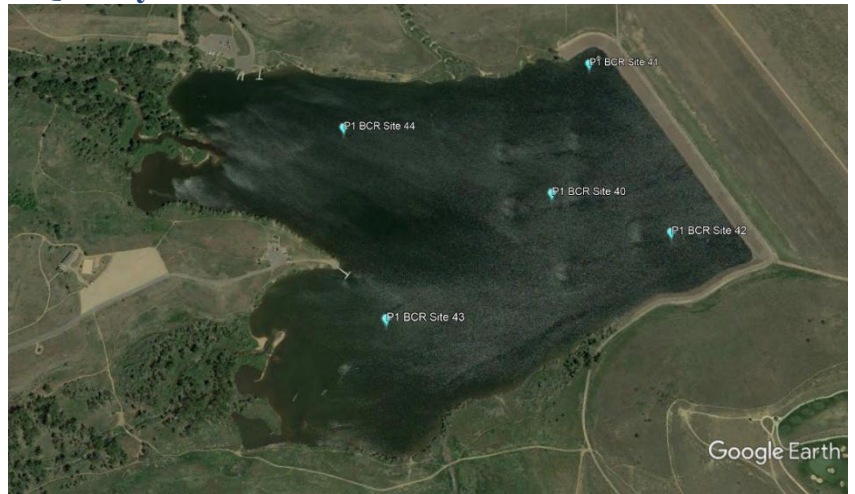
Figure 13 Reservoir Monitoring Stations; Site 40 is the Routine P1 Station

The BCWA monitoring plan details the 2022 reservoir and watershed monitoring programs as approved by the BCWA Board and submitted to the Water Quality Control Division staff (WQCD). This monitoring plan serves as a supplement to the adopted Association Quality Assurance Project Plan (Bear Creek Watershed Association, 2006). The 2022 monitoring program (version 2022.01) details changes, updates, major continuation studies and monitoring program elements. The *BCWA Policy 14 Data Collection in the Bear Creek Watershed* defines expectations for other groups or agencies that conduct overlapping monitoring activities within the watershed.

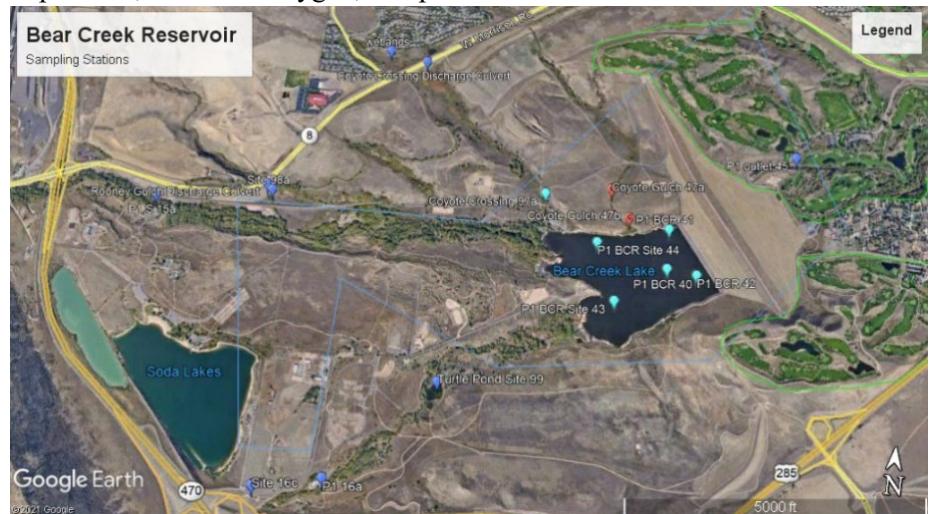
Figure 14 Monitoring Stations (Active and Historic) in Bear Creek Lake Park

Figure 10 shows all active and historic monitoring stations within Bear Creek Park. The Association maintains maps of recent and historic sampling sites, wastewater treatment plant locations and special study areas in the Association’s electronic watershed plan.

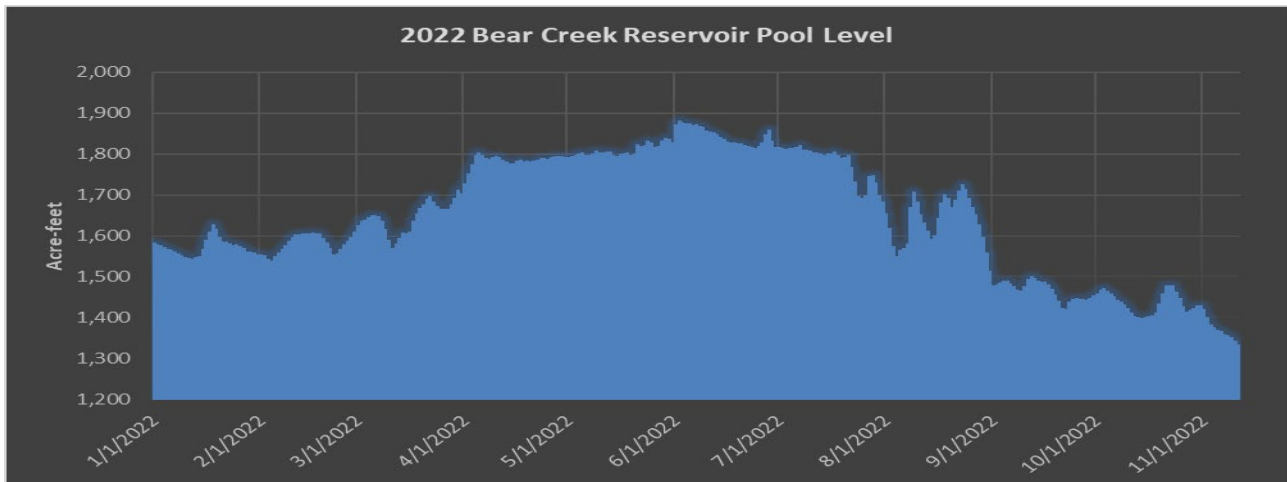
Figure 16 No Flood Stage in Bear Creek Reservoir

The average inflow into Bear Creek Reservoir from both Turkey Creek & Bear Creek (1987-2022) was 28,702 acre-feet per year (Table 5). The 2022 inflow is estimated at 16,112 acre-feet (Figure 15) with the June flow at 23% of the annual total flow. There was no flood stage (> 2,000 ac-ft) for BCR (Figure 16). The reservoir was below normal (<1,500 acre-feet) from January through early April. The U.S. Army Corps of Engineers lowered BCR from September to December by about 400 ac-ft.

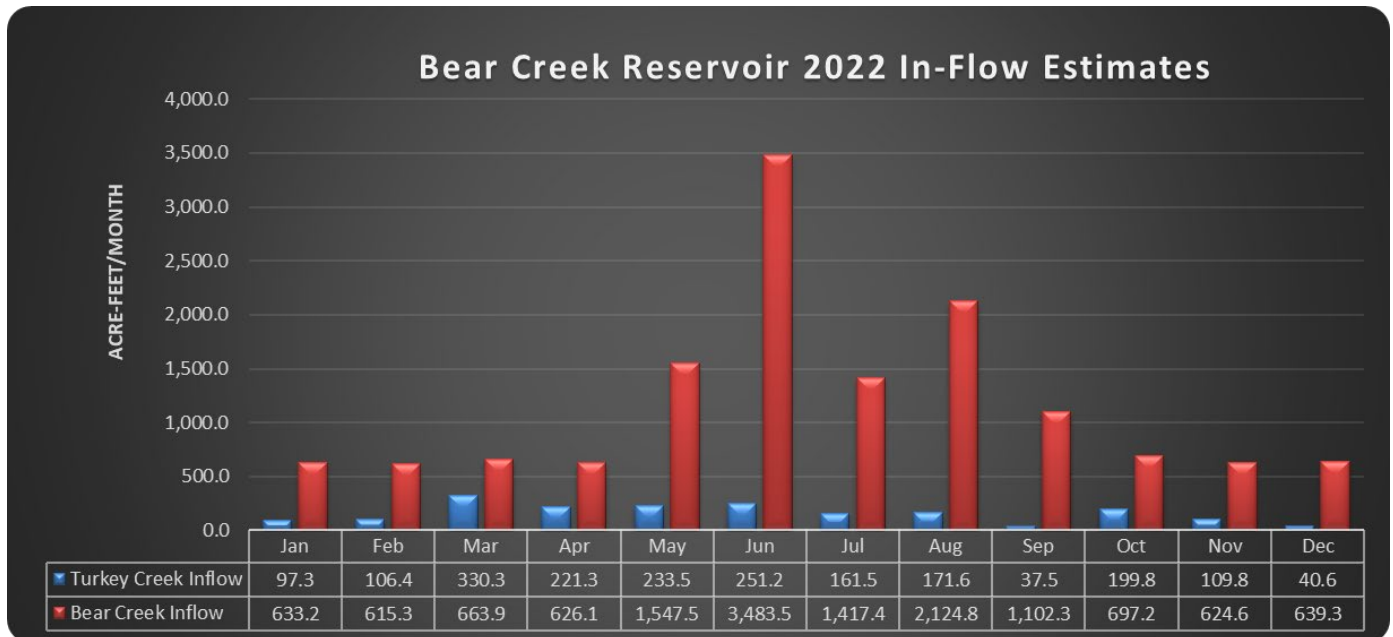
Figure 17 **Annual Flows into Bear Creek Reservoir**

The reservoir inflow represents flows below the water diversions and is not representative of the total watershed flows. Figure 17 compares the 2022 reservoir monthly inflow estimates from Bear Creek (88%) and Turkey Creek (12%). Peak spring and stormwater runoff occurred in June 2022 (23% of annual flow). Figure 18 shows the Bear Creek in-flow estimates (1987-2022) above Bear Creek Reservoir, in Bear Creek Park. Figure 19 shows the flow estimates at the Evergreen station. Additionally, the longer time trends shown in 19 depict a basic linear trend of declining flow in Bear Creek.

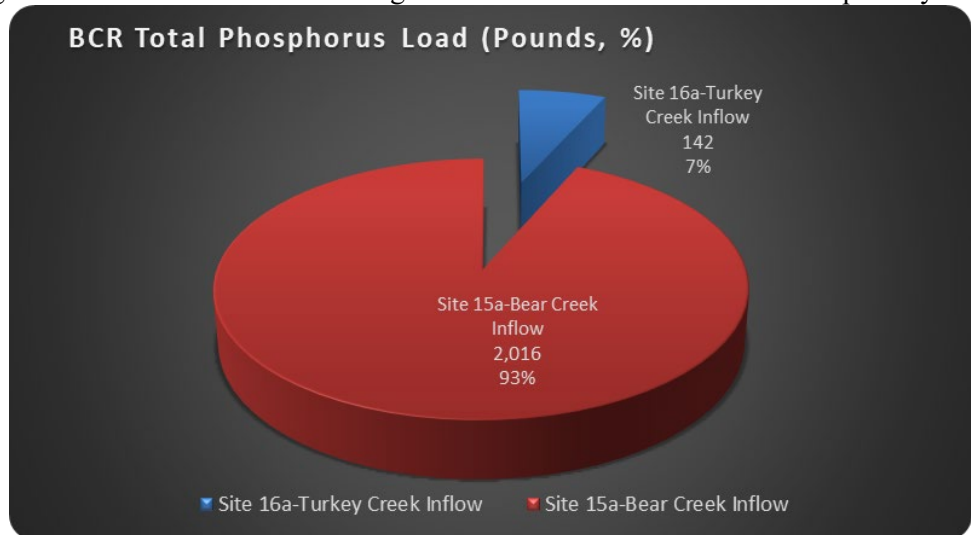
Figure 20 Estimated Total Phosphorus loading into Bear Creek Reservoir

load in 2022 from all sources reaching the reservoir was 2,157 pounds at a flow of about 16,136 acre-feet. Bear Creek drainage contributed 931% of the TP load (Figure 20).

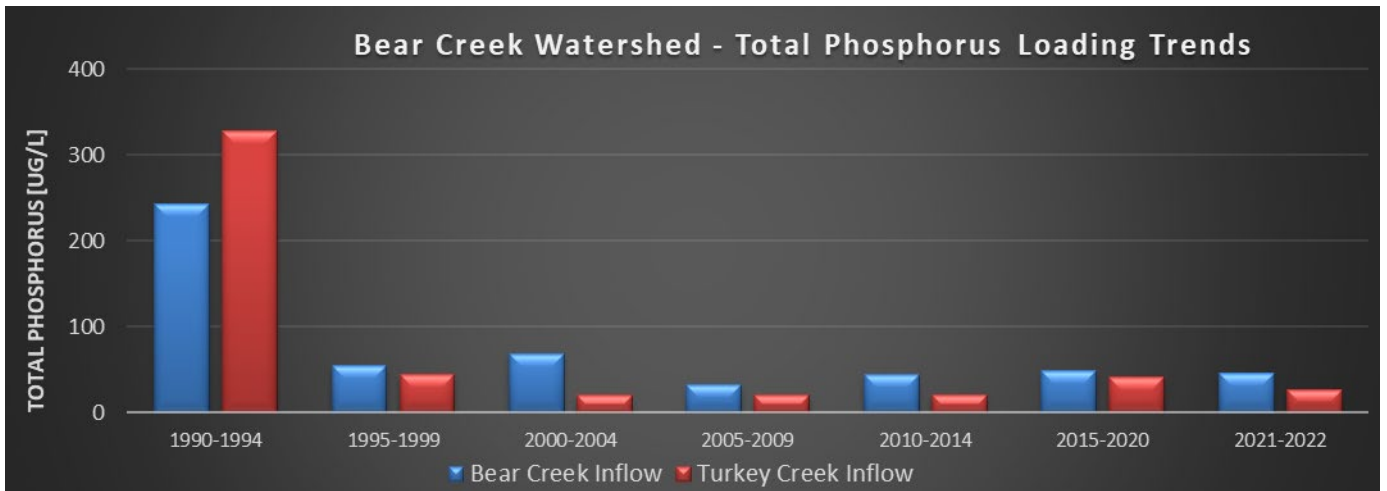
Figure 21 5-Year Average Total Phosphorus Trend BCR Compared with 2021

The management program targets reduction of total phosphorus reaching the reservoir on an annual basis. Figure 21 shows the total phosphorus reservoir loading trend from 1990 through 2022 in 5-year blocks. The total nitrogen loading (Figure 22, about 29,878 pounds) had 85% of the load coming from Bear Creek. Figure 23 shows the Total Nitrogen trend in BCR. Since 2011 the total nitrogen loading has shown an increasing trend into Bear Creek Reservoir, with 2022 as the highest loading year.

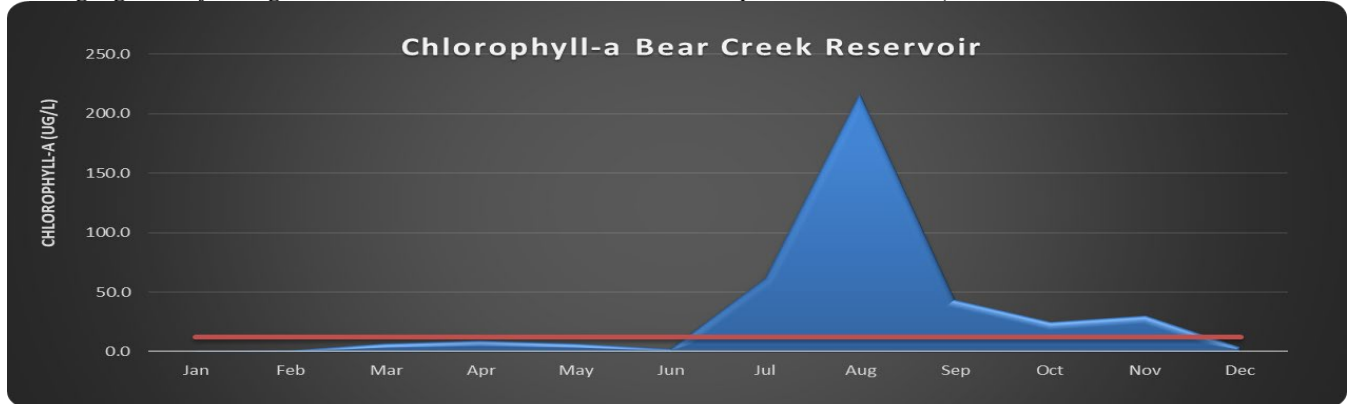
Figure 25 Bear Creek Reservoir Chlorophyll Trend

The reservoir had several algal blooms in 2022 as evidenced by peak August through September chlorophyll concentrations (Figure 25). The August chlorophyll measurement of 248.9 ug/l is the highest ever recorded for Bear Creek Reservoir. Historically, blue-green phytoplankton species are associated with major blooms in the reservoir (*BCWA Fact Sheet 57 Cyanotoxins, BCWA Fact Sheet 58 Cyanobacteria Guide BCR, Fact Sheet 60 Managing Harmful Algal Blooms, and Fact Sheet 61 HABs Exposure and Risks*).

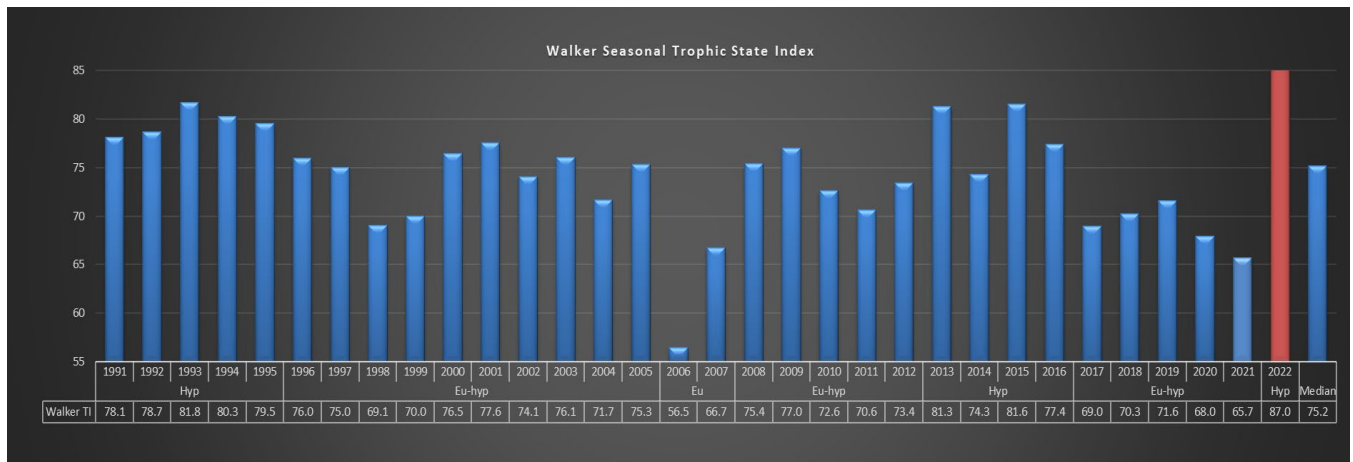
Figure 26 Walker Trophic Index Trend Bear Creek Reservoir

The reservoir trophic state was hypereutrophic (Walker Index, Figure 26). The Carlson Index shows a similar eutrophic trend. External nutrient loads were higher than historic trends, the reservoir continues to have an internal nutrient loading problem, which causes eutrophic water quality conditions.

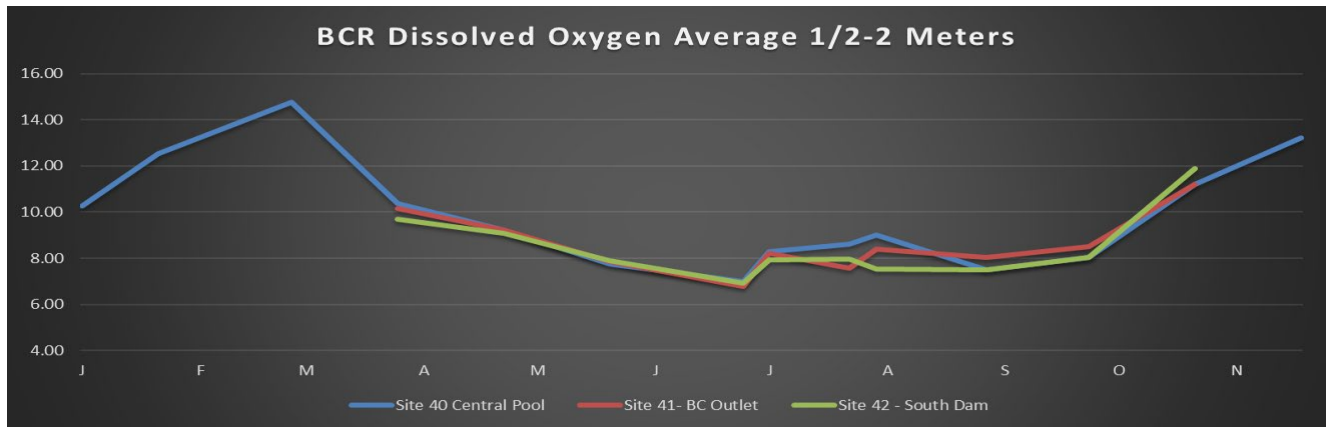
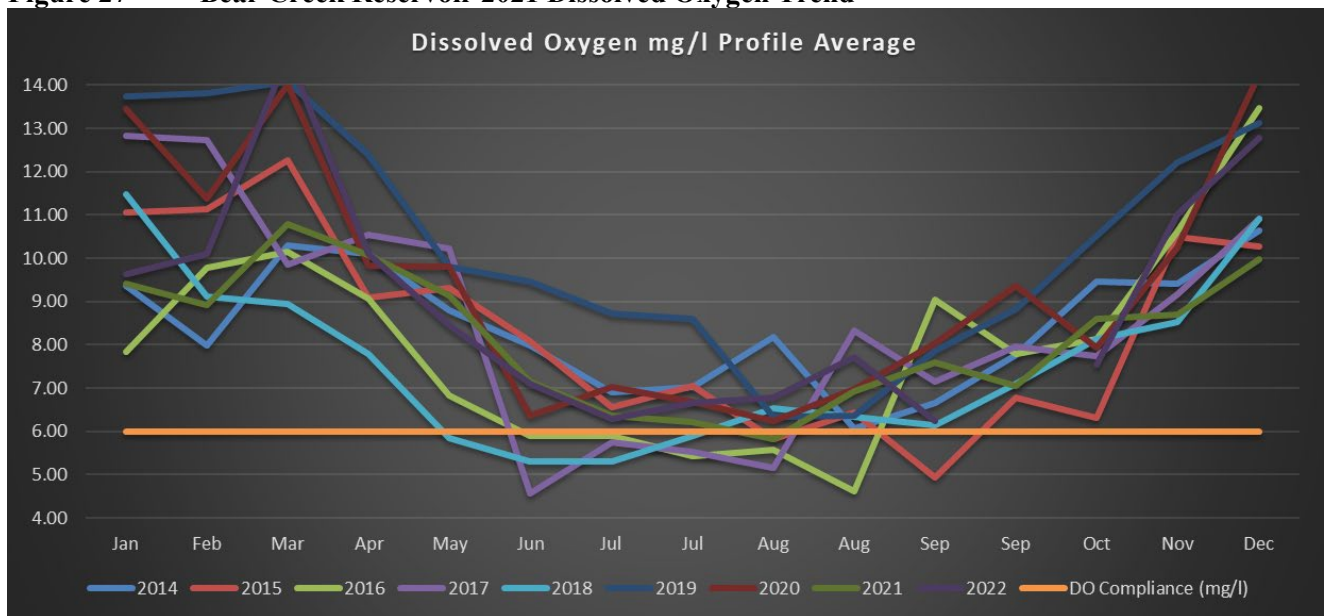
Reservoir aeration is also a necessary management tool in low flow conditions. The aeration system has been operational since the summer of 2002 and uses a fine-bubble diffusion system with aerators distributed across the hypolimnion. In 2022, the Association and Lakewood operated the aeration system to maximize oxygen transfer during phased on-off cycling (Figure 27 and 28), with the aeration system phased on in the growing season. In

2022, the dissolved oxygen in the lower water column was below the standard in mid-August. The aeration system can increase the dissolved oxygen concentrations throughout the water column by about 2 mg/l within a two-week period.

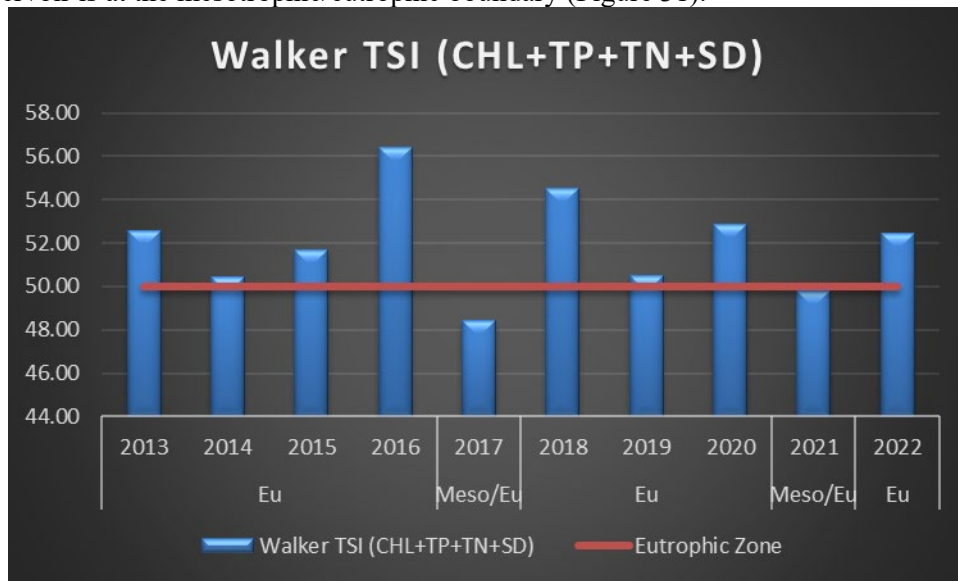
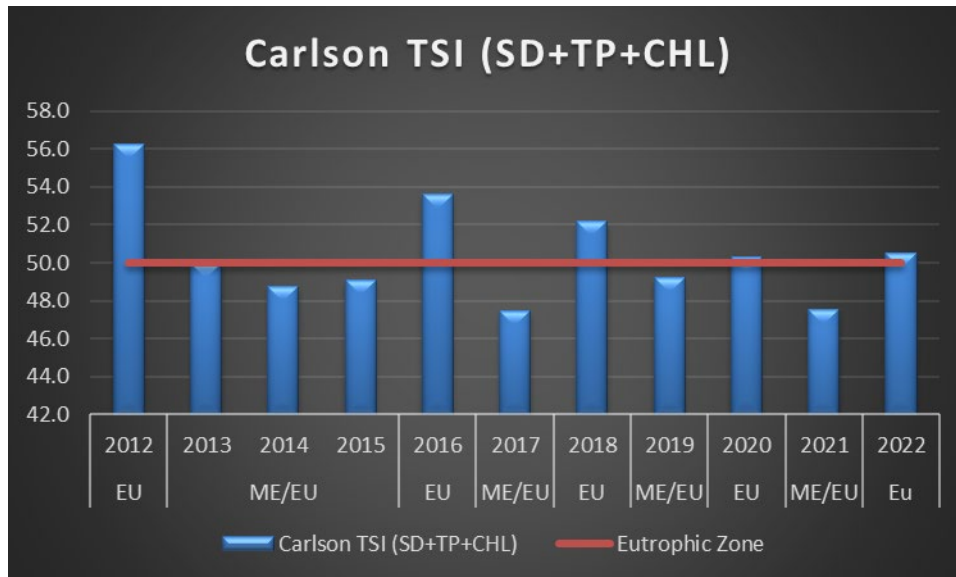
The trophic state of Evergreen Lake is currently balanced on the Eutrophic boundary (Figure 30 and 31). The Walker Index suggests the reservoir has already tipped into a Eutrophic state (Figure 30). The Carlson Index suggests the reservoir is at the mesotrophic/eutrophic boundary (Figure 31).

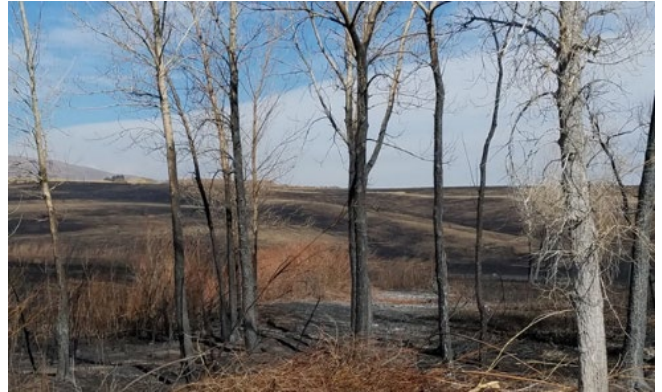
A water quality sample was taken at the Coyote Crossing and Coyote Gulch monitoring sites on February 11th. There was evidence of new melt runoff from the wildfire at the sites, but samples did not appear to have a significant water quality impairment (based on sediment observations). There was some ash in the water samples. It was apparent that the wildfire could alter upstream water quality in the spring runoff period, which could affect sediment loading, nutrient loading, water temperatures, dissolved oxygen, specific conductance, and pH. Additional water quality monitoring and flow measurements were done in 2021-2022 to determine the magnitude of water quality degradation and loadings caused by the fire (Figure 32).

The monitoring program was shifted to monthly sampling to better track burn water quality impacts. The 2022 runoff greatly increased nutrient loading throughout the year reaching Bear Creek Reservoir. The February nutrient loads for Total Nitrogen and Total Phosphorus were significantly increased from historical conditions (Figures 33 and 34). The nutrient loading increased about 500-600% over the previous post construction baseloads (Table 26). There was also an increased sediment loading, and subsequent erosion in the upper Coyote Gulch and along Coyote Crossing.
