2016 Hydrographic and Satellite Monitoring Branch Annual Report

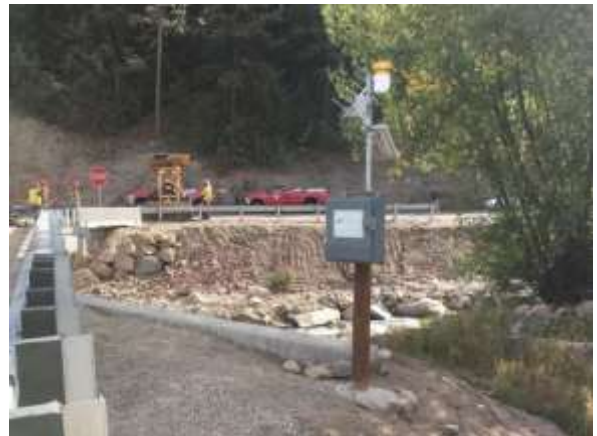
This year, the Big Thompson, North Fork Near Drake, CO (BTNFDRCO) was reactivated on September 14, 2016, three years and 1 day after the flood event following repairs made to the stream and adjacent infrastructure by Larimer County. Additionally, the United States Bureau of Reclamation also completed repairs to their Dille Tunnel Diversion (DILTUNCO) site and were able to divert water into and through the C-BT system this year.

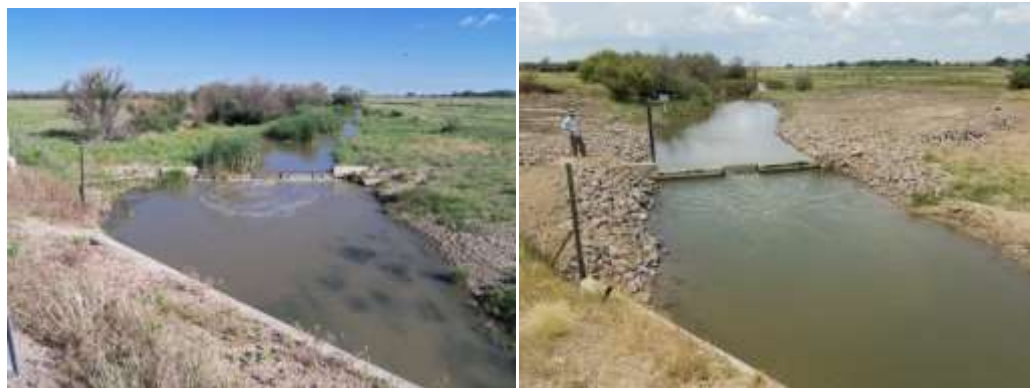
Horse Creek at Hwy 194 Before and After

- The existing compound weir at Horse Creek at Hwy 194 (HRC194CO) was allowing water to pass by the weir in higher flows due to a gradual shift in the channel. Upon analysis of satellite photography, it was determined that the channel shifted due to increased growth of aquatic vegetation in the weir pool and along the channel. The weir walls were extended approximately 15-20 feet on either side of the weir using sheet pile. The channel was reshaped, cleaned out and armored with rip-rap. The approach to the weir was cleaned out and the banks re-armored to protect the new sheet pile weir. This site had also had a failing CFB line. Due to the warm water and availability of bionutrients, algal growth would occur on and in the CFB. The CFB was replaced with a radar level sensor attached to a steel I-beam driven 8 feet into the upstream weir pool. Data quality has been excellent at this site after the upgrade. Division 2 staff undertook the design and managed the construction. Gracious support was provided by the Fort Lyon Canal Company, who has an interest in this gaging site.

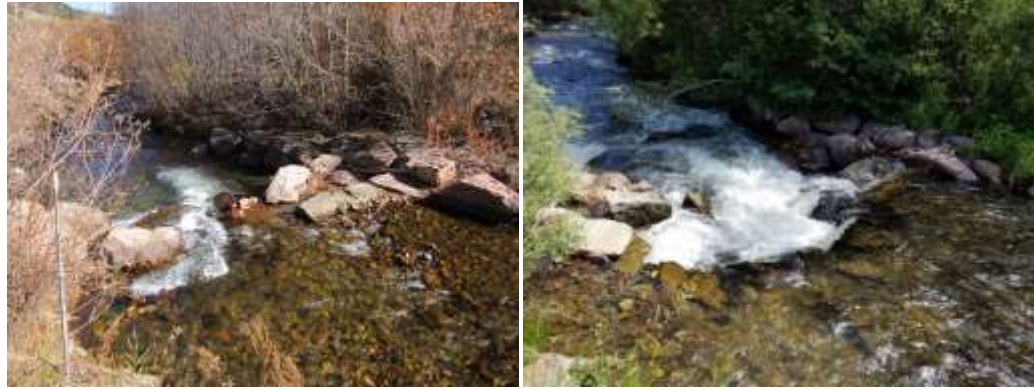
Huerfano River near Redwing (HURREDCO)

- The rock weir control was reconstructed at Huerfano River at Redwing (HURREDCO). The previous control had collapsed over time and shifts to the rating showed that there had been a decreasing trend in the reliability of the control. Using larger boulders nearby, a heavier duty control was constructed trying to implement a "cross vane weir" type configuration with a better armored scour pool to prevent scour related erosion and collapse of the new weir. A radar level sensor was also installed to replace the failing stilling well. Construction efforts and spring run-off compromised the reliability of the stilling well. Efforts to repair the stilling well failed, so installing a non-contact level sensor seemed appropriate. Division 2 staff undertook the design and construction, oversight and construction management for the weir as well as the mount for the radar. A levels survey is required spring of 2017 to determine ice affect damage from the winter.

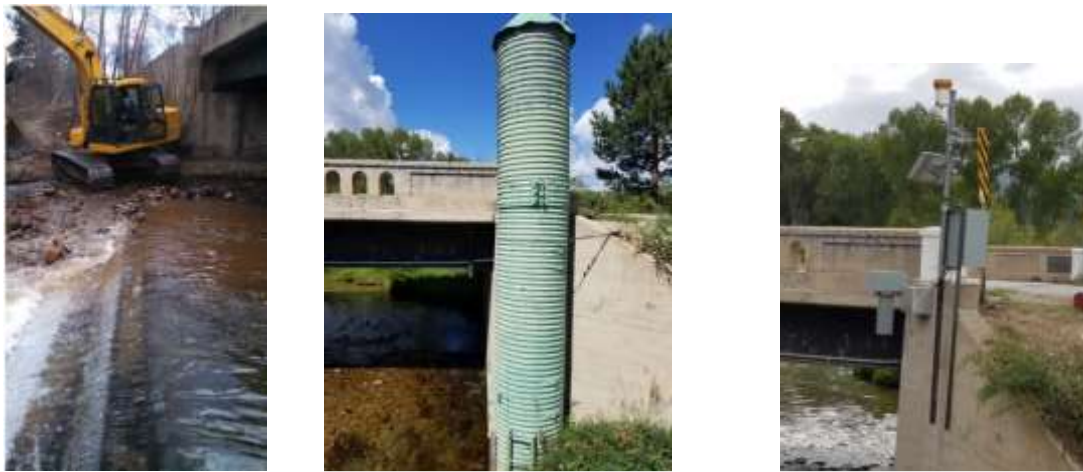
Chalk Creek at Nathrop (CHCRNACO) Weir C/O, SDR “rocket ship”; new Primary

- The weir pool at Chalk Creek near Nathrop (CHCRNACO) had significantly filled in and was starting to erode downstream of the control. A project was undertaken to clean out the weir pool and shape the channel downstream of the existing of the existing control. An effort to use existing materials to develop hardened banks was undertaken as well. The old stilling well was also removed from service and a radar level sensor was installed. Division 2 oversaw and assisted with the construction as well as performed construction management.

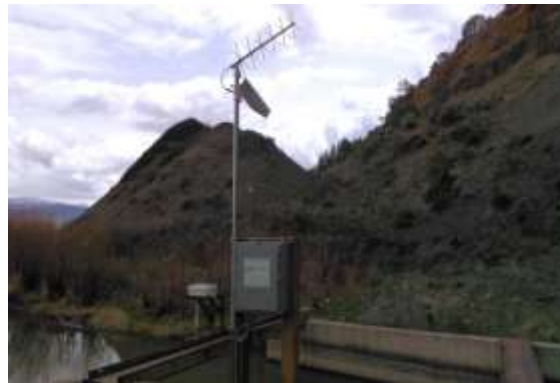
New SMS & Radar West Canal Tunnel

- New Gaging Station the Overland Ditch at Oak Mesa. This helps three Water Commissioners to save time and mileage in their administration. The Uncompahgre Valley Water Users Association became cooperators to install SMS on six of their main diversions from the Uncompahgre River to help with their efficiency in operating flows from the Gunnison Tunnel. These installations were accomplished by David Hutchens in three phases and the UVWUA has been very pleased with the results.
 - The Montrose and Delta Canal
 - The Selig Canal
 - The East Canal
 - The Loutsenhiser Canal
 - The Garnet Ditch
 - The West Canal Tunnel

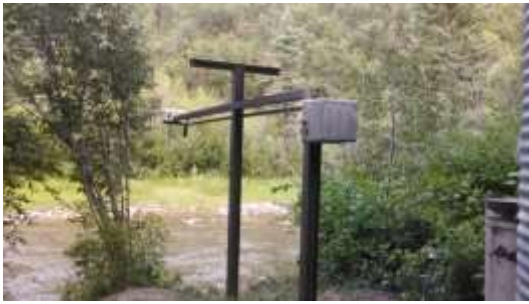
- A new cantilevered radar water level sensor and wire weight gage was installed at Muddy Creek above Paonia Reservoir. The stilling well inlets were continually silting in and experienced varying degrees of drawdown during higher flow regimes. This upgrade has increased efficiency and accuracy at MUDAPRCO.

New Radar and Wire Weight Gage at MUDAPRCO

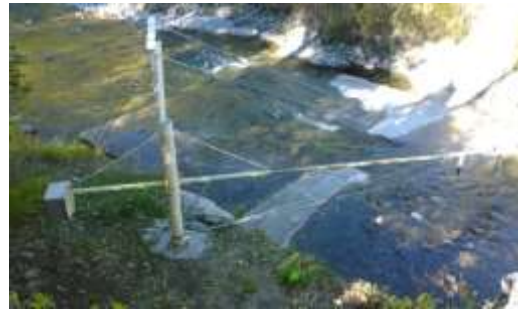
- An existing cantilevered wire weight gage was modified to accept a radar water level sensor at Cow Creek nr. Ridgway Reservoir. This alleviates problems with the bubbler orifice end being buried during flash rain events and spring runoff.

New Radar on an existing cantilever at Cow Creek nr Ridgway Reservoir.

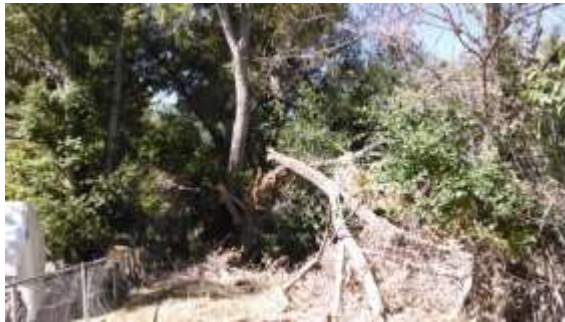
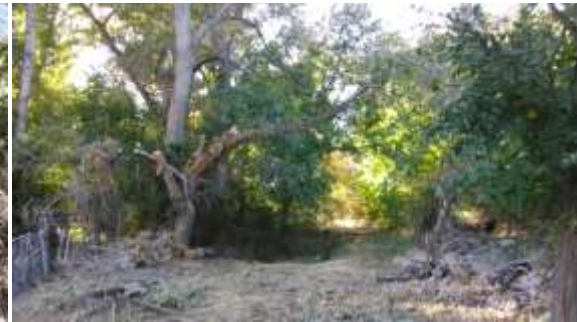
- The two track access road into the Uncompahgre River nr. Olathe runs through an over mature grove of cotton wood trees. There were two occasions when blow down had to be cleared to gain access to the gage.

Uncompahgre River near Olathe access road blow down before and after.

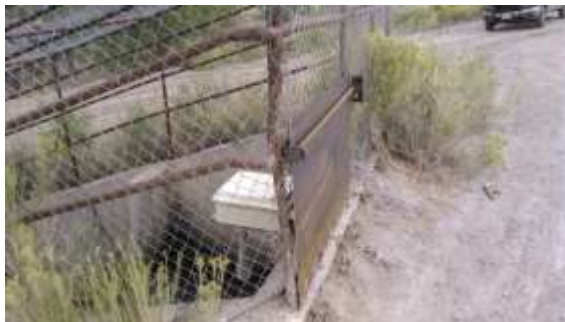
- The radar unit at the Fairview Diversion was vandalized. Project 7, the domestic water supplier for much of the area, cooperated in fabricating a security plate.

Fairview Diversion security plate.

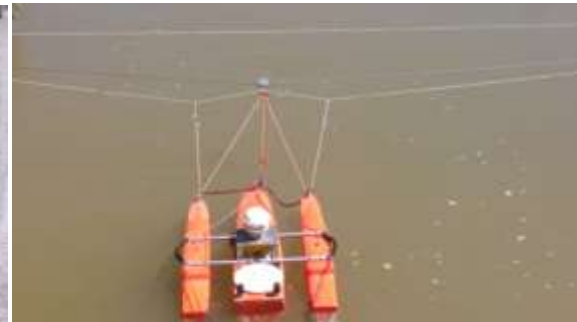
The RioPro at the Ironstone Canal

The Rio Grande Workhorse which had been in service in Division 4 since 2005 was upgraded to a Rio Pro which entailed new electronics. The ability to measure even more shallow depth allowed one ADCP instrument to be used in a wider range of deployments. This allowed the Stream Pro in use since 2005 in Division 4 to be redeployed to Division 3 in Alamosa.

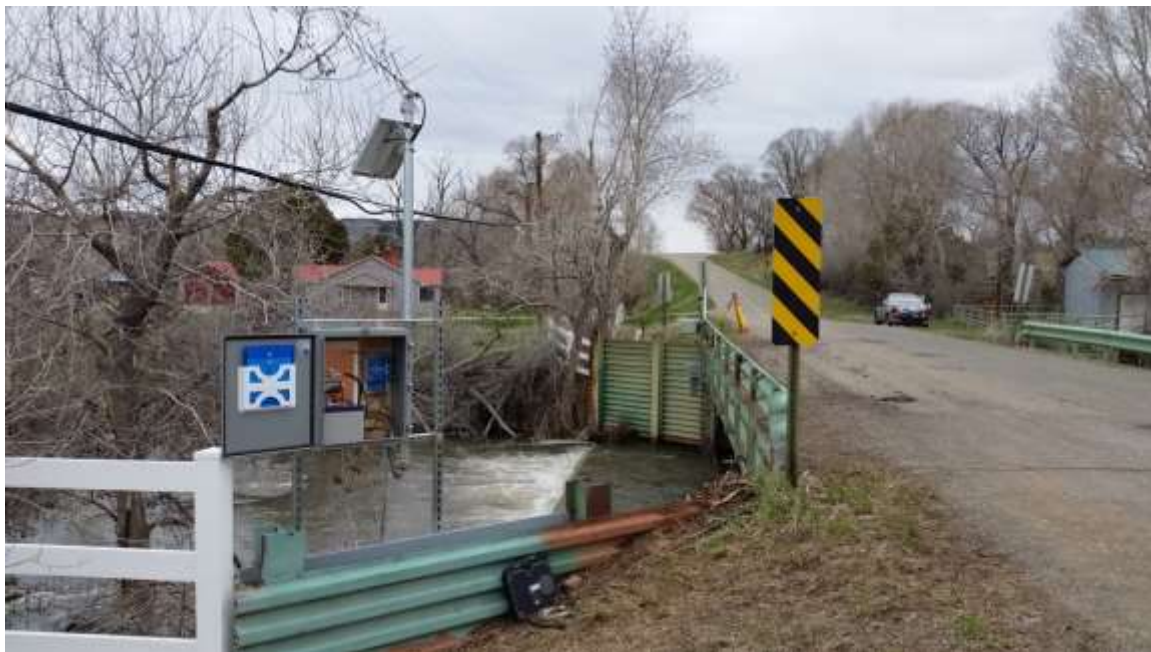
MANCHICO

- Upgraded the Jackson Canal (JACCANCO) to a radar water level sensor.
- Division 7 installed a new radar gage on the Mancos River at CJ's Bridge (MANCHICO) which is located approximately 2,300 feet below Chicken Creek. The new gage was installed to provide administrative support for the Mancos water commissioner in district 34.
