# Colorado Department of Transportation Roadside Fen Inventory

May 2018

Lemly, J., K. Schroder, L. Long, and G. Smith. 2018. Colorado Department of Transportation Roadside Fen Inventory. Colorado Natural Heritage Program, Colorado State University, Fort Collins, Colorado.

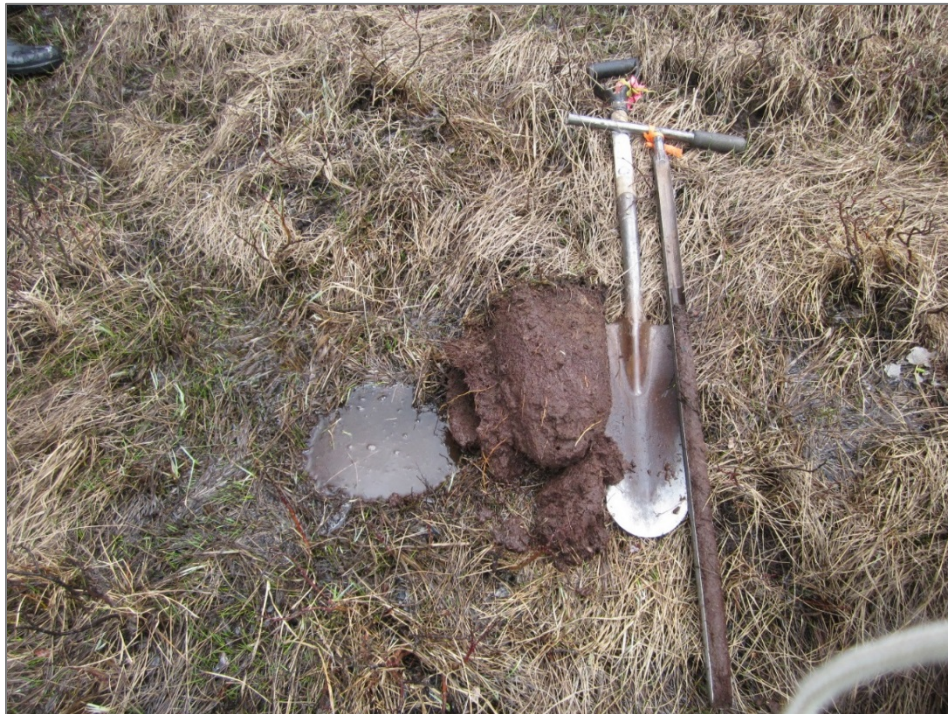
**Figure 2. Soil cores taken with a sharpshooter shovel and a gouge auger.**

Soil cores were either dug with a 40-cm sharpshooter shovel or sampled with a 100-cm gouge auger (Figure 2). The auger provided quick access to deep in the soil profile with little ground surface disturbance, but in some circumstances the auger could not adequately break through the soil and the sharpshooter shovel was used instead. Pits dug with a sharp sharpshooter shovel were slightly larger than the width of the shovel on all sides to minimize disturbance to the ground surface. Pits were dug to the depth of one shovel length, when possible. The core was removed and set down next to the pit, and care was taken to keep all horizons intact and in order. Pits were always back filled after data were recorded to avoid leaving a tripping hazard for wildlife or people. Because it was difficult to dig soil pits in areas with deep standing water, crews concentrated on areas with no or shallow standing water.

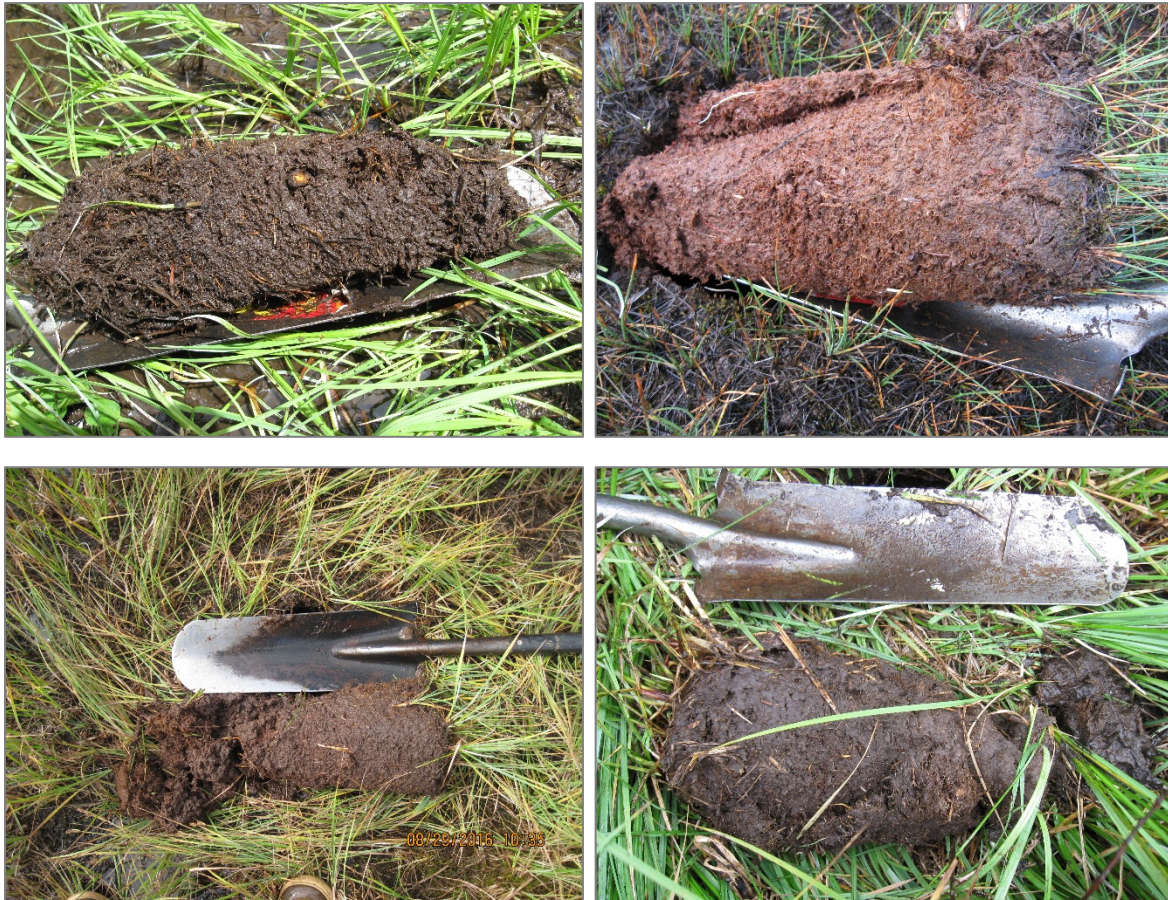
**Figure 3. Examples of organic soil. Note the presence of roots and fibric organic material throughout the soil core. Color may be dark brown to reddish brown depending on source material. Soil holds together.**

For each soil core, the depth of organic material observed, if any, was recorded. The gouge auger allowed for observations deeper in the soil profile (up to 100 cm) than the sharpshooter shovel (up to 40 cm). If the core was dug with a sharpshooter shovel, only the top 40 cm of the soil profile was visible, but this was typically enough to confirm whether the polygon was a fen (Figure 3).

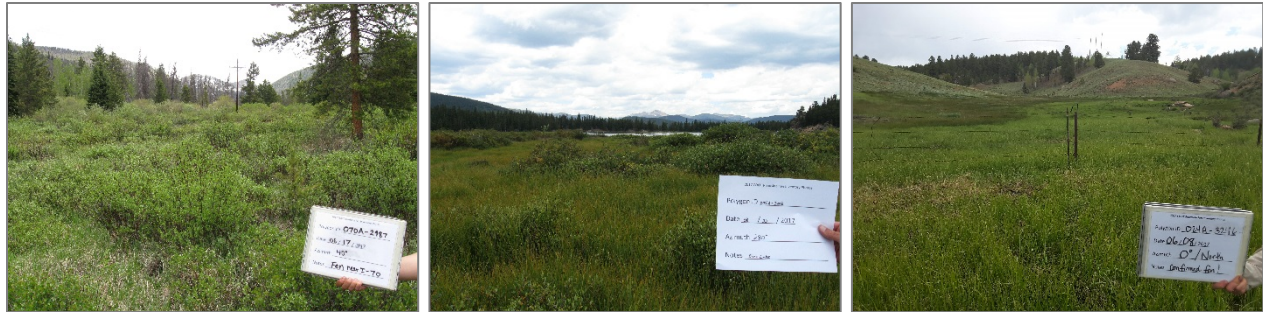
**Figure 4. Example photos. Note placement of photo placard in corner and information written on placard.**

At least one representative photo was taken for each confirmed fen and these photos were taken with a photo placard whenever possible (Figure 4). Photo placards were placed in the very corner of the photo, taking up only a small portion of the frame, with as little arm or body visible as possible. The fen polygons ID was written in full on the first line of the placard (e.g., 285A-2347). The second line of the placard contained the date, and the third line contained the direction of the photo.

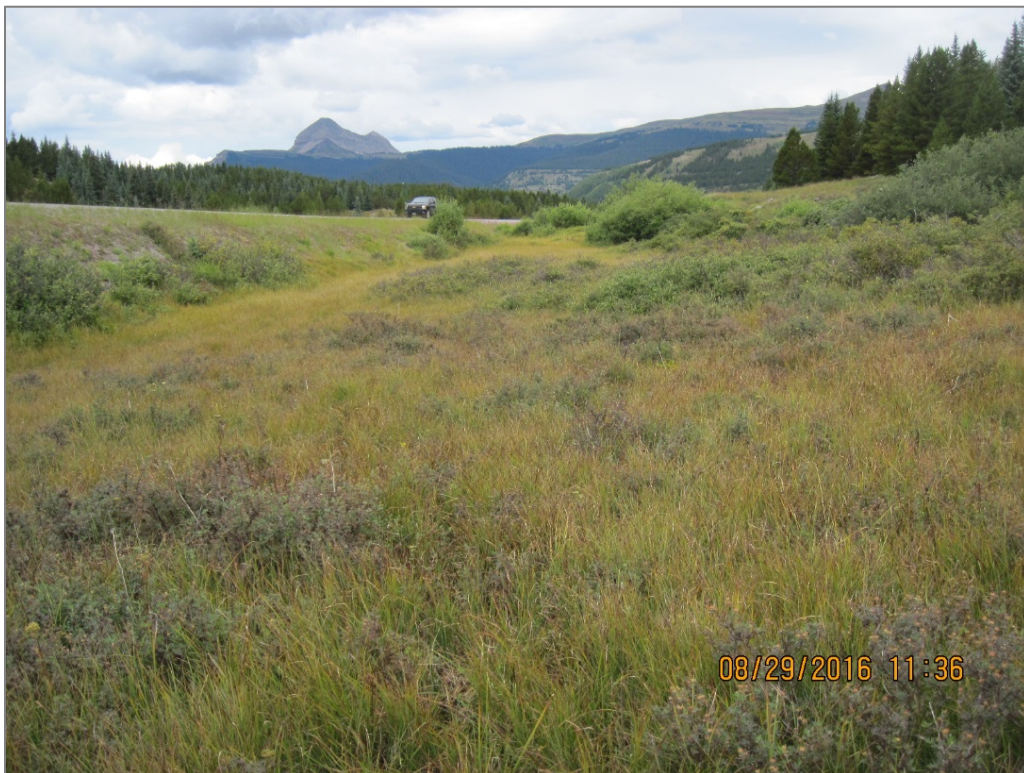
**Figure 9. Polygon 550B-0363 in the Molas Pass area. This fen was immediately adjacent to the highway and was likely bisected when the road was built.**

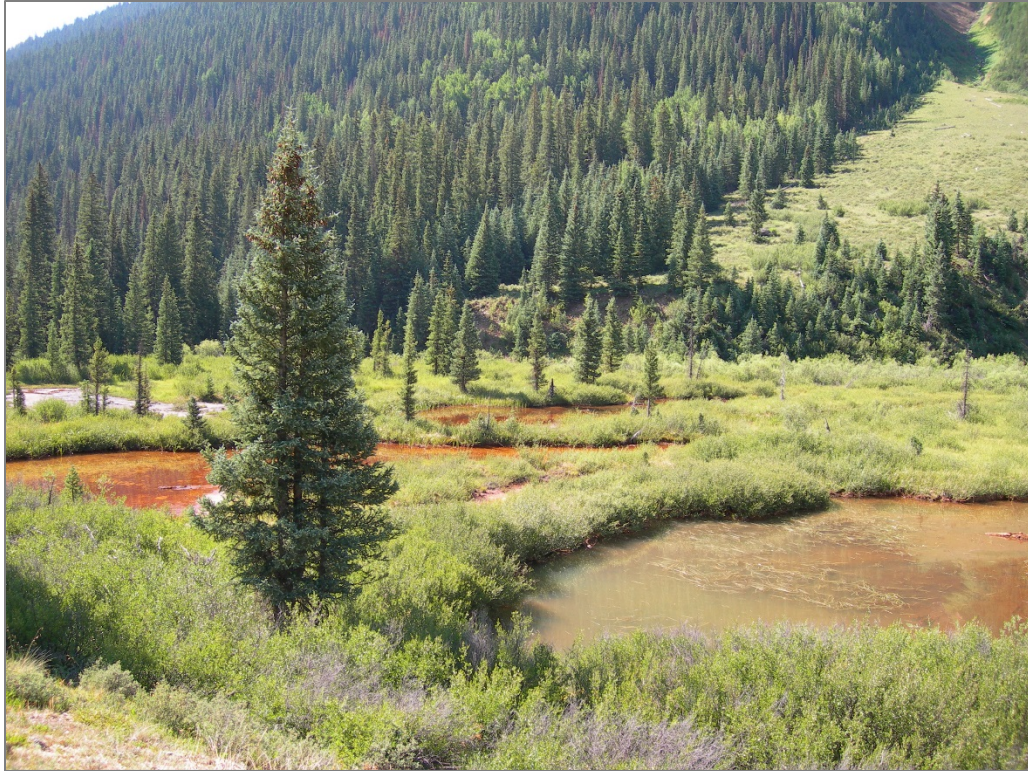
**Figure 11. Polygon 550B-0583, Chattanooga Iron Fen along Mineral Creek outside of Silverton. Photo taken in 2007 as part of the Chimner et al. (2008) study.**

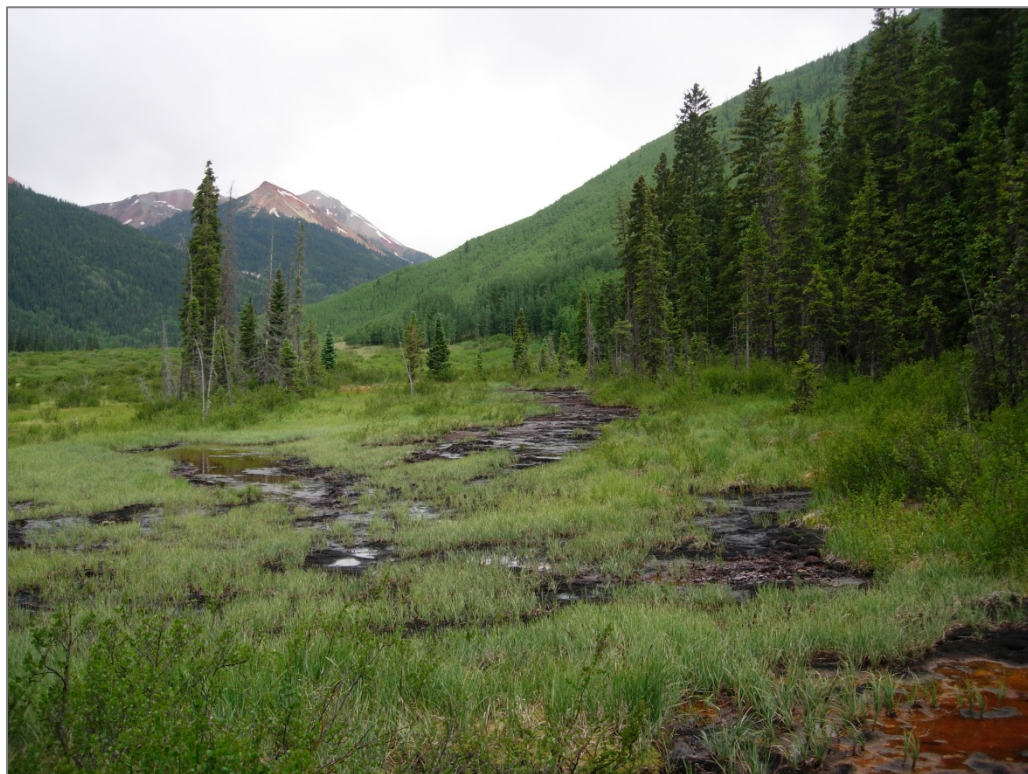
**Figure 12. Polygon 550B-0871 in Ironton Park. Note pools of iron-rich water. Photo taken in 2006 as part of the Chimner et al. (2008) study.**
