# Research Newsletter

Spring 2009

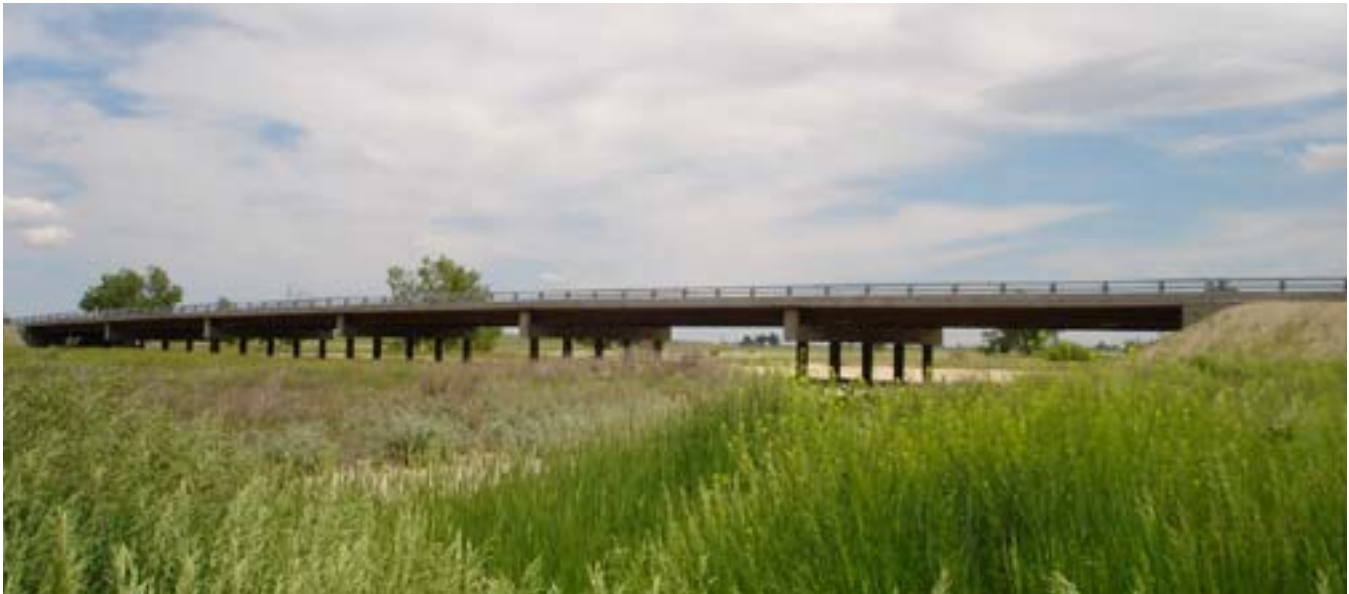
CDOT's first simple made continuous steel bridge, completed in 2006, crosses Box Elder Creek on U.S. 36

The research study focused on investigating the use of compact rolled sections in the application of a simple made continuous design and construction approach to steel bridge design. Design elements include steel beams placed and designed as simply supported for self weight and wet concrete, termed dead load I; the beams designed as continuous and composite (designed to carry railings, wearing surface, etc.), termed dead load II; and the composite continuous section designed to carry live load.

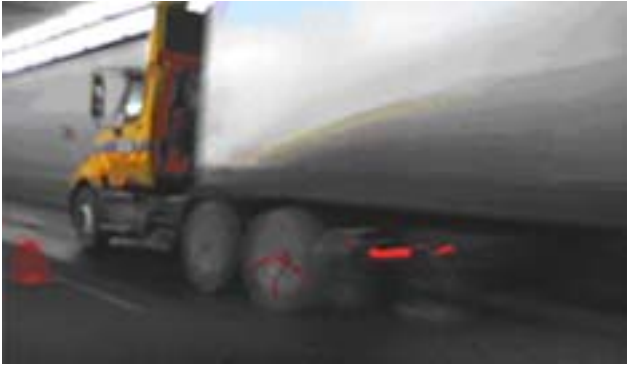
The CDOT Research Branch is currently involved in the evaluation of the in-service performance of AutoSocks for Trucks™, an alternative (to chains) traction device that received probationary approval last May for use during the winter season. The Research Branch was instrumental in developing an approval process and criteria so that alternative traction devices can be evaluated and approved. Colorado chain law requires that to be accepted as an alternative a device must demonstrate traction equal to or better than chains. AutoSocks' manufacturer submitted results of tests conducted by third parties which demonstrated that AutoSocks for Trucks can outperform traditional chains in terms of starting traction, hill climbing traction, braking traction, and lateral acceleration. Comparison was also made to chains in terms of durability in snow and

on dry roads, as well as ease of installation. AutoSocks for Trucks demonstrated durability sufficient to traverse I-70 from the east side of Floyd Hill to the west side of Vail Pass under snow conditions. They could also go that far on dry pavement (which chains can't) if driven under 25 MPH. Installation is a snap – the 4 AutoSocks for trucks required for a typical tractor (outboard drive wheels, as shown in the photo) can be installed in a couple minutes without prior instruction, whereas chains take about 30 minutes to install even for those who have practiced.
