State of Colorado 2006 Flood Documentation Reports

Prepared by: ICON Engineering, Inc 8100 S. Akron St. Suite 300 Centennial, CO 80112 303-221-0802

Prepared for: Colorado Water Conservation Board 1313 Sherman St. Room 721 Denver, CO 80203 303-866-3441

June 2007

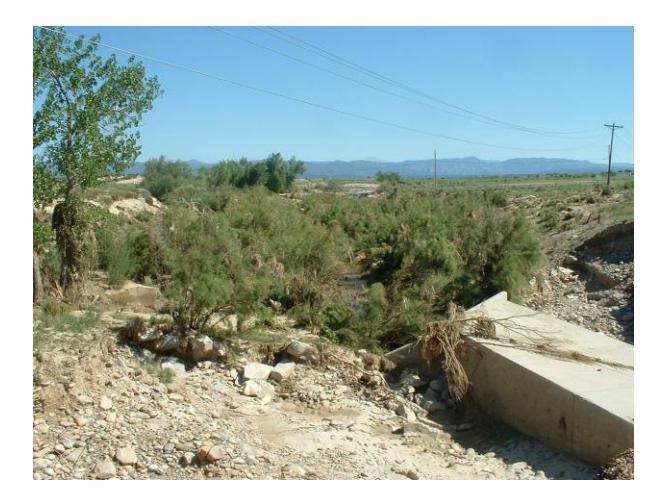
Figure 1.20 – Brush Hollow Creek - Highway 115 Culvert Looking Upstream

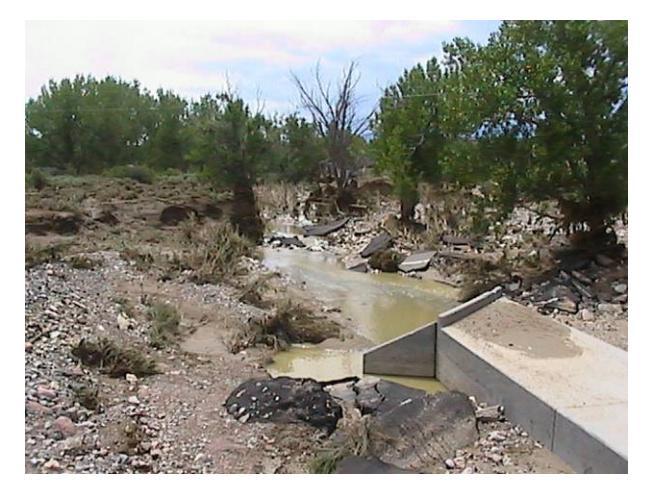
Figure 1.21 – Brush Hollow Creek - Highway 115 Culvert Looking Downstream

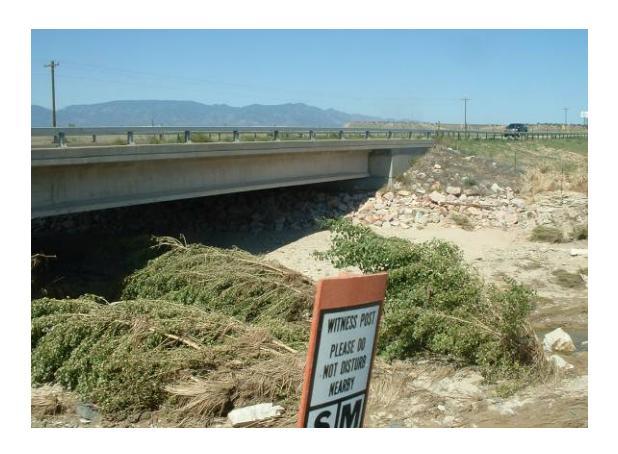
Figure 1.27 – Brush Hollow Creek Highway 50 Bridge – Eastbound Bridge Note: no reported overtopping.

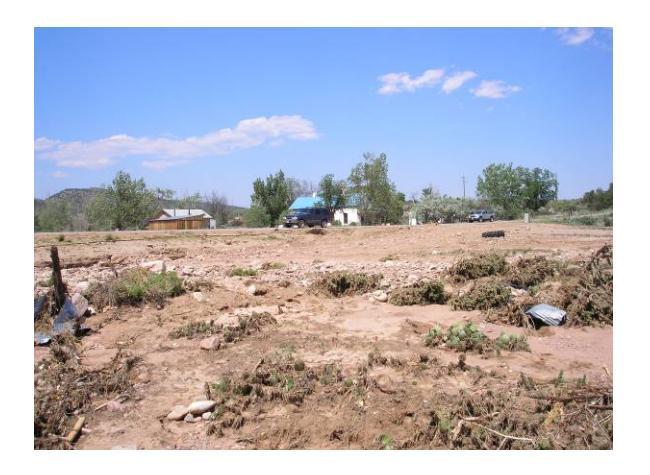
Figure 1.32 – County Road 123 at Eightmile Creek Looking Upstream Towards Coffee Residence

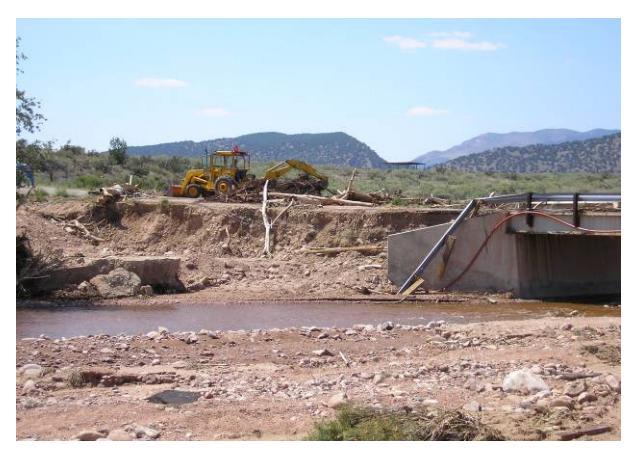
Figure 1.34 – County Road 123 at Eightmile Creek, Downstream Wing-wall

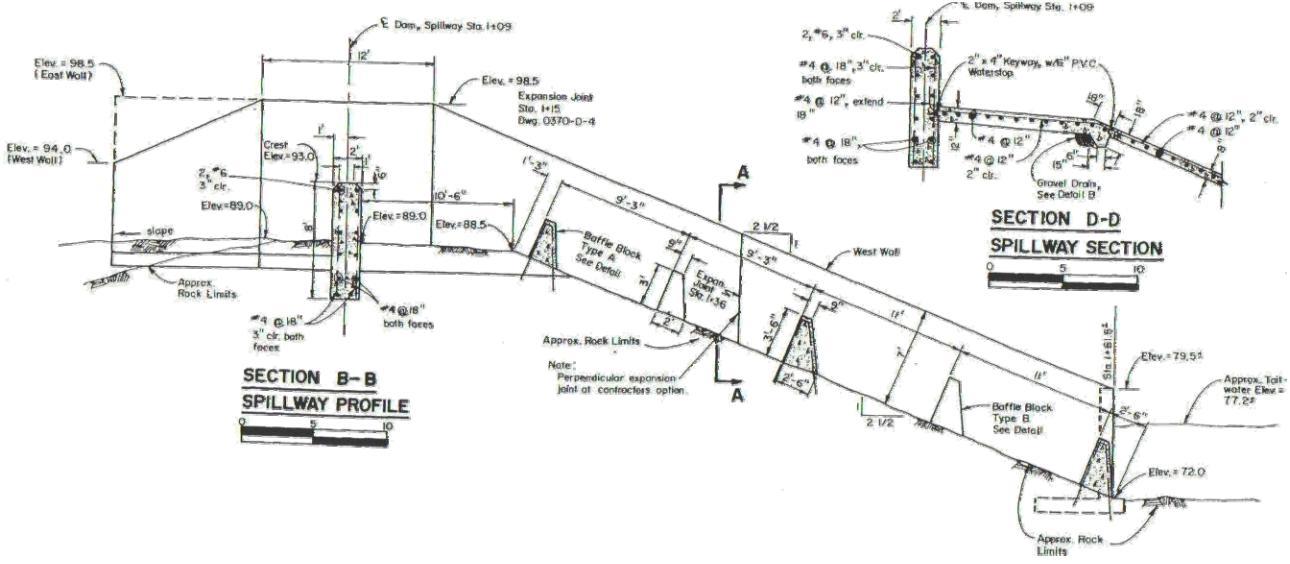
spillway indicates that the actual height of the wingwalls is closer to 5.3 feet. The spillway has a maximum capacity of approximately 2900-cfs corresponding with 5.3-feet of head. This spillway is concrete-lined and has a 75-feet wide crest. Figure 2.15 (below) was taken from the dam construction drawings.

Figure 2.15 – J.O. Hill Dam Spillway Design

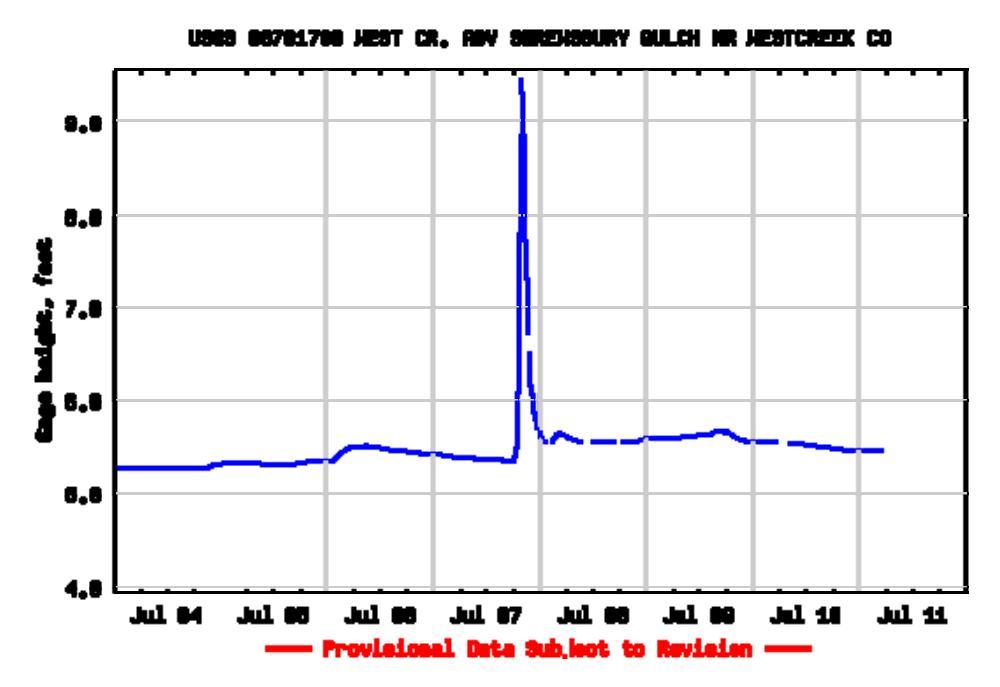
A USGS reservoir and precipitation gage is located upstream of the dam crest along the bank of the reservoir. Based upon the information provided by the State Engineer's office, a total of 2.28 inches of precipitation was recorded (with a corresponding maximum outflow of 2170-cfs) from 6:00PM to midnight on July 7, 2006. It is worth noting that the method for determining the flow rate was not indicated. Table 2.2 summarizes this data and Figure 2.16 shows a graph of the gage height at this location.

Figure 2.16 - Gage Height at USGS Gage Located Upstream of the J.O. Hill Dam

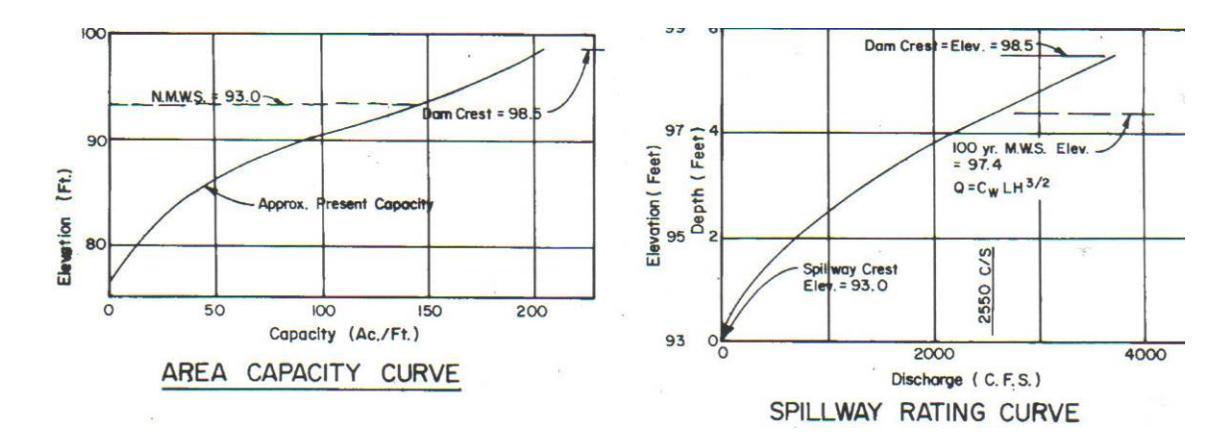
Figure 2.17 – Area Capacity and Spillway Rating Curves for the J.O. Hill Dam Spillway

Figure 2.17 shows the area capacity curve and spillway rating curve taken from the dam design drawings. Note that the elevations shown in the design drawing curves are not necessarily on the same vertical datum as the USGS Gage information provided in Table 2.2.

The spillway rating curve in Figure 2.17 shows that the 100-year maximum water-surface was designed to be at an elevation of 97.4, with a corresponding discharge of 2550-cfs, and a depth of flow equal to 4.4-feet above the spillway crest. Using this depth and discharge, the spillway crest length of 75-feet, and the design weir equation of: $Q=C_w LH^{3/2}$, the design value of C_w can then be determined as 3.68. Next, using the flow equation taken from the design drawings of the emergency spillway and the field surveyed high-water marks, the calculated flow over the crest at the height of the flood can be calculated.

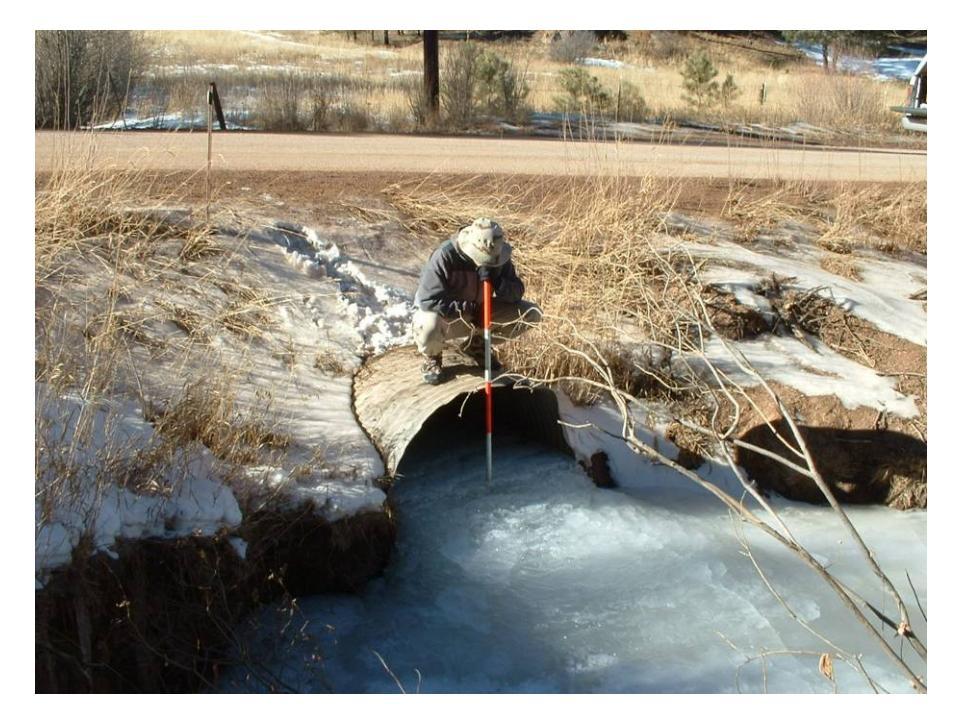
Abbey Avenue Culvert: Abbey Avenue crosses West Creek just upstream of Highway 67 and downstream of the J.O Hill Reservoir. Prior to the storm, the roadway had an 84-inch and a 48-inch corrugated-metal-pipe (CMP) culvert at this location. These culverts, and the gravel roadway above them, were extensively damaged during the flood. High-water marks upstream of the roadway indicate that the roadway crossing created a large backwater area behind the roadway before the road was eventually overtopped. ICON was not able to determine the degree to which the culverts were plugged with debris, nor could they determine the time frame between the creation of the high-water marks and the culvert/road failure. However, for the purposes of this analysis, ICON assumed that the road and culvert were intact at the time of the high-water.

Figure 2.18 – Picture of Abbey Avenue Crossing Along West Creek before July 7, 2006 Flood Picture courtesy of Moser and Associates Engineering

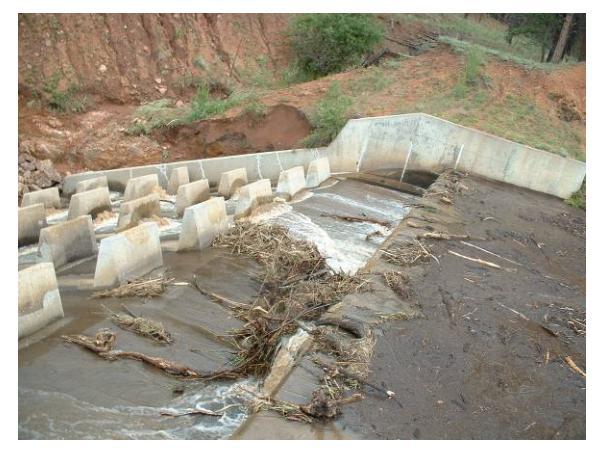
During the July 7th flood event, the reservoir was filled nearly to capacity but the flows did not overtop the dam. On July 11th, 2006, ICON Engineering, Inc. (ICON) surveyed some high-water marks on the face of the dam which indicate that the water-level in the reservoir rose to a depth of 3.56-feet above the crest of the emergency spillway which was within 1.4-feet of the designed crest elevation of the dam. Observations made after

the storm event also indicate that the low-point of the dam crest was actually less than the elevation called out in the design drawings for the dam. Further field observations indicate that the reservoir came to within 0.5-foot of overtopping at the dam low-point. After the July 7th flood, this low point, which was adjacent to the emergency spillway, received several loads of fill which built-up the crest of the dam.

Figure 2.19 – West Creek – J.O. Hill Reservoir Emergency Spillway

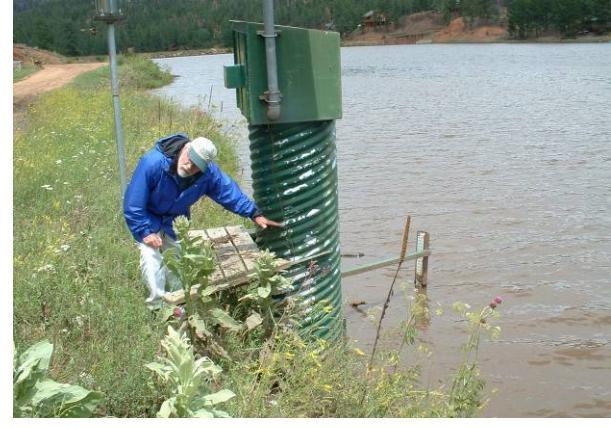
Figure 2.20 – West Creek – High-water Mark on USGS Gaging Station at J.O. Hill Reservoir

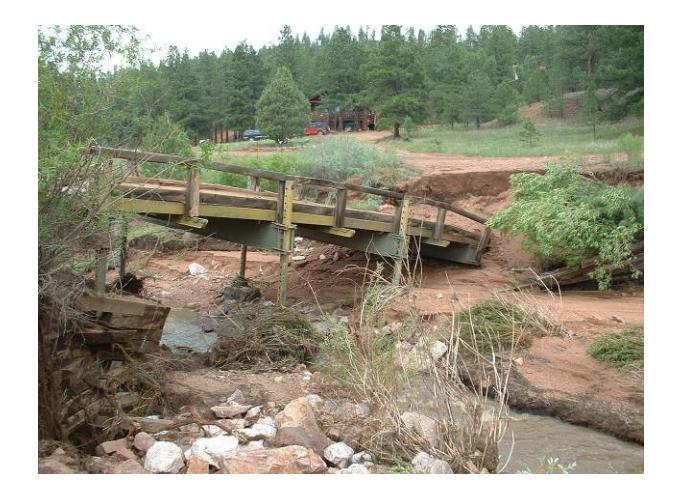
Figure 2.21 – West Creek – Private Bridge Downstream of J.O. Hill Reservoir

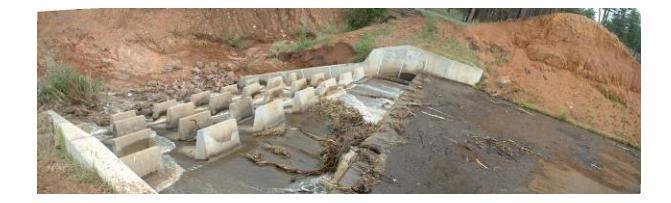
Figure 2.23 – West Creek – J.O Hill Reservoir Emergency Spillway Panorama. High water mark is approximately 12-inches below wall.

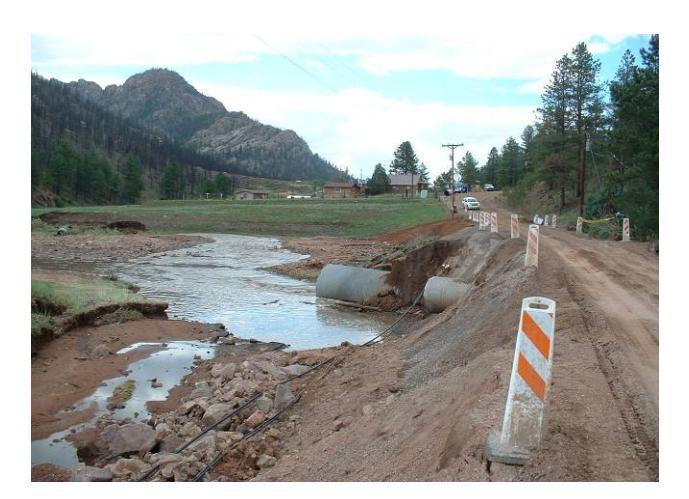
Figure 2.25 – West Creek – Abbey Road Crossing

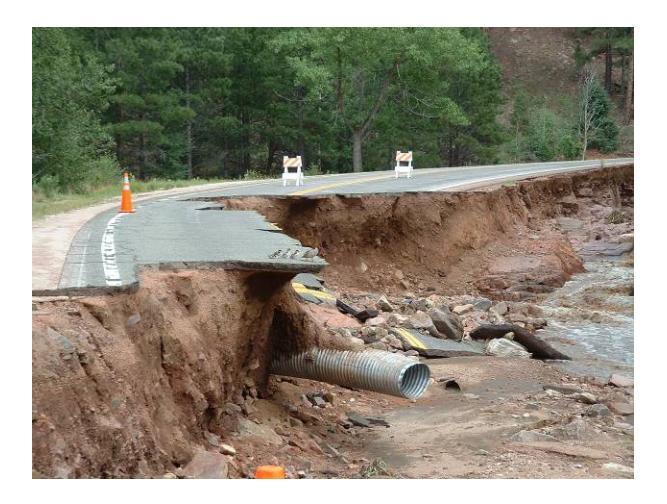
Figure 2.27 – West Creek - Highway 67 Culvert Looking Upstream

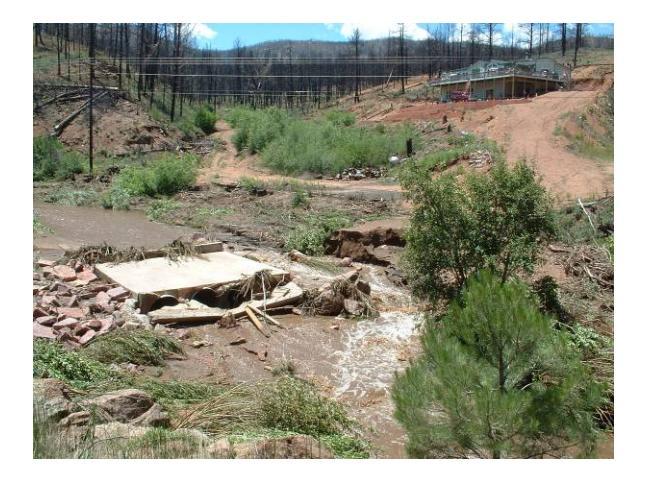
Figure 2.34 – West Creek - Highway 67 Damage

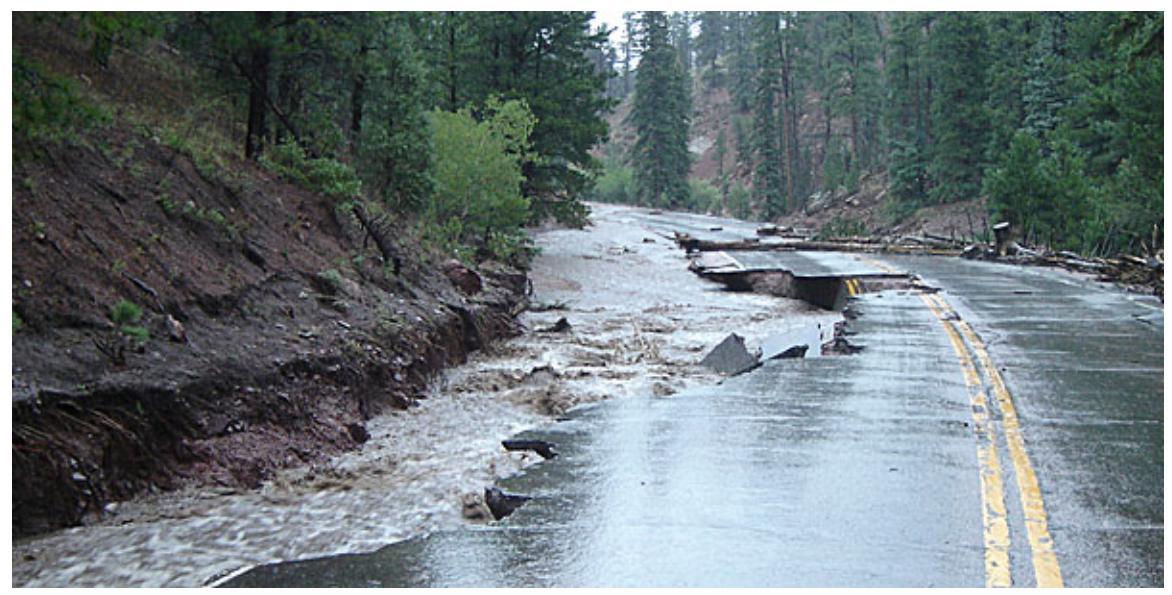
Figure 2.39 – Picture Taken of State Highway 67 along West Creek during July 7th Flood Photo Courtesy of the Douglas County Office of Emergency Management

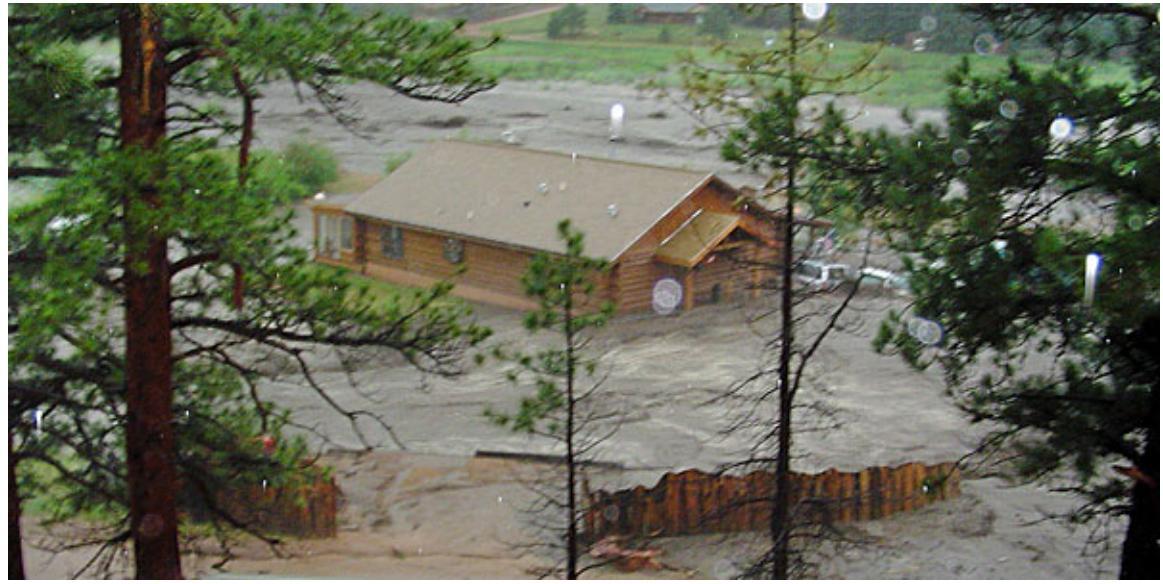
Figure 2.40 – Picture Taken of Residence along West Creek during July 7th Flood Photo Courtesy of the Douglas County Office of Emergency Management

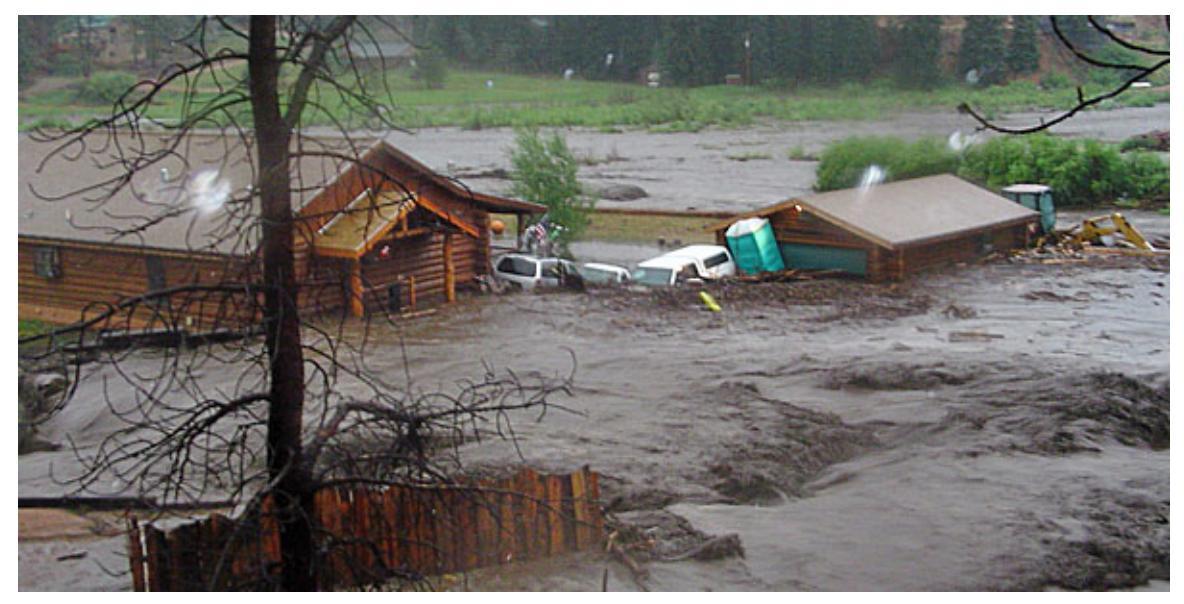
Figure 2.41 – Picture Taken of Residence along West Creek during July 7th Flood Photo Courtesy of the Douglas County Office of Emergency Management

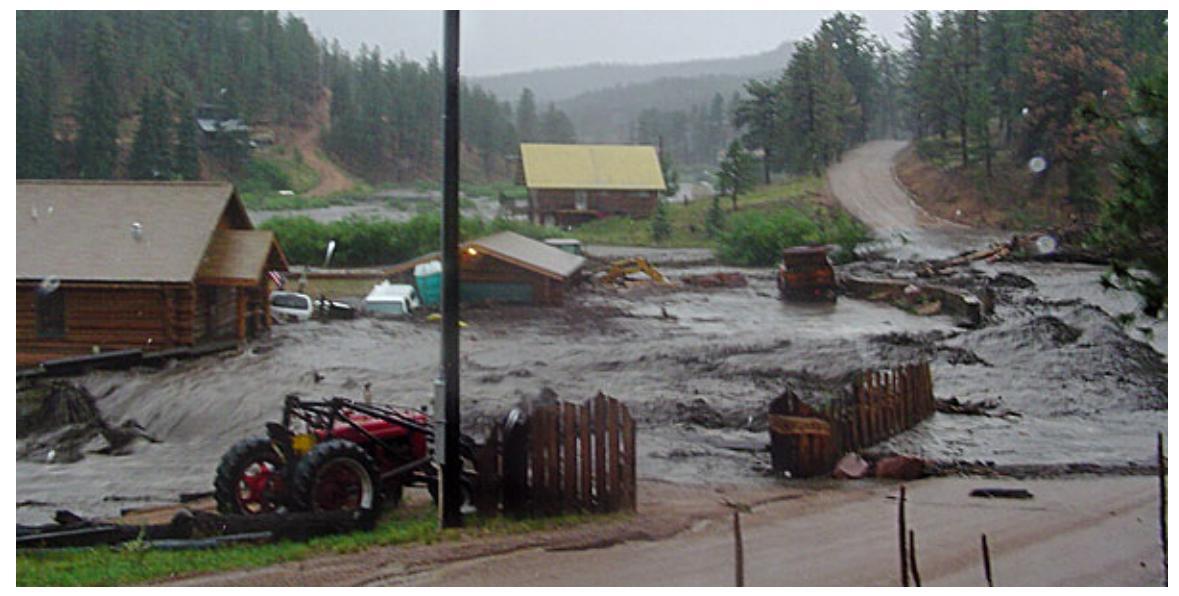
Figure 2.42 – Picture Taken of Residence along West Creek during July 7th Flood Photo Courtesy of the Douglas County Office of Emergency Management

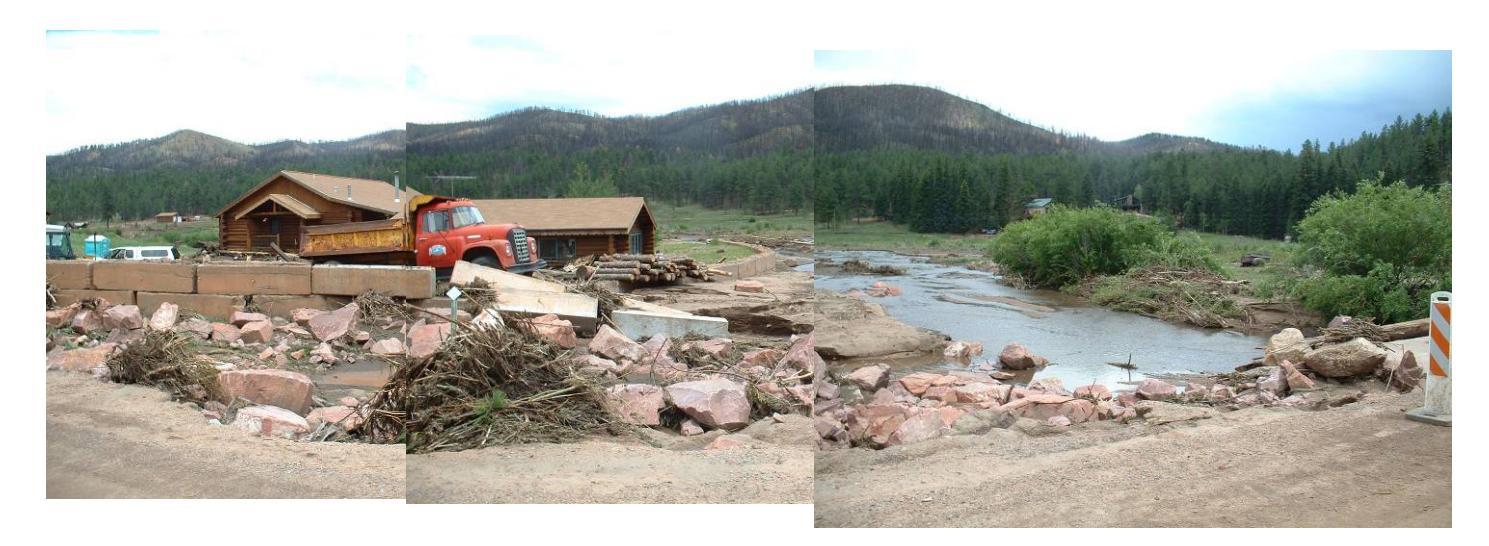
Figure 2.43 – Panoramic Pictures Taken from Road Crossing on July 11th of Residence in Pictures 2.40 thru 2.42

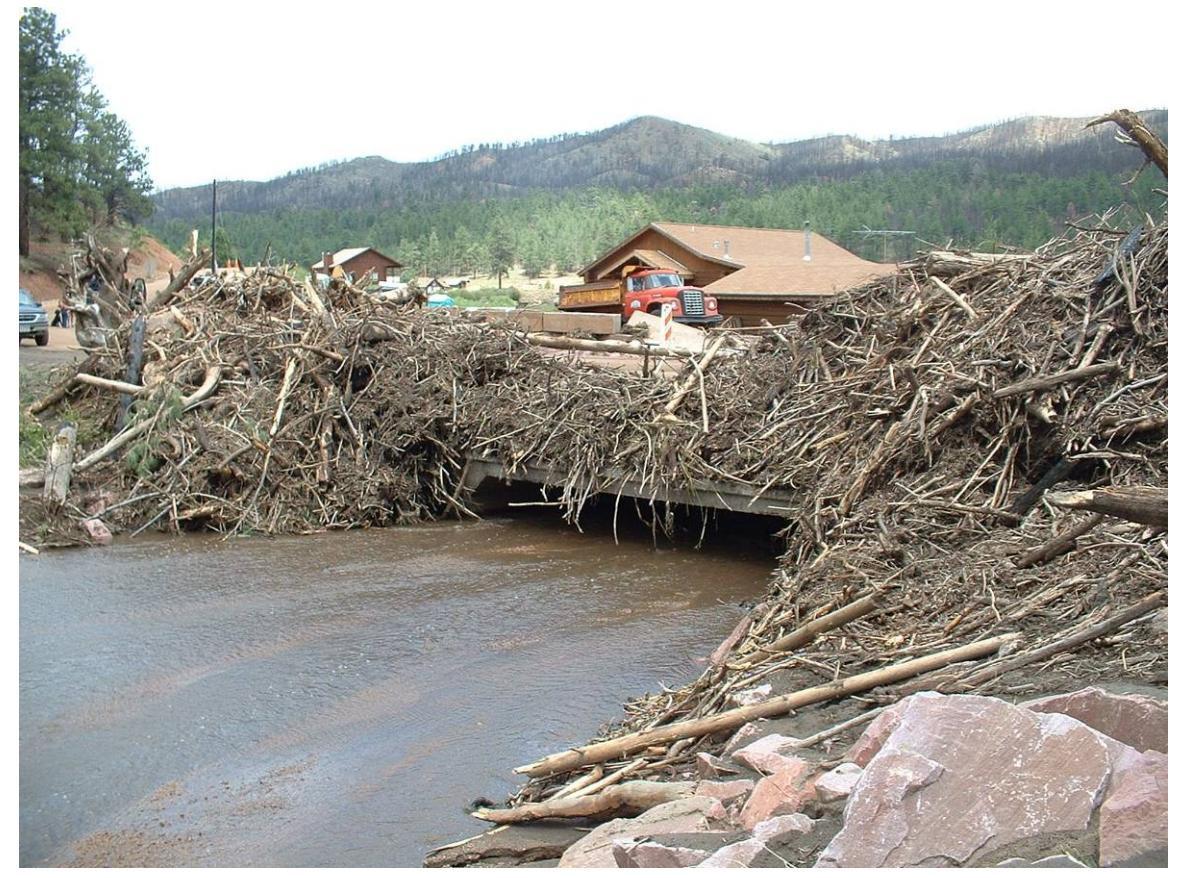
Figure 2.44 – Picture Taken from Upstream of Box Culvert at Road Crossing on July 11th
